500 kV Tower Incident (Cressy) 31 January 2020

Incident report

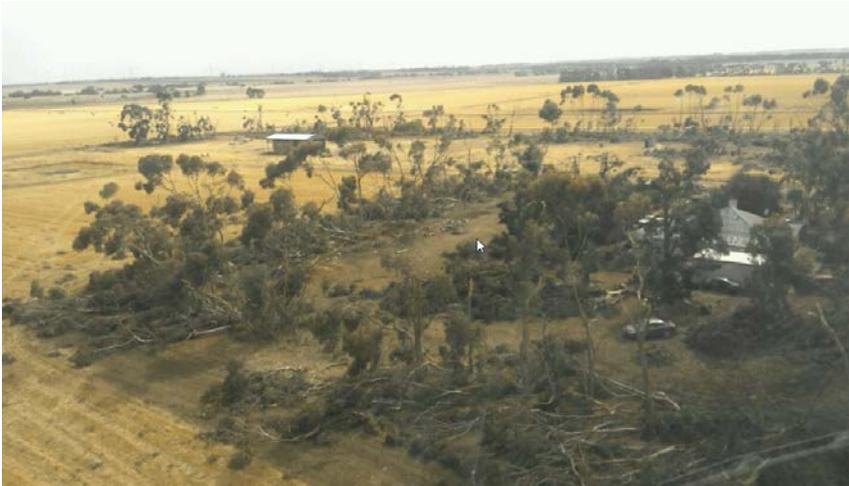
From the evidence of damage at the site and in the local area, it appears that a severe convective downburst occurred in the local area, and the wind speed at the site when the towers collapsed was determined to have been in excess of 125 km/h.

Figure 2 - Damage to trees near the tower line

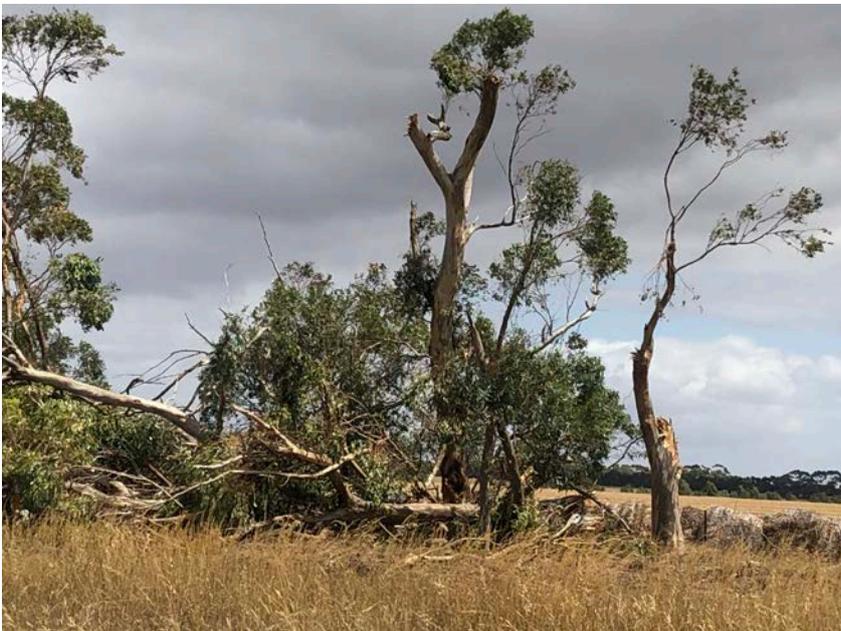
Figure 3 - Close up photo of damage to trees

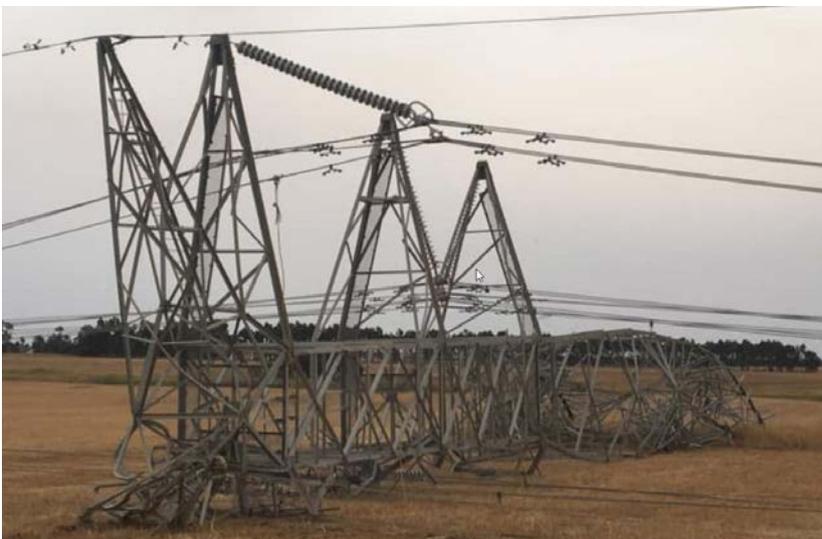
Figure 4 - One of the collapsed towers

ESV's investigation of the Cressy incident including of technical information provided by AusNet Services Transmission in relation to the incident concluded that the incident was caused by a severe weather event and beyond the design specification of the towers.
