Gnotuk Fire Ignition (Camperdown–Bullen Merri Fire) 17 March 2018

**Transformer Pole 8 Cross Forest
Road, Gnotuk**

Technical investigation report

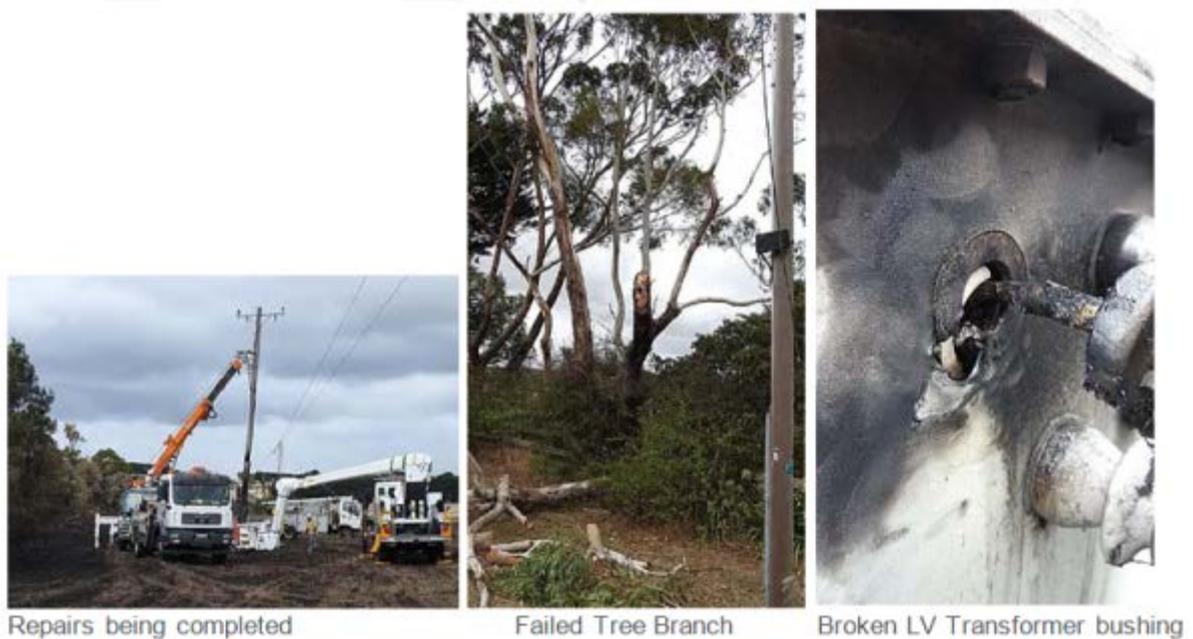
Figure 3: Images provided by CFA

These photos show the:

- pole replacement being undertaken by Powercor
- broken tree limbs on the ground
- position of limb failure on the tree
- damage of LV bushing of the transformer that was removed
- charring on the pole where the HV earth cable is assumed to have been attached.

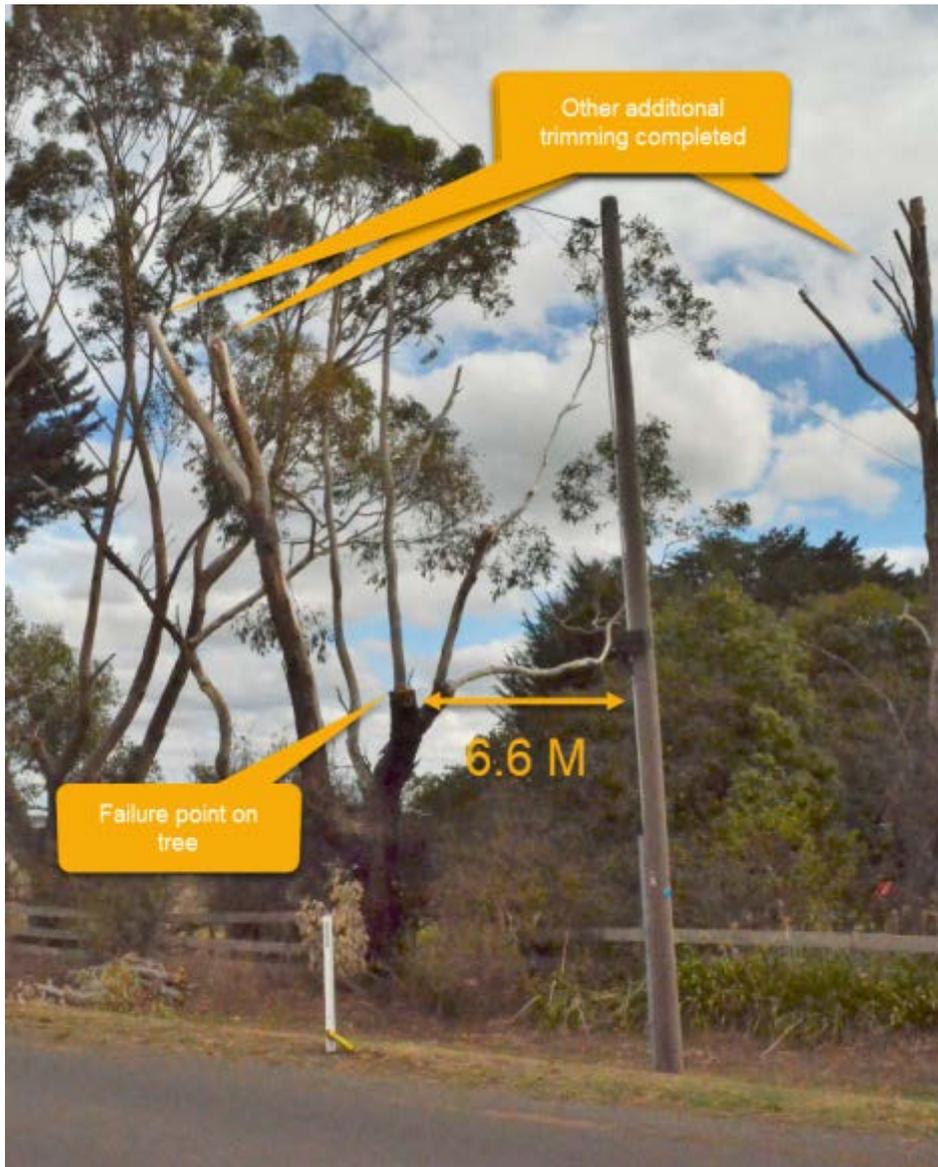
Figure 4: Details from ESV site visit

Site observations:

- the site visit indicated a tree, Eucalyptus species, had a branch that failed approximately four metres from ground level
- the tree was growing on the customers property
- the tree branch failure position was identified against photos supplied by CFA
- subsequent additional trimming of branches has been undertaken by Powercor's vegetation management contractor as advised by the land owner
- the location where the branch broke away from the trunk of the tree was measured at 6.6 metres horizontally from the service pole using a Laser Rangefinder⁴
- customer advised ESV investigators that the tree had previously been cut/trimmed by Powercor contractors in 2015 and 2017
- new Tx P8 was installed with a new service cable installed to the service pole.

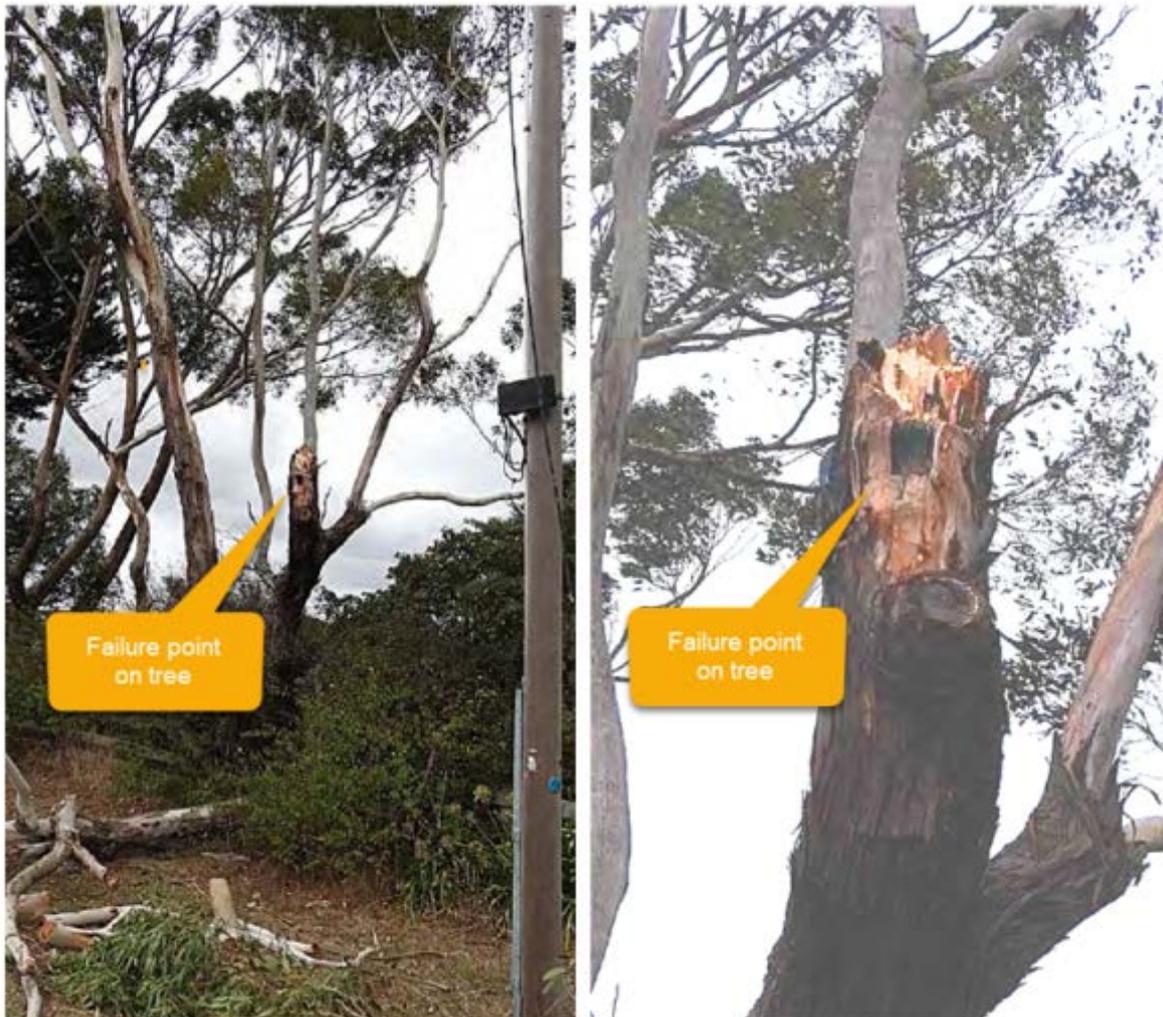
Figure 5: Image of failure point on tree

Figure 5 shows the failure point of the tree branch. The failed branch had grown from the site of an old wound where the tree had been cut back prior. The ESV arborist on site noted this as a point of structural weakness in the tree.

ESV concludes that the local damaging winds were strong enough to cause the limb to break and fall towards the powerlines.

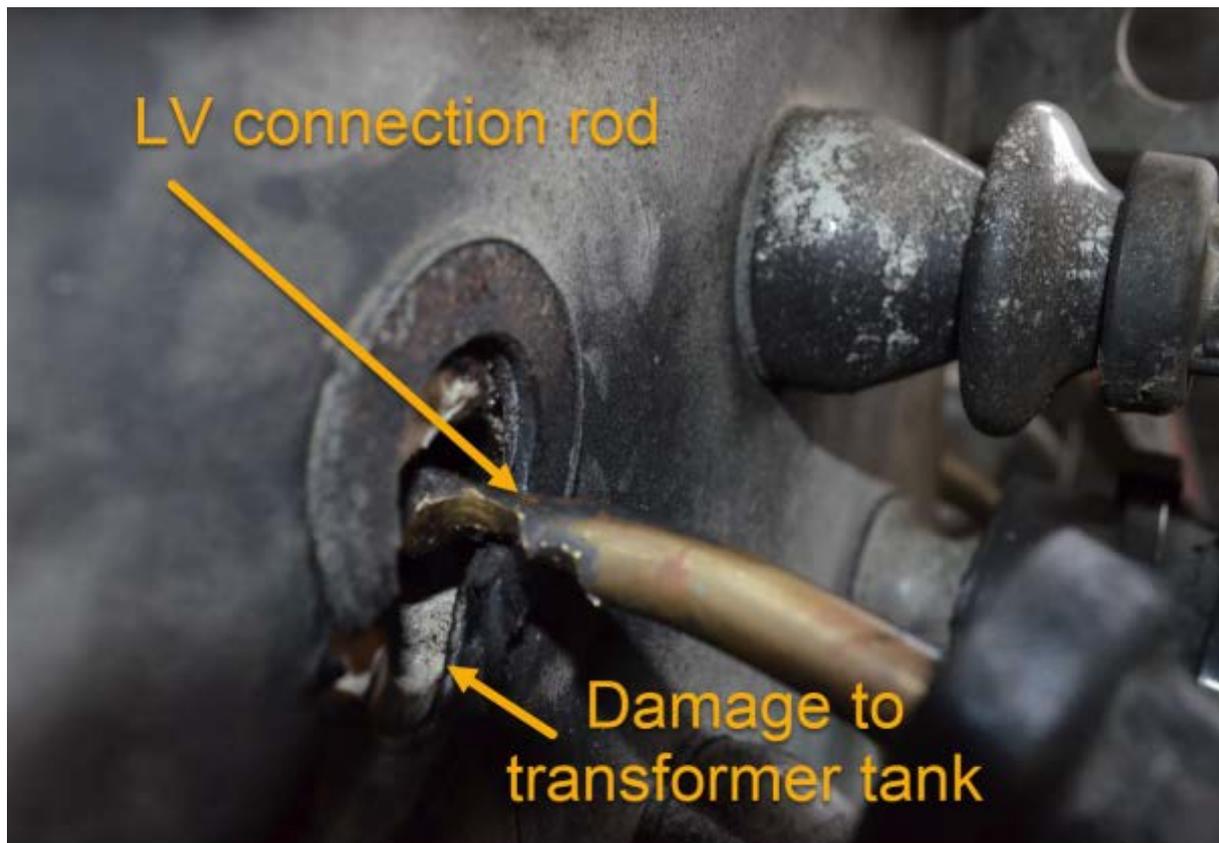
Figure 6: Damage to transformer

This inspection identified that at least half of the internal LV connection rod that attached to the LV terminal bushing had been melted away. This damage is consistent with the contact of the rod to the transformer tank. The transformer tank also showed signs of damage due to an arcing event as shown in Figure 6.

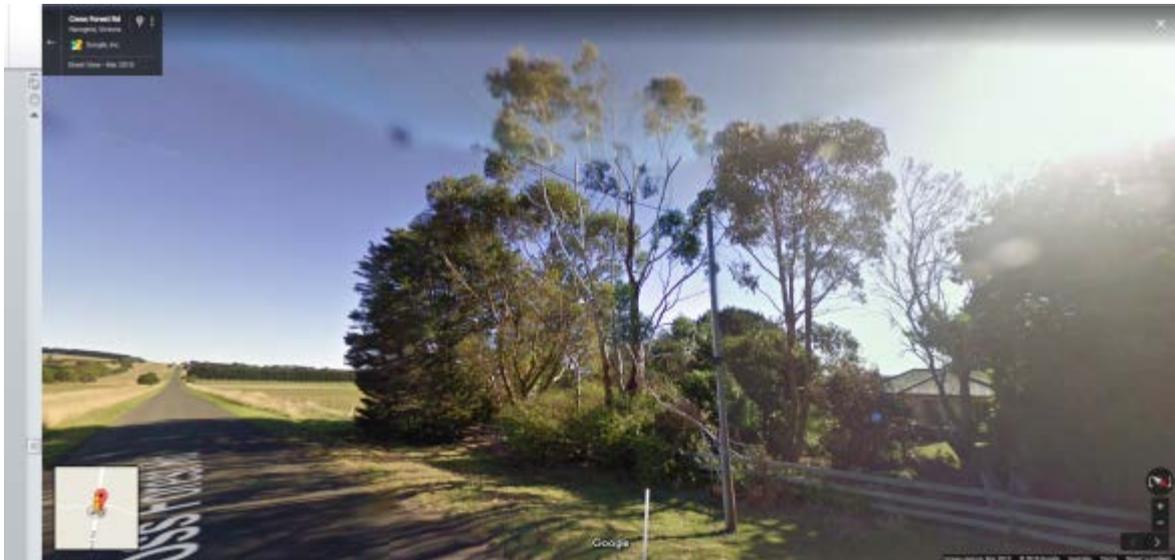
Figure 7: Google maps screen capture

From the evidence remaining on site and review of Google maps images (see Figure 7 & 8) it appears that the tree branch was attached in reasonably vertical position from the failure point and therefore at least 6m away from the service line. Due to its height above the failure point it was of sufficient length to contact the powerlines when it failed.

A search and review of images provided by Google maps⁶ shows the site and that the tree branches were well clear of the service cable at that time the photograph was taken (March 2010). The image also confirms that the failed tree branch was significant in length and height.

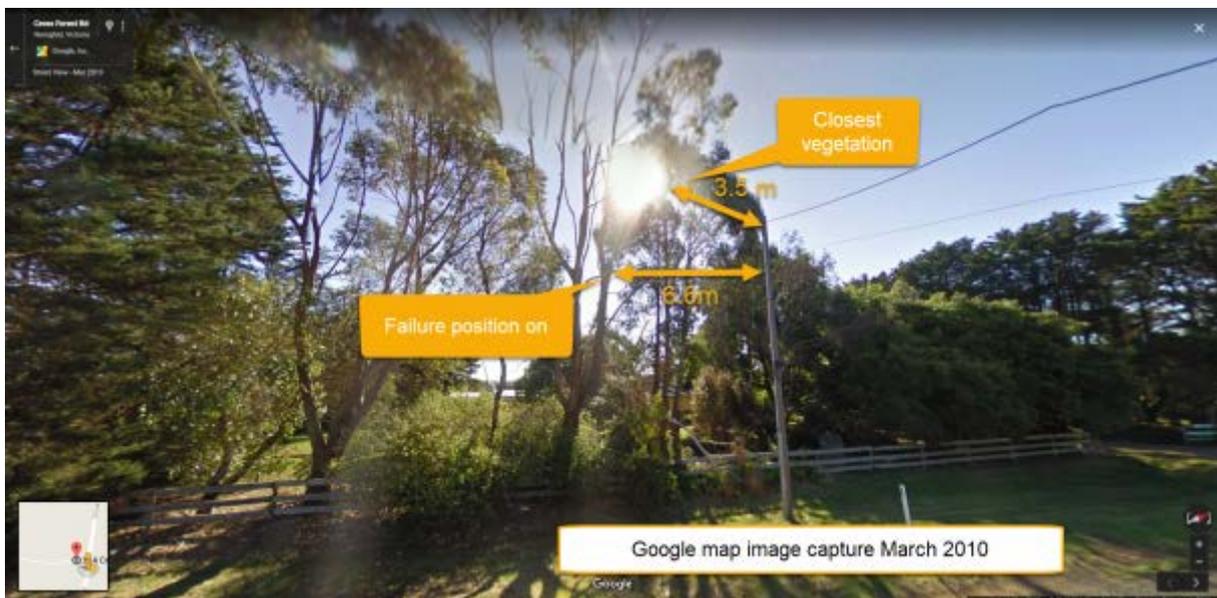
Figure 8: Marked up image with distances

Figure 8 below (Google maps image) shows the distances marked up from Google and LiDAR information sourced as part of the investigation.

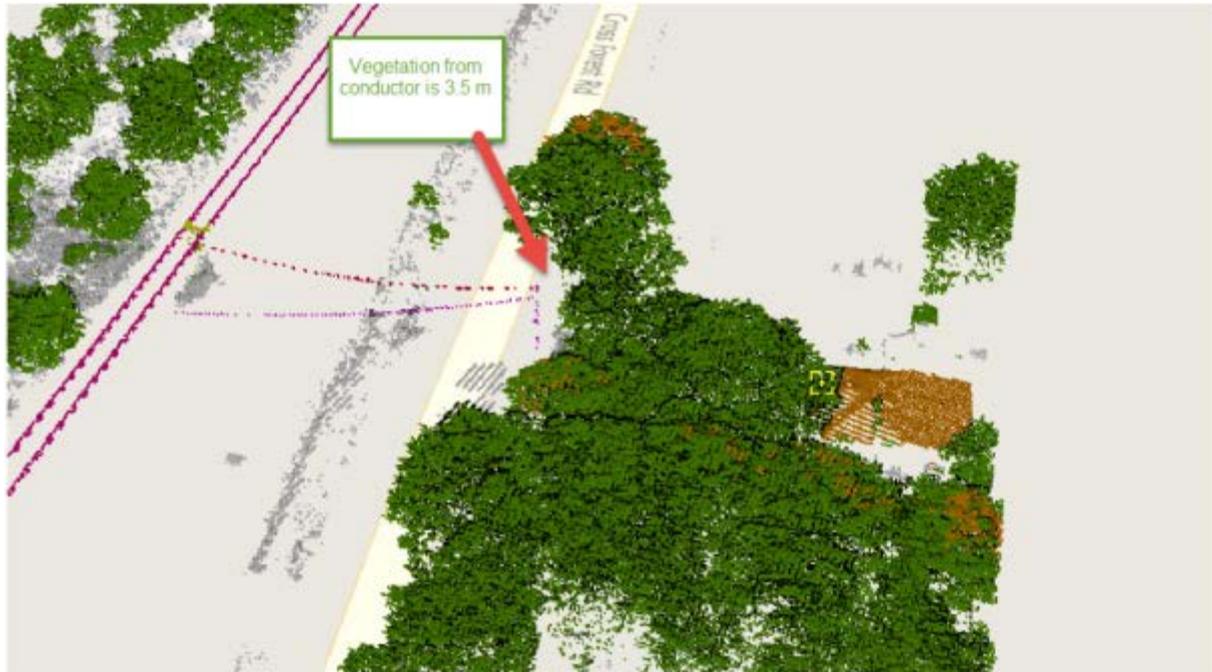
Figure 9: LiDAR image of site provided by Powercor

Powercor provided ESV with a copy of the most recent LiDAR (Light Detection and Ranging) measurements recorded for the incident site, from flight data recorded in 2017. The data indicates that the closest vegetation was assessed at 3.5 metres horizontally from the service line. See Figure 9 below.

From the above Google and LiDAR information provided, along with other images obtained and reviewed ESV is satisfied that the minimum clearance requirements as required by the Electricity Safety (Electric Line Clearance) Regulations 2015 were maintained prior to the incident.
