Minjah Fire Ignition 17 March 2018

**Tree failure Pole 322 Hawkesdale
– Minjah Rd, Minjah**

Technical investigation report

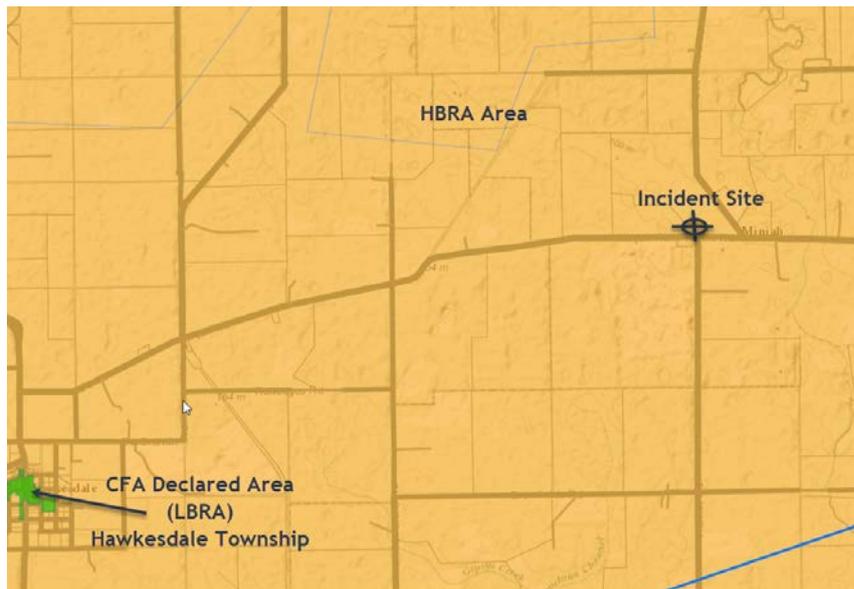
Figure 2: Incident site map

Figure 2 shows a map of the incident site in relation to the CFA declared Low Bushfire Risk Area (in green) and the HBRA area (in amber).

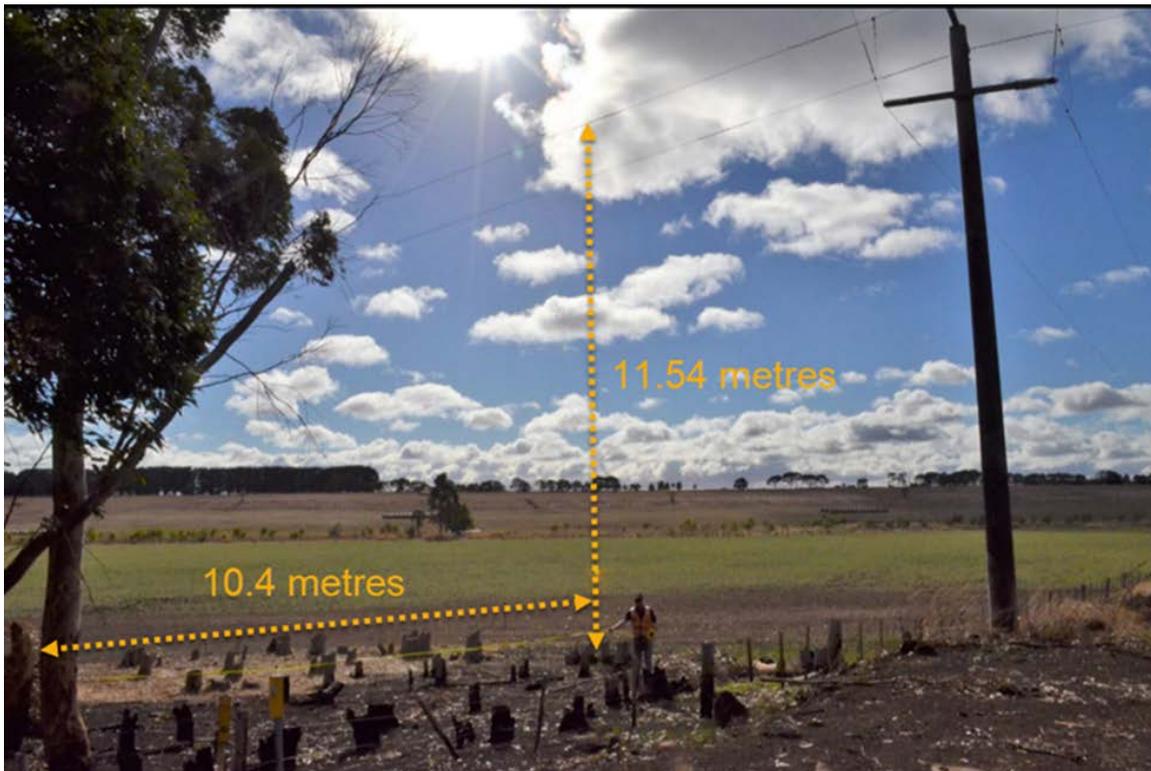
Figure 3: Tree position in relation to the HV conductors

- the horizontal distance measured from the tree stump failure position to the closest HV conductor was 10.4 metres as per Figure 3
- conductor height at the assumed contact point was measured at 11.54 metres using a Suparule Cable Height Meter⁴

From the evidence remaining on site it appears that the base of the tree was 10.4 metres away from the closest conductor, and therefore ESV determines that the failed limb was well outside the minimum clearance requirements under the Electricity Safety (Electric Line Clearance) Regulations 2015, however it was of sufficient length to contact the powerlines when it failed.

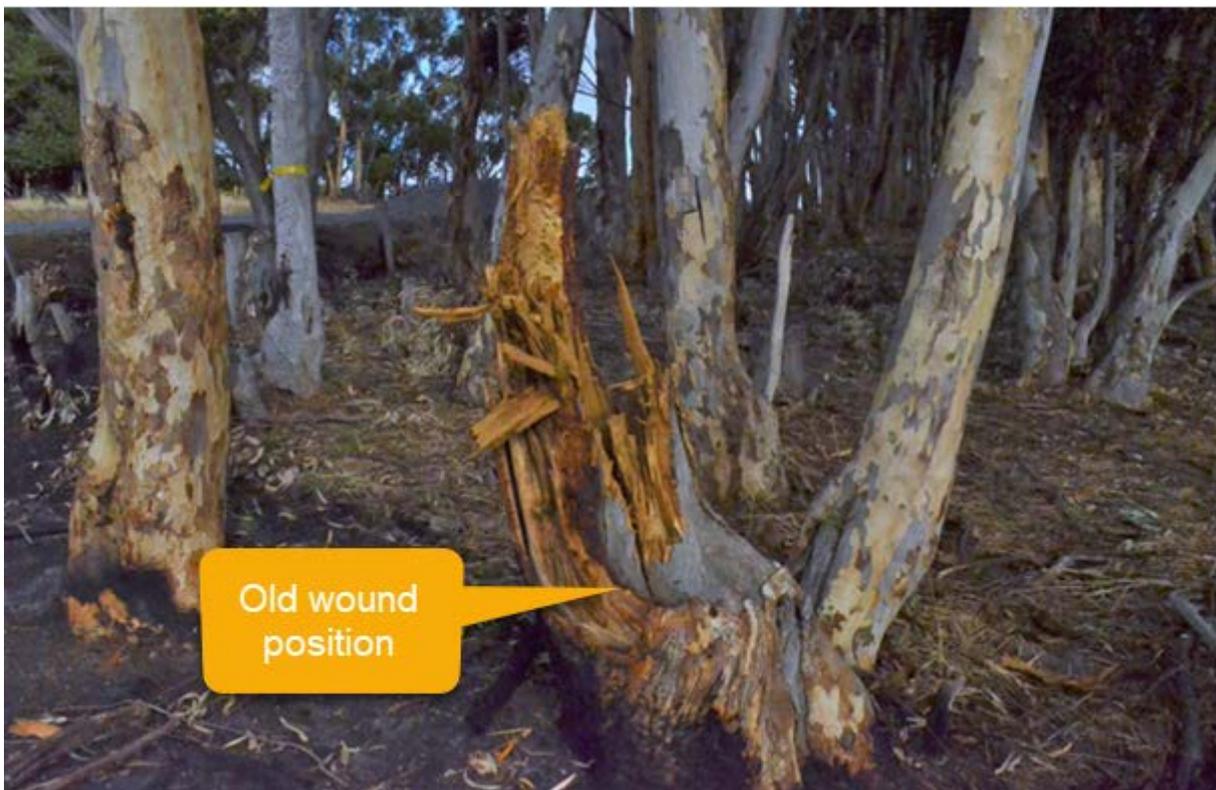
Figure 4: Image of failure point on tree

Figure 4 shows that the failure point of the tree limb is located above an old wound where the tree had been cut back prior, and subsequently regrown. The ESV arborist on site noted this as a point of structural weakness in the tree.

ESV concludes that the local damaging winds were strong enough to cause the limb to break and fall towards the powerlines.

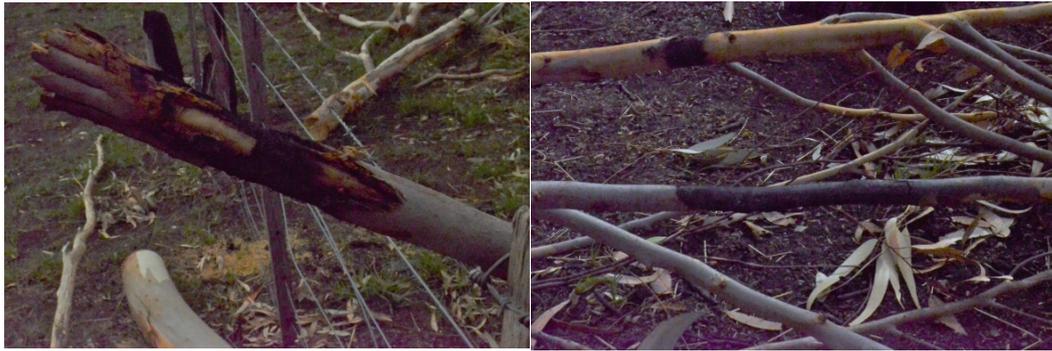
Figure 5: Images of burnt branches found onsite

- a number of tree branches were charred
- adjacent trees were of similar height
- new conductors and conductor sleeves have been installed following the incident at pole 322.

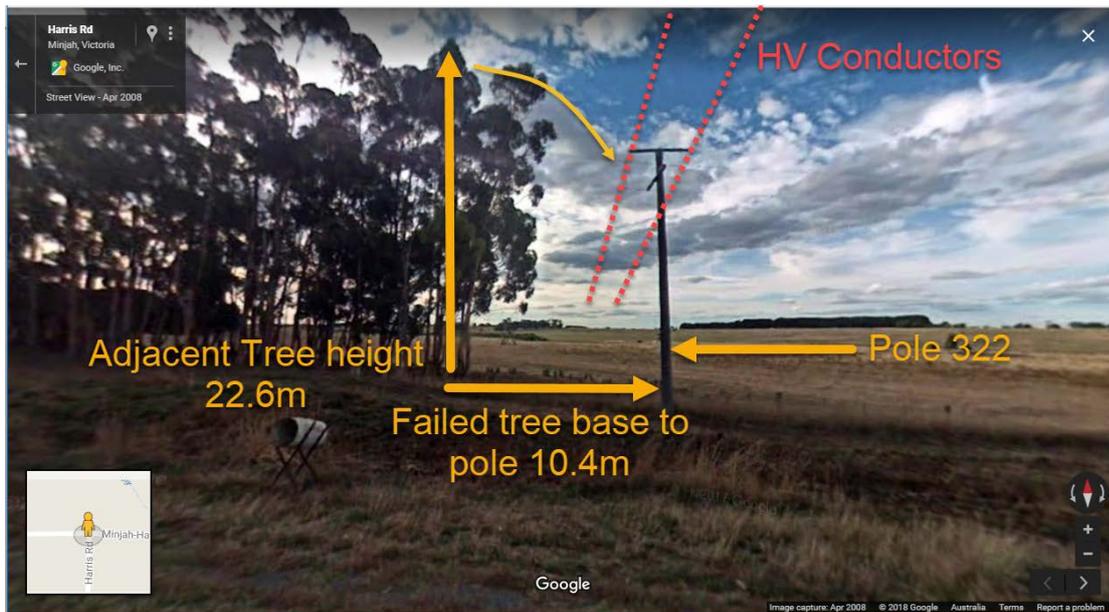
Figure 6: Image from Google maps street view

A search and review of images⁶ provided by Google maps shows the site with tree branches clear of the HV conductors at that time (April 2008). The image also provides detail supporting the assertion that the failed limb was significant in height to make contact with the powerlines if it failed.

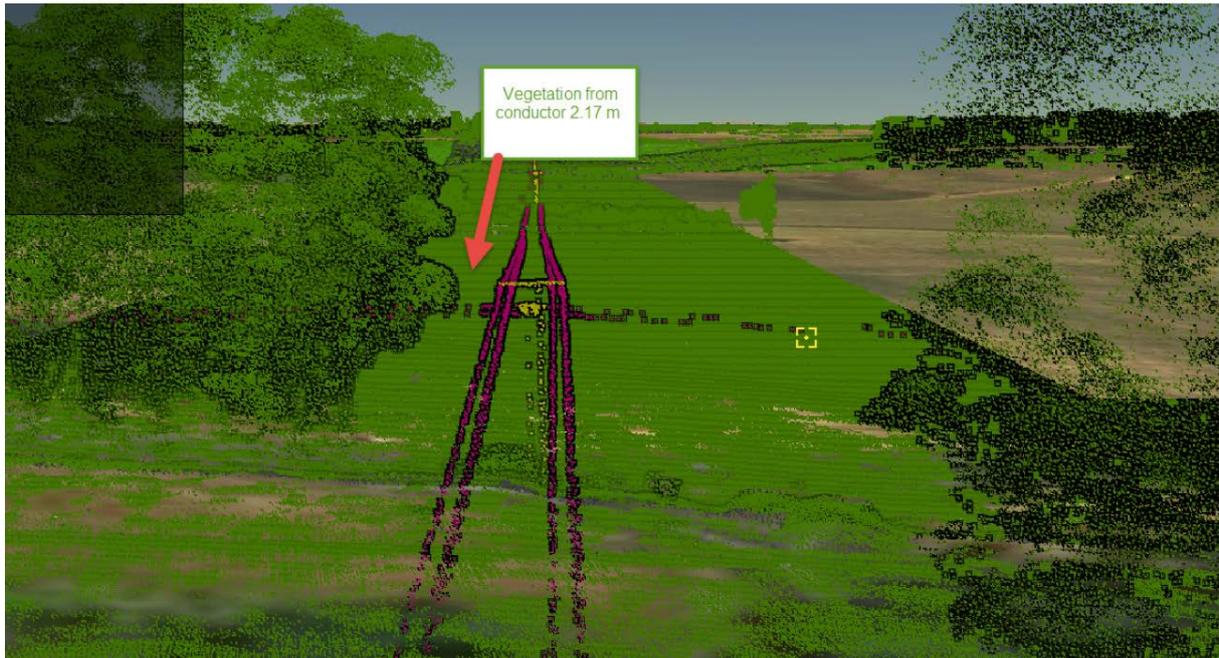
Figure 7: LiDAR image of site provided by Powercor

This indicates that the closest vegetation was assessed at 2.17 metres horizontally from the closest HV conductor as per Figure 7.

From the evidence gathered and analysed, site observations made and review of available images ESV estimates the tree was more than 2 metres from the HV conductor and therefore ESV is satisfied that the minimum clearance distance has been maintained prior to the incident.
