66kV Salt Creek Wind Farm – Terang Transmission Line Failure

Technical investigation report

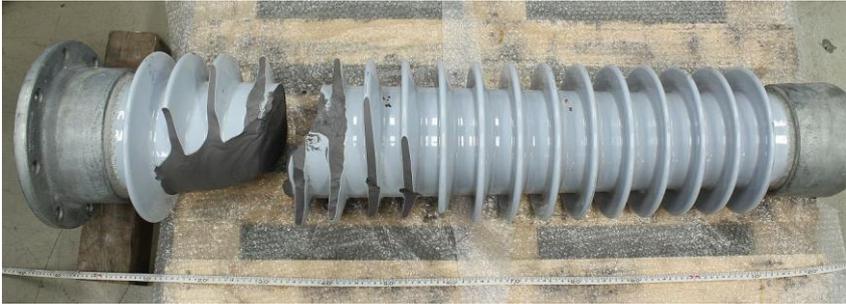
The examination of the failed insulator identified a main fracture area between the 4th and 5th sheds (numbered from the base of the insulator) and numerous partially fractured sheds and a large slant/inclined fracture on the pole base of the insulator.

The damage is illustrated in the photographs: Figure 1 shows the two halves of the failed insulator, and Figure 3 shows a close up of the two halves of the failed insulator.

Figure 1: Overall view of the two main sections of the failed insulator

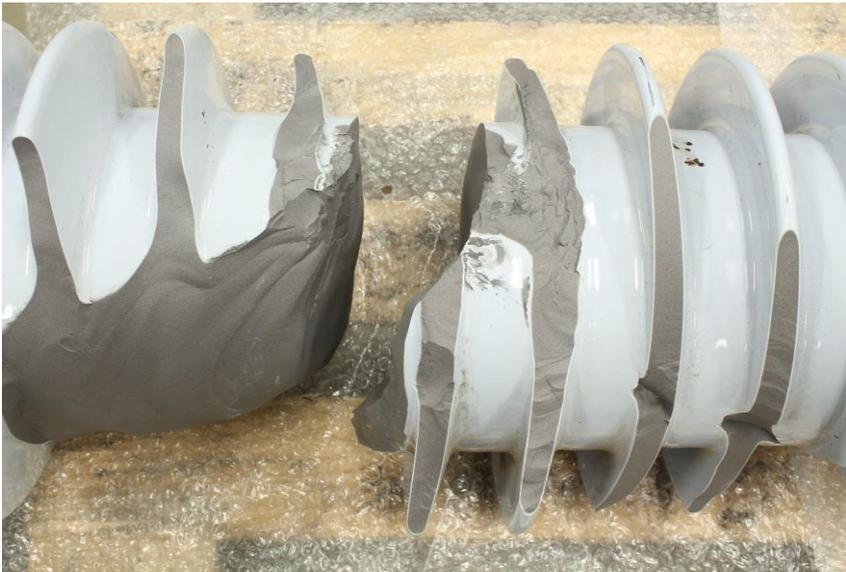
Figure 2: Close-up view of the two main sections of the failed insulator

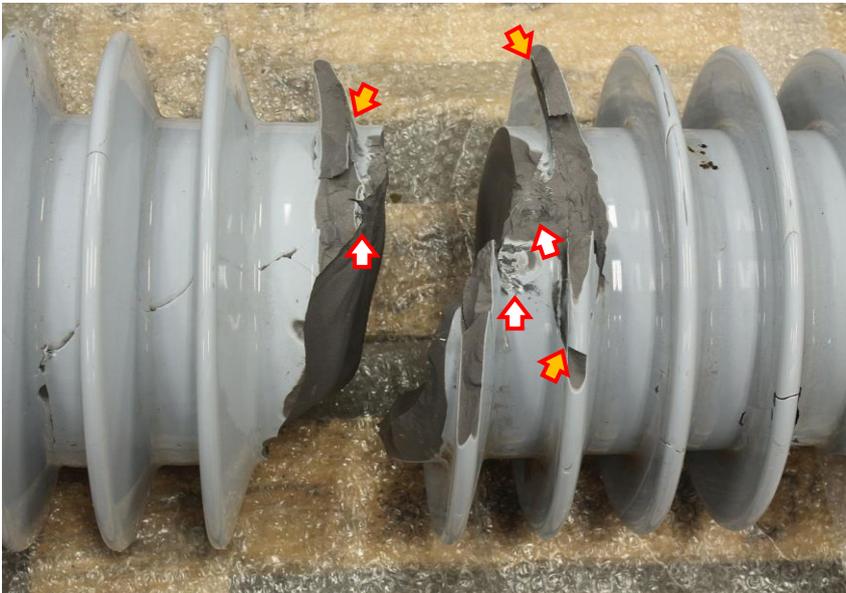
A visual examination of the fracture region revealed one impact point, and possibly a second adjacent impact point, on the outer surface of the insulator between the 4th and 5th sheds. The impact points presented as indentations and/or black marks (see Figure 3) and were located approximately at the 9 o'clock (side) position on insulator (when viewed from the front/line-end of the insulator). No similar marks were evident elsewhere on the insulator.

The fracture originated at one of the impact regions, where noticeable surface damage (spalled material) and numerous faceted fracture surface regions developed prior to a more uniform fracture surface.

Figure 3: Views of the fractured region of partially reconstructed insulator

Note: White arrows highlight indentations, and orange arrow highlight black marks.

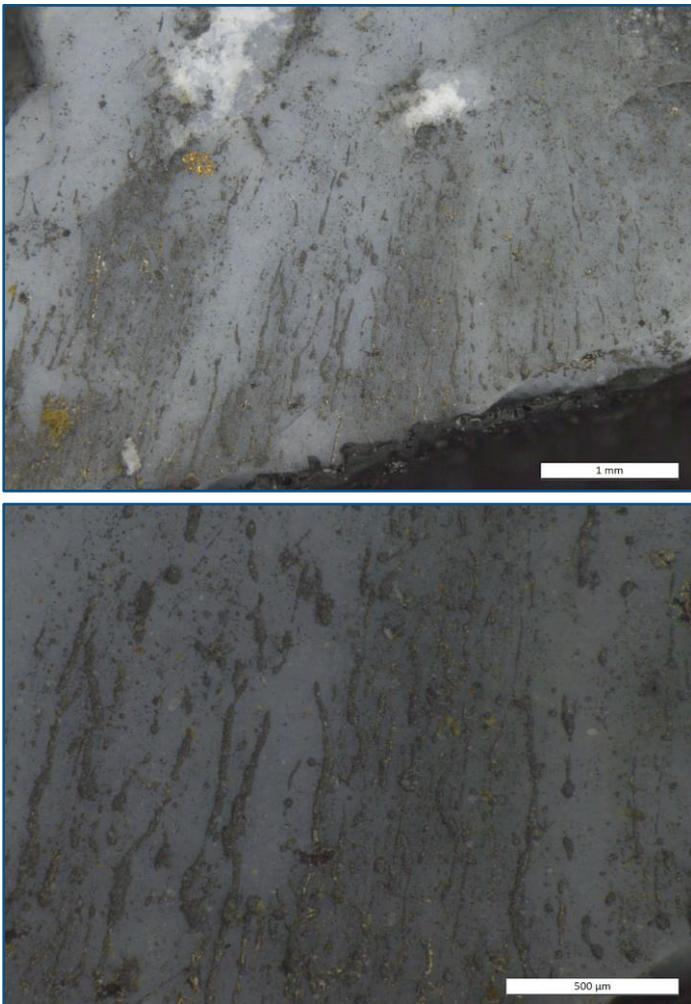
Two spalled fragments (designated as sample 1 and 2) exhibiting insulator surface regions with black marks were chosen for examination. Sample 1 was from shed 5 and sample 2 from shed 4, as shown in Figure 4 and Figure 5 below.

Examination of the insulator surfaces using a stereomicroscope revealed that the black marks were deposits of a typically dark grey material that was mostly in the form of fine aligned strips/ridges or smeared regions and occasionally as irregular, globular particles. Occasional yellow/copper-coloured regions were also observed.

Elemental analysis using a scanning electron microscope (SEM) equipped with semi-quantitative energy dispersive x-ray spectroscopy (EDS) revealed that the deposited material was rich in lead and to a lesser extent oxygen. The deposited material is considered to be metallic lead and/or lead oxide.

This is consistent with impact from a bullet or bullets striking at high velocity.

Figure 4 - Detailed views of the sample 1 insulator

Figure 4 shows the insulator surface with fine dark-grey and yellow-coloured deposits present.

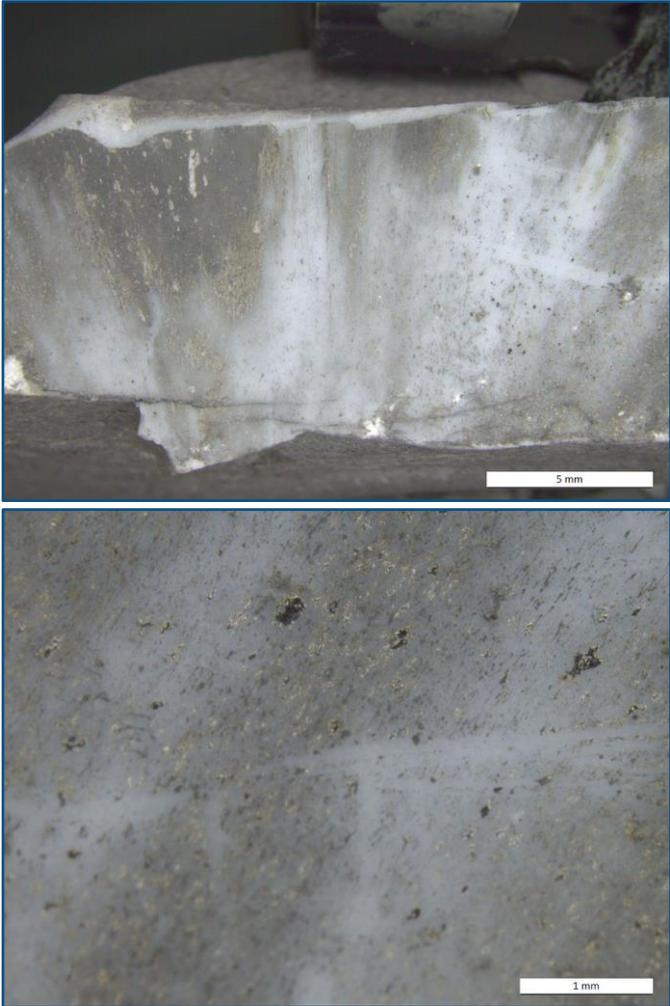
Figure 5: Detailed views of the sample 2 insulator

Figure 5 shows the insulator surface with dark-grey and yellow-coloured patches and particles present.

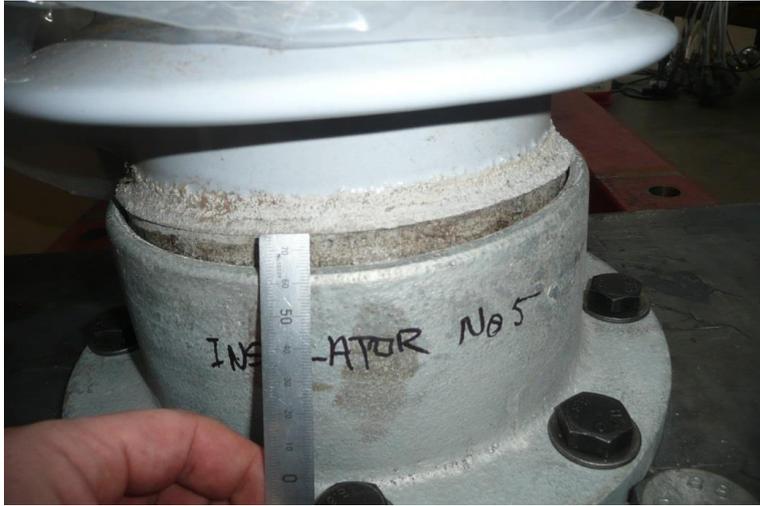
Three insulators were tested, all exceeded 30 kN under cantilever loading. One failed at 36.7 kN and testing was discontinued on the other two when they reached 40 kN. The insulator that reached a maximum of 36.7 kN could not sustain further loading as the porcelain began to separate from the cap at its base, at the securing cement line. The other two insulators tested to 40 kN also showed the early stages of this failure mode, with the cement line breaking and starting to separate, as shown in Figure 7.

Figure 7: Insulator 5 after completion of mechanical failing load (MFL) test.

Figure 7 shows the porcelain separating and rotating in the base cap.

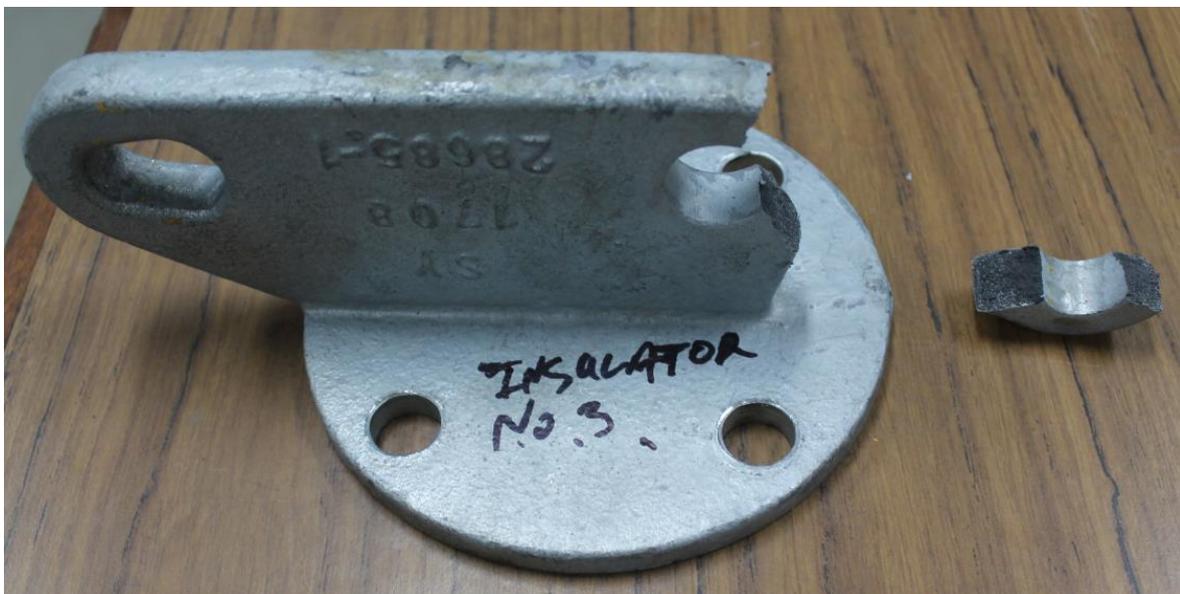
Two samples of the insulator bracket fitting were tested statically to 70kN and did not permanently deform. The samples were then tested to failure, with breaking loads of 129 kN and 129.5 kN as shown in Figure 8.

Figure 8: Image of a failed bracket after the mechanical failing load test

Figure 8 shows a fracture through the round hole.
