Warrnambool-Cobden Fire Ignition 17 March 2018

**Tree failure 2450 Warrnambool-
Cobden Road, Laang**

Technical investigation report

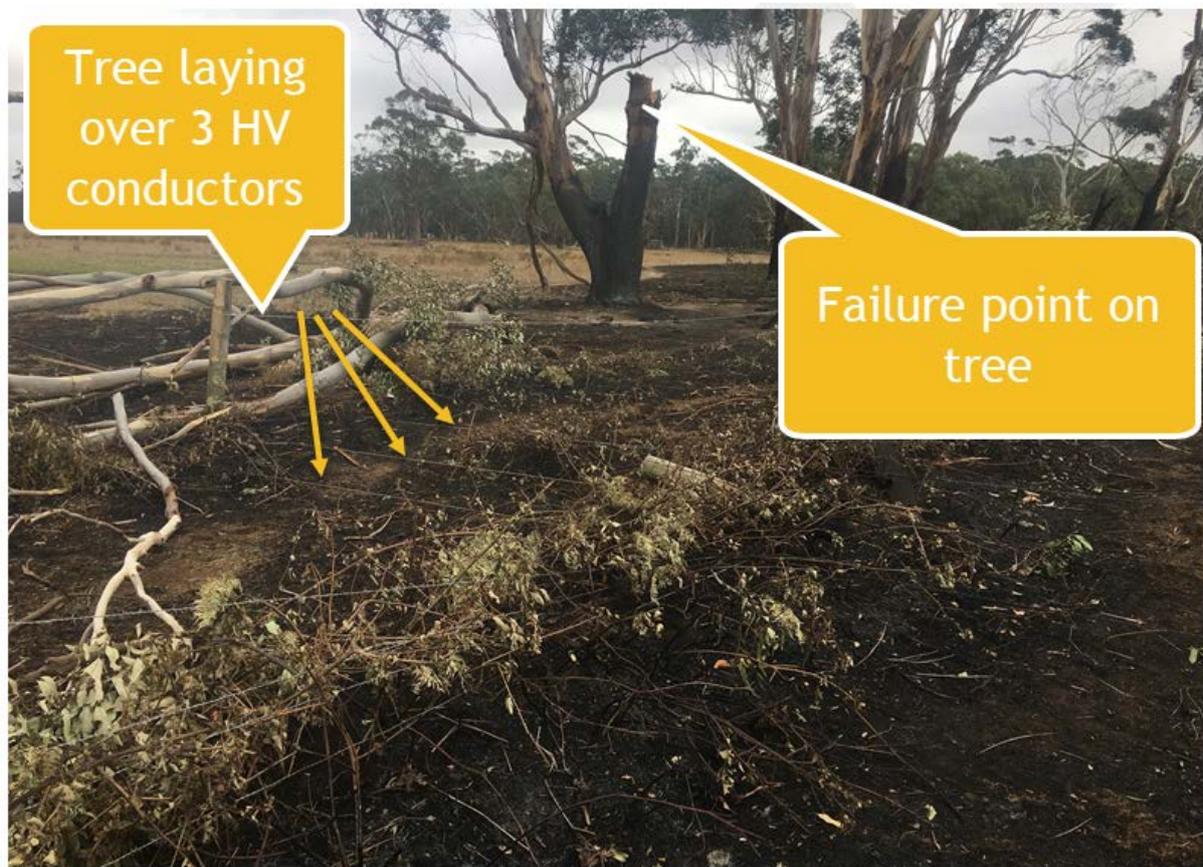
Figure 3: Tree failure showing HV conductors on the ground

- tree and position of the break in tree
- fallen part of tree laying over all three HV conductors.

Review of the photo provided by CFA indicates that there was a significant distance between the HV conductors and the failure point on the tree.

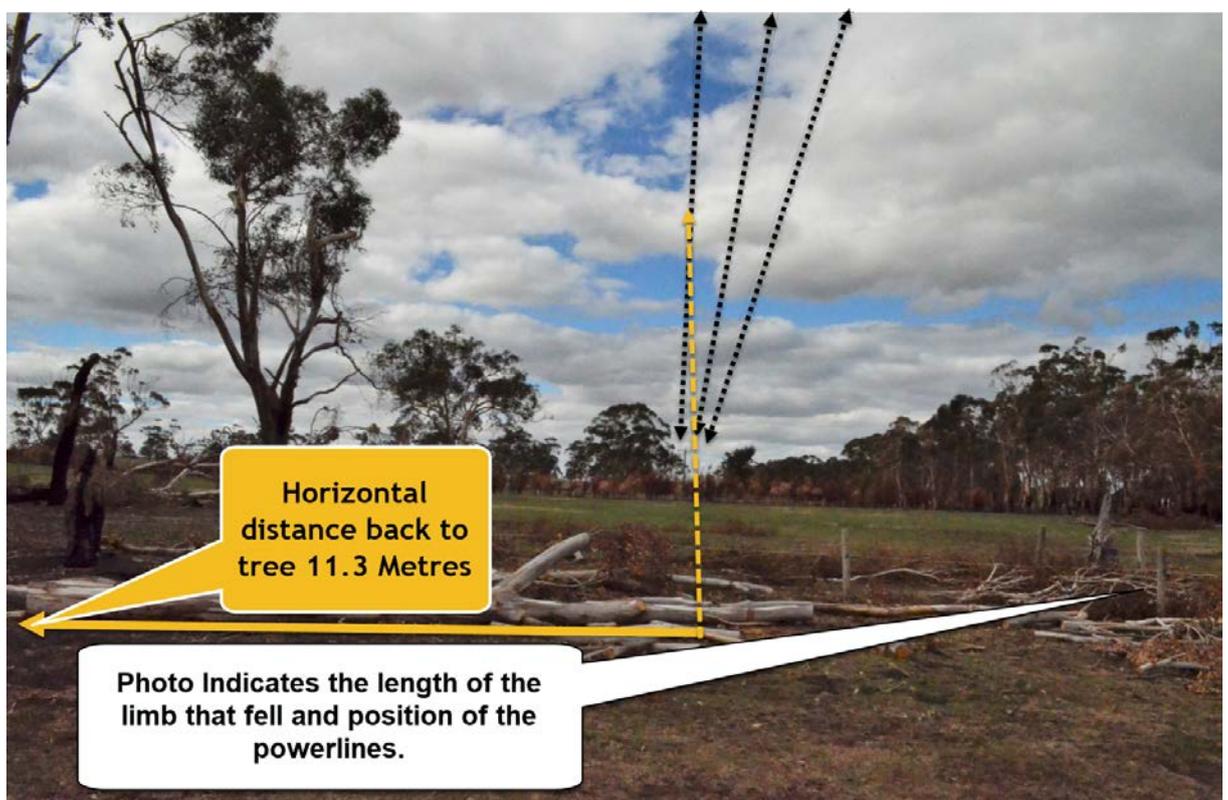
Figure 4: Tree position in relation to HV conductors

- The combined length of these sections was estimated to be 20 metres. The failure point was estimated to be four metres above the ground. This means the estimated height of the tree would be approximately 24 metres

- Failure point on the tree was approximately four metres above ground level and 11.3 metres horizontally adjacent to the closest HV conductor
- Given the estimated height of the tree it could reasonably be expected to make contact with HV Overhead conductors when it fell

- The point of contact was approximately in the middle of the 307 metre conductor span as measured with a laser rangefinder⁴
- Remaining tree branches on the ground had burn marks consistent with contacting live high voltage conductor/s.

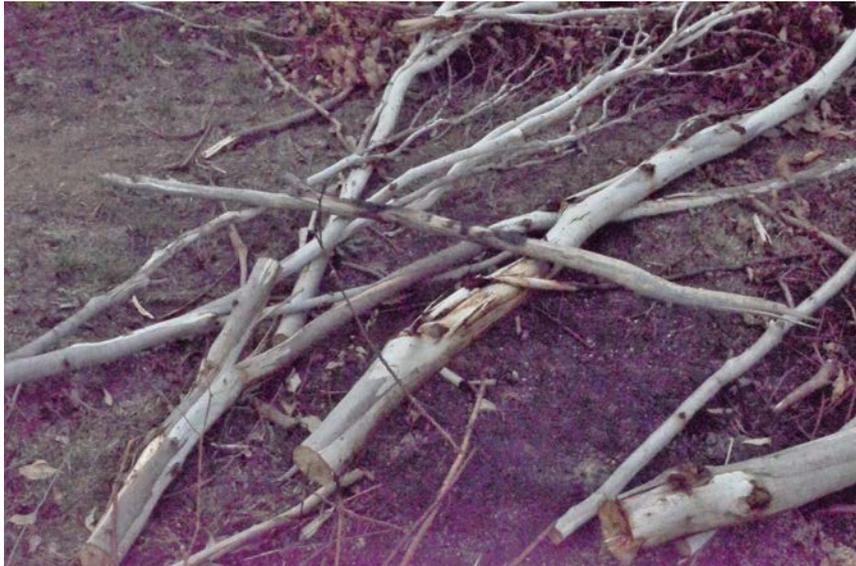
Figure 5: Images of burnt branches found onsite

- a number of tree branches were charred
- adjacent tree branches were of similar height.

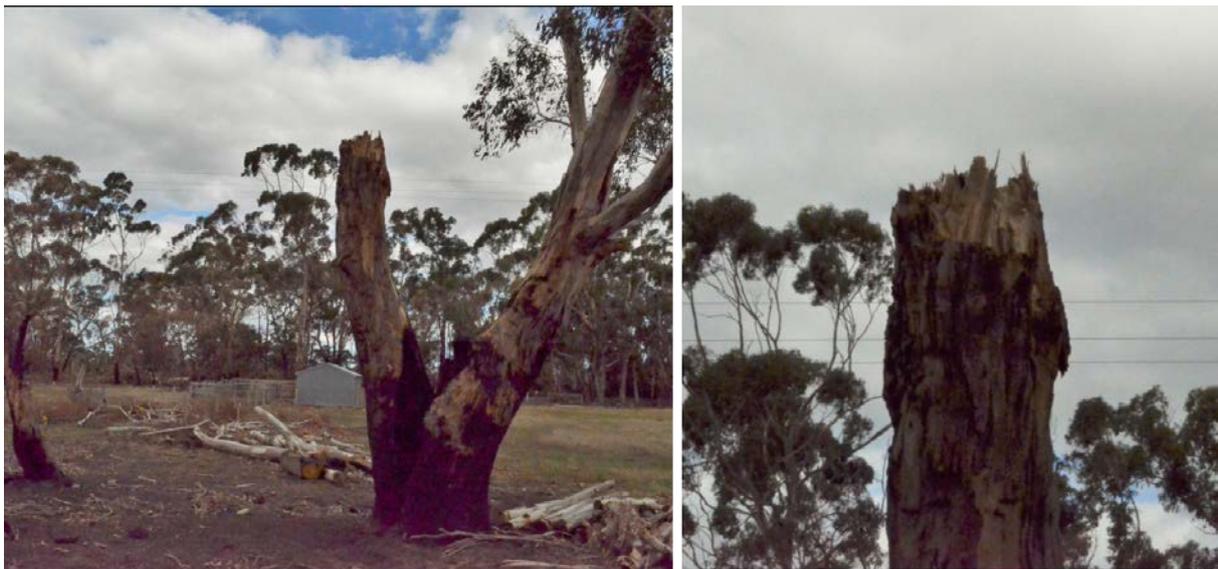
Figure 6: Images of failure point on tree

- The site visit indicated a tree, Eucalyptus species, had a large limb which failed
- much of the failed limb had been cut and removed, however remaining tree debris on the ground indicated the alignment of where the limb landed and its length

From the evidence remaining onsite it appears that the failure point on the tree was 11.3 metres horizontally away from the closest conductor, and therefore ESV determines that the failed limb was outside the minimum clearance requirements under the Electricity Safety (Electric Line Clearance) Regulations 2015, however due to its height it was sufficient in length to contact the powerlines when it failed.

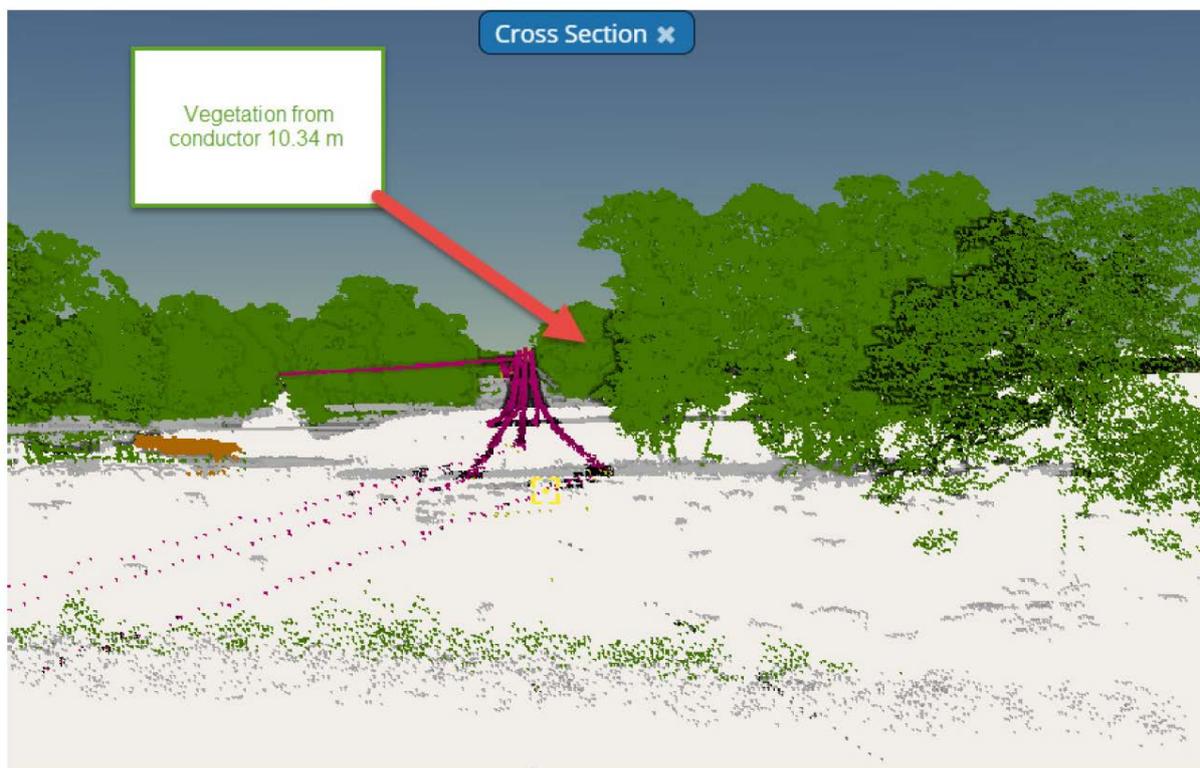
Figure 7: LiDAR image of site provided by Powercor

This indicates that the closest vegetation was assessed at 10.34 metres away from the closest HV conductor as per Figure 7.

Further review of recent (to the incident date) LiDAR data provides measurement of clearance from trees to the HV conductors and confirms that regulatory requirements were met.
