ELECTRICITY SAFETY ALERT

WARNING: METERING ANTENNA MOUNTING BRACKET FOUND TO BE LIVE

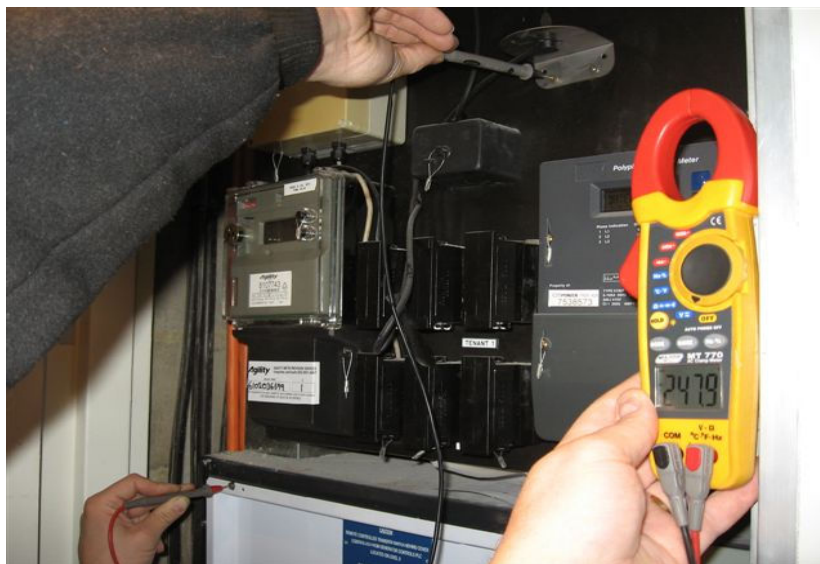
He made simultaneous contact with the metallic duct and a "live" metallic antenna mounting bracket associated with the metering communication equipment.

The antenna mounting bracket was fixed to the meter panel with two 23mm self-tapping metal screws. The screws protruded through the front and the rear of the meter panel and penetrated into the single insulation cables within the metering enclosure, therefore allowing the screws and the metal bracket to become "live".

As a result of the screws penetrating the single insulated cable, the antenna mounting bracket was measured to be "live" at 247.9 VAC.

Live antenna mounting bracket

This method of installation is contrary to the fundamental safety requirements of AS/NZS 3000:2000 in that the bracket should have been attached with insulated screws.

Metallic antenna mounting bracket fixed with metal screws should be treated as "live".
