OFFICE OF THE CHIEF ELECTRICAL INSPECTOR

INCORRECT USE OF EXTENSION LEADS

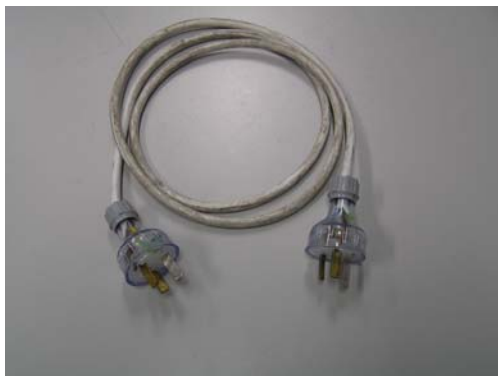
The extension lead as shown in photograph 1 had 2 male plugs fitted, and was purposely made to connect together the socket outlets on 2 separate display counters located within a large shopping complex.

As the person was handling the extension lead after connection had been made at one end, the person made contact with the live male plug at the other end receiving an electric shock that could have been fatal.

*Photograph 1 extension lead
with 2 male plugs*

The OCEI strongly recommends that under no circumstances is it safe to use an extension lead with 2 male plugs fitted.

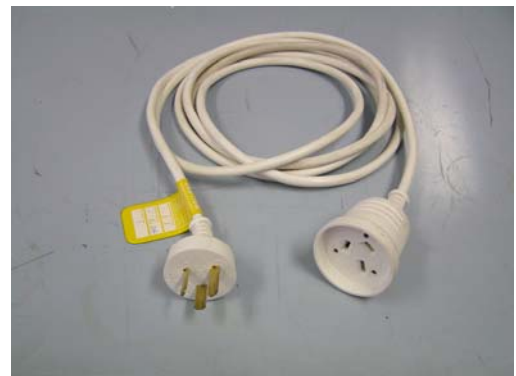
*Photograph 2 extension lead
with male / female plug*

In this case the display cabinets should have been connected via a correctly wired male / female connection as shown in photograph 2.
