WIRING OF SPLIT SYSTEM AIR-CONDITIONERS

Energy Safe Victoria has become aware of a technical issue with the installation of wiring between the (compressor) outside unit and the (head) indoor unit on various split system air-conditioners.

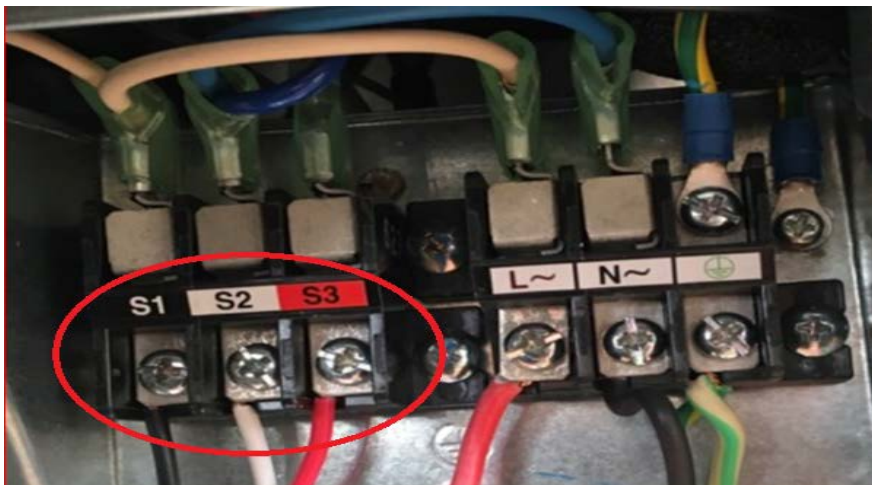
The photo depicts the connection of the wiring installed between the outdoor unit and the indoor unit that has been connected / terminated incorrectly and does not comply with the conductor insulation colour identification requirements of Clause 3.8 of AS/NZS 3000:2007.

The technical issue is with the interconnecting cable terminals of both the indoor and outdoor units; these terminals are labelled S1, S2 & S3 but are also distinguished by use of colour;

Terminal	Colour	Technical issue
S1	Black	connects directly to the incoming active conductor (L ~)
S2	White	connects directly to the incoming neutral conductor (N ~)
S3	Red	Communication – no issue

Electricians are incorrectly connecting the wiring installed between the indoor and outdoor units to the terminal colour coding, resulting in the **black conductor becoming an active conductor**, the **white conductor becoming a neutral conductor** and the **red conductor being communication**.

The wiring installed between the outside unit and the indoor unit is classified as installation wiring and shall comply with the conductor insulation colours as specified in Table 3.4 of AS/NZS 3000:2007.

Should an electrician encounter this situation, immediate rectification is required.

It is most important to isolate supply, test before you touch and Lock out Tag out (LOTO) before starting work.
