Gnotuk Fire Ignition (Camperdown–Bullen Merri Fire) 17 March 2018

**Transformer Pole 8 Cross Forest
Road, Gnotuk**

Technical investigation report

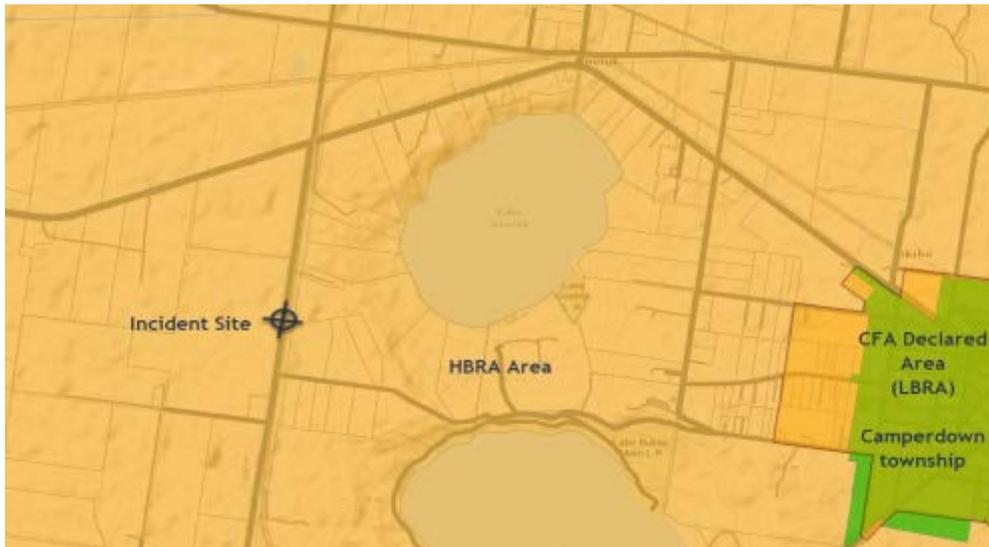
Figure 2: GIS incident site area map

Figure 2 shows a Graphical Information System (GIS) area map of the incident site in relation to the CFA declared Low Bushfire Risk Area (in green) and the HBRA area (in amber).
