66kV Salt Creek Wind Farm – Terang Transmission Line Failure

Technical investigation report

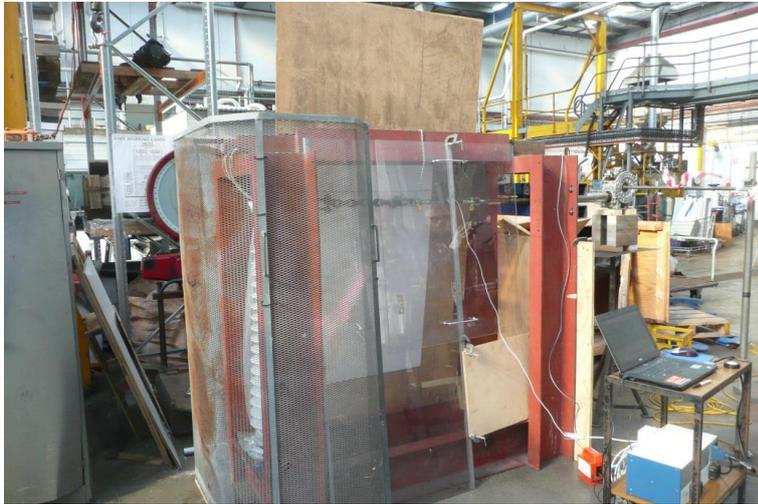
Figure 6: Image of the insulator loading frame for the insulator mechanical failing load test, in accordance with AS/NZS 2947.1

HRL conducted the mechanical failing load test according to section 19.1 of AS/NZS 2947.1 on three samples of the Suzhou line post insulator, drawing number 28685. This test is designed to establish the cantilever load the insulator can withstand. The insulator is rated at 30 kN and must sustain this load to pass the test, as shown in Figure 6.

Three insulators were tested, all exceeded 30 kN under cantilever loading. One failed at 36.7 kN and testing was discontinued on the other two when they reached 40 kN. The insulator that reached a maximum of 36.7 kN could not sustain further loading as the porcelain began to separate from the cap at its base, at the securing cement line. The other two insulators tested to 40 kN also showed the early stages of this failure mode, with the cement line breaking and starting to separate, as shown in Figure 7.

It is the opinion of Energy Safe Victoria that the Suzhou insulator, drawing number 28685, complies with this test (section 19.1 of AS/NZS 2947.1).
