Warrnambool-Cobden Fire Ignition 17 March 2018

**Tree failure 2450 Warrnambool-
Cobden Road, Laang**

Technical investigation report

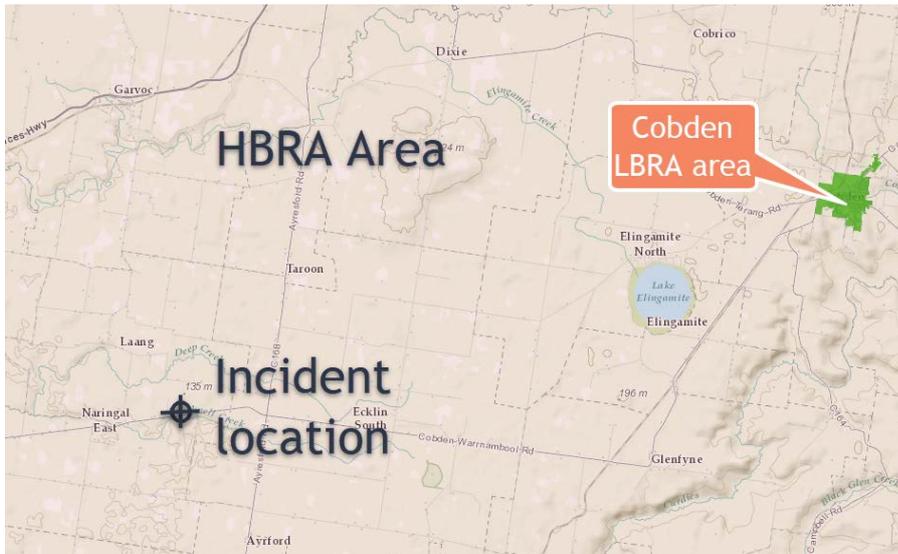
Figure 2: Incident site map

Figure 2 shows a map of the incident site in relation to the CFA declared Low Bushfire Risk Area (in green) and the HBRA area (in tan).
