AusNet Services Wood Pole Management

An assessment of sustainable
wood pole safety outcomes

Public Technical Report

February 2022

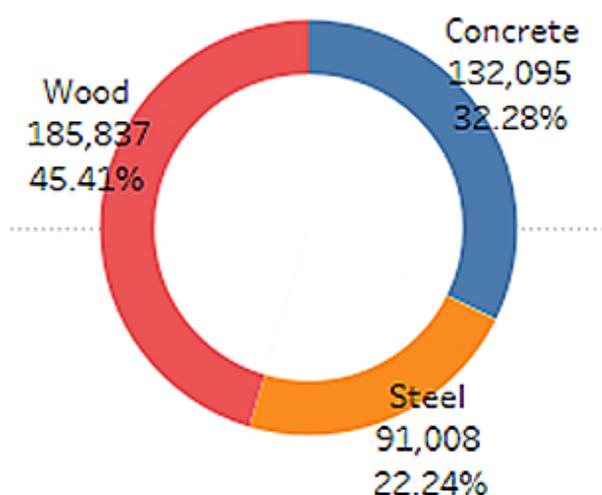
Figure 2: Composition of pole materials

The composition of poles by material type is shown in Figure 2 and bushfire risk classification is shown in Table 1 below.

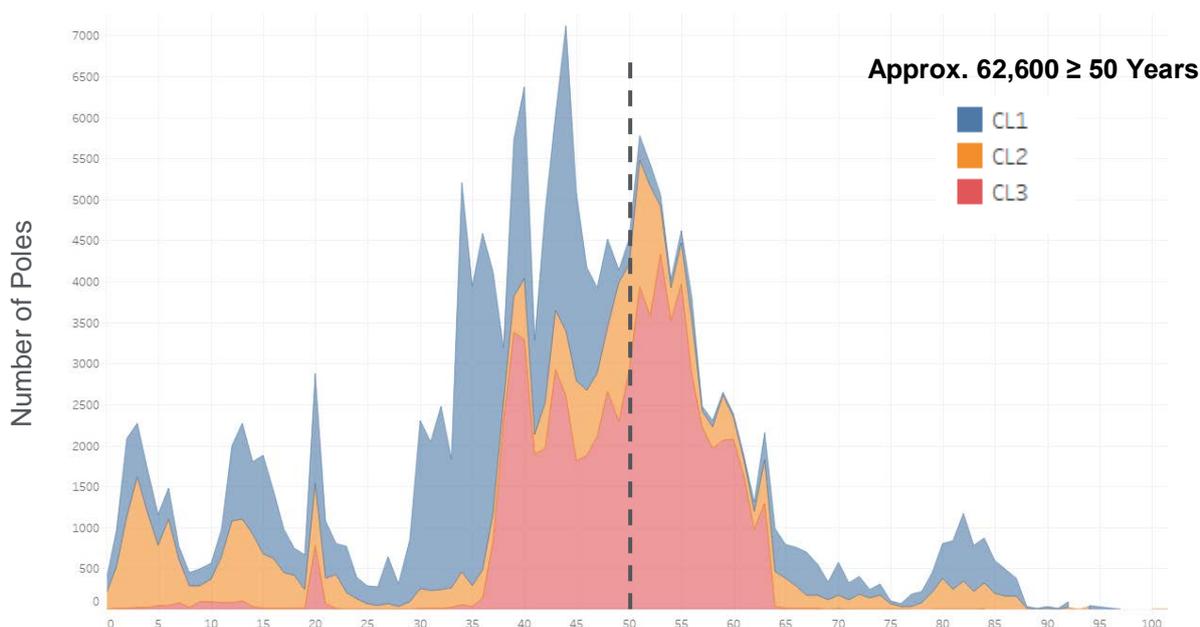
Figure 3: Age profile of wood poles installed by durability class (as at July 2020)

The life expectancy of wood poles varies widely across the network with the average service age of 40 years, and approximately 62,000 wood poles (34 per cent of the total wood pole population) are more than 50 years old. The distribution of wooden power poles by age and by durability class is shown in Figure 3.

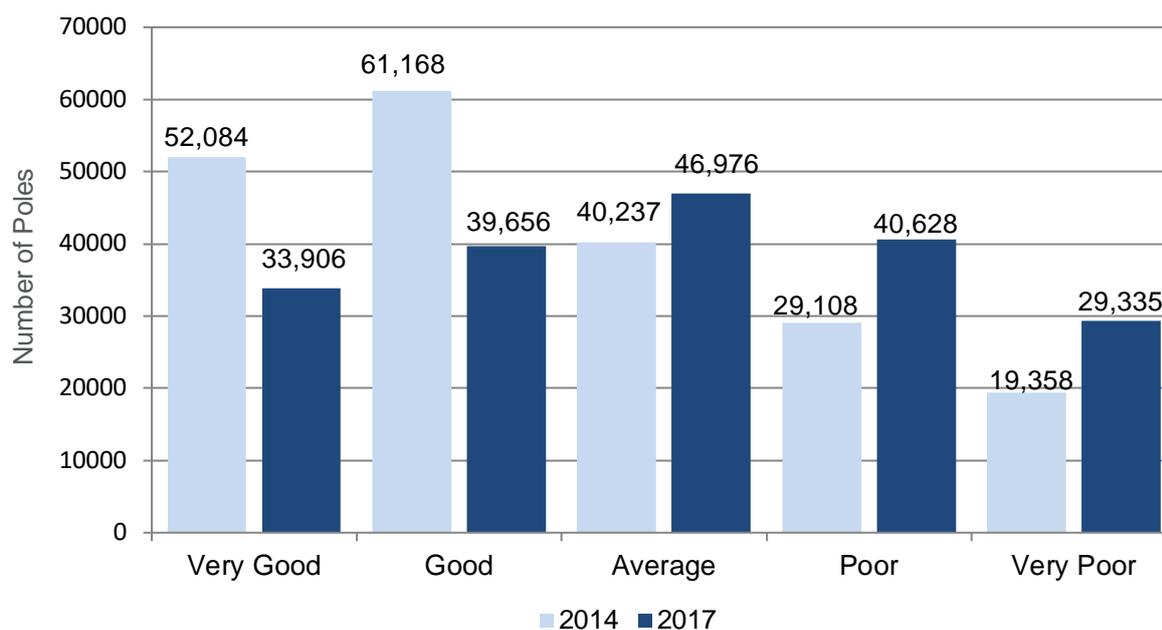
Figure 4: Comparison of the number of poles by condition score between 2014 and 2017

ESV has reviewed the condition scoring system for this representation shown in Figure 4 and is comfortable that this generally represent a population of safe wood poles. In addition, ESV has inspected more than 1,000 wood poles during this investigation and those results support this finding.

- 65 per cent of the total pole population has a condition score of “Good” or “Very Good”, however only 39 per cent of wood poles have the same condition score (as shown in Figure 4)
- White Stringybark and Messmate timbers increasingly feature in replacement volumes
- to defer increasing replacement rates the introduction of new wood pole life-extension techniques, including alternative reinforcement methods, rebutting and pole head reinforcement systems will be required.

As shown in Figure 4, AusNet Services has identified that more than 29,000 wood poles have a condition score of “Very Poor”; this means that 15 per cent of the wood pole population will require intervention in a five-to-10 year period. The increasing trend of deteriorated poles shown in this analysis, and the increased volume of poles now in a deteriorated state, suggest that more may need to be replaced in the future to mitigate any increase in safety risk. This hypothesis was tested in the ESV assessment that follows.

This provides further support to the observation of an apparent increasing number of deteriorated poles in the population (as shown in Figure 4) and indicates that additional interventions may be required to mitigate any increase in safety risk. This hypothesis was tested by ESV in the assessment of AusNet Services’ practices.

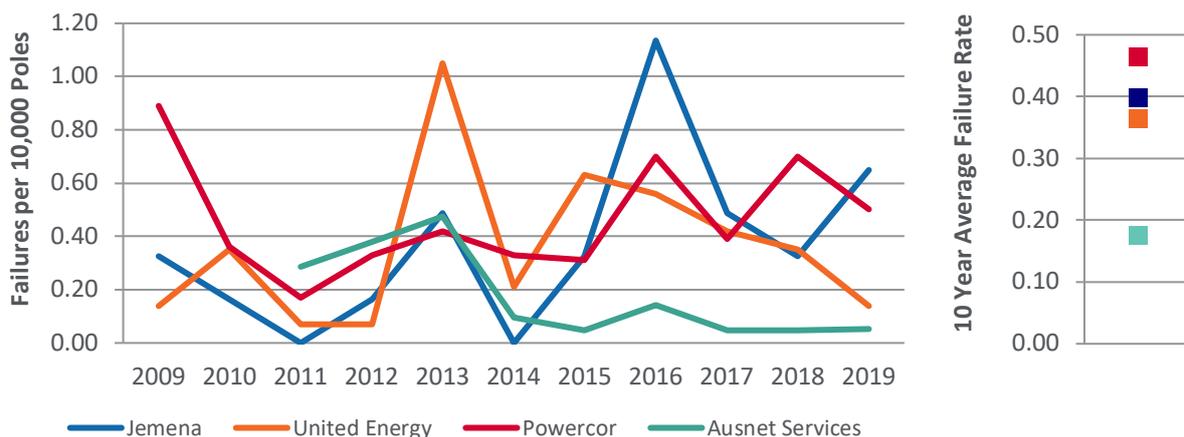
Figure 5: Comparison of unassisted wood pole failures per 10,000 poles by MEC

AusNet Services 10-year average of 0.17 unassisted pole failures per 10,000 poles is the lowest of the Victorian MECs presented in Figure 5. AusNet Services has maintained this level of performance or

close to it since 2014. Each MEC’s unassisted wood pole failure statistics were adversely affected by weather events in 2013.

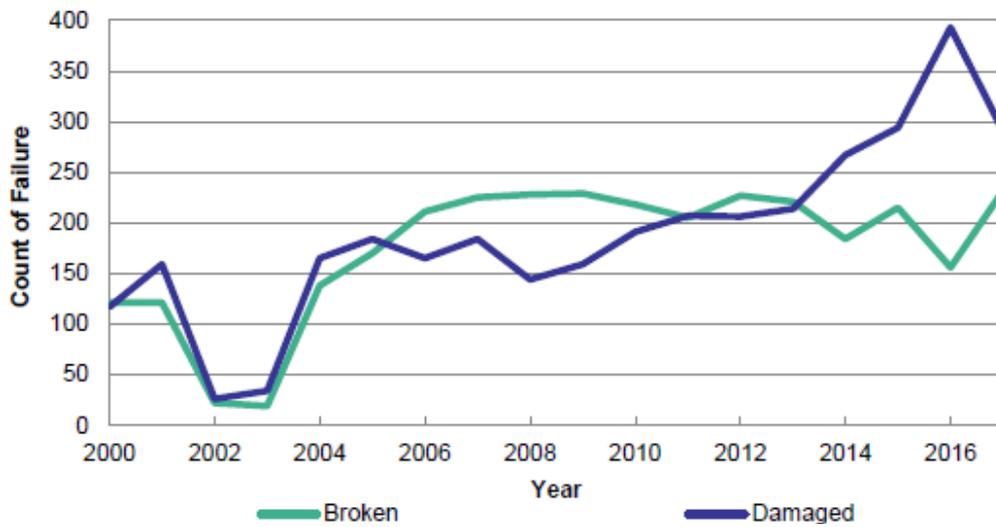
Figure 6: AusNet Services trend analysis of wood pole failures

As shown in Figure 6, there has been an increasing trend in the number of damaged poles, while the number of broken poles is relatively constant.

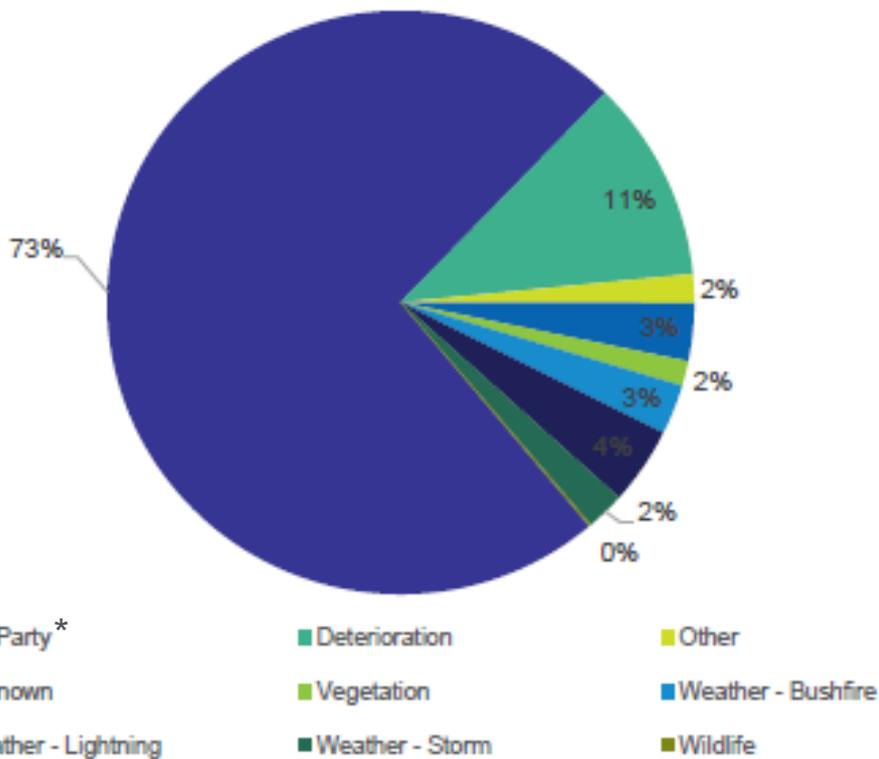
Figure 7: AusNet Services cause breakdown of wood pole failures

As shown in Figure 7 the major cause of pole failure is third party damage, comprising 73 per cent, with deterioration at 11 per cent.

* Note: Third-party means pole failures directly resulting from contact/collision with poles by persons other than those employed by the MECs (e.g. the public), and include, but not limited to: car accidents, or other plant and equipment such as farm machinery, trucks, and backhoes and excavators.

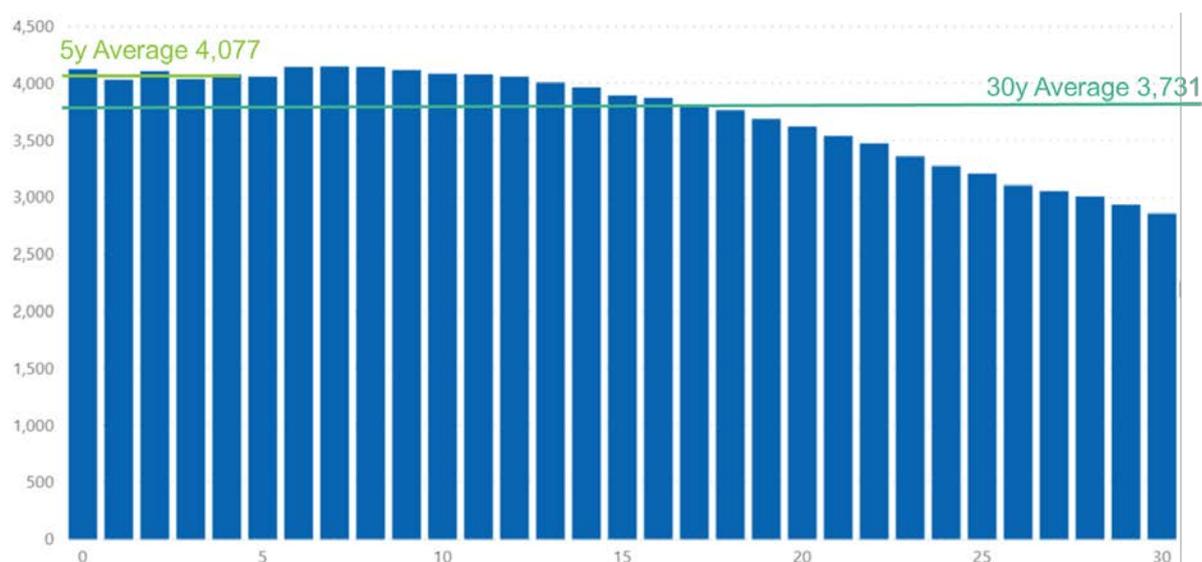
Figure 8: Predicted wood pole interventions (replacement and reinforcement at historical rates)

The results of AusNet Services predictive model are shown in Figure 8 below.
