2019–20

Gas and Pipeline Infrastructure Safety

Performance Report

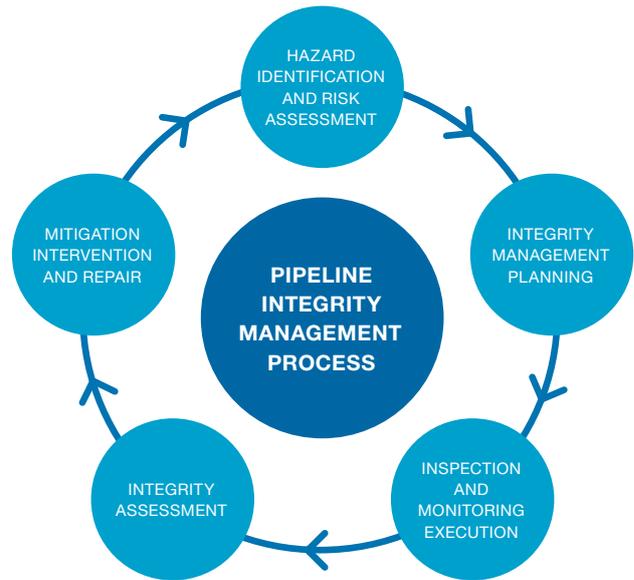
Figure 1 – Pipeline integrity management process

- identifying, assessing and mitigating hazards through risk assessments
- planning and completing regular inspections
- intervening and repairing when required.

The pipeline integrity management process comprises two management strategies:

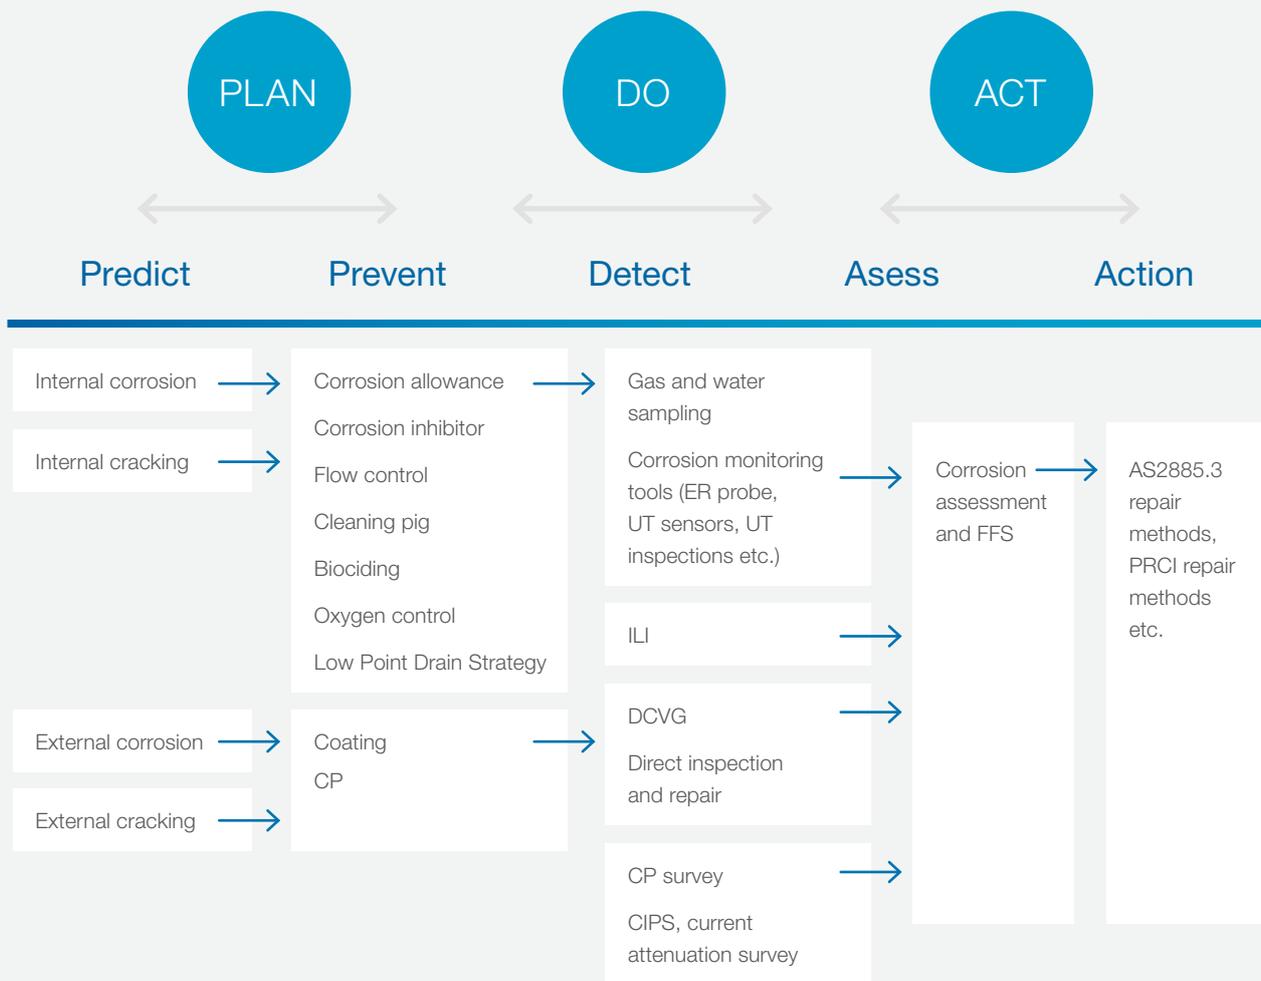
Figure 2 – Corrosion management

Both strategies detail the threat identification process, prevention and detection measures, assessment processes, and the required rectification action (such as fitness for purpose assessments and repairs).

- corrosion management (see Figure 2 – Corrosion management)
- third-party interference management (see Figure 3 – Third-party interference management).

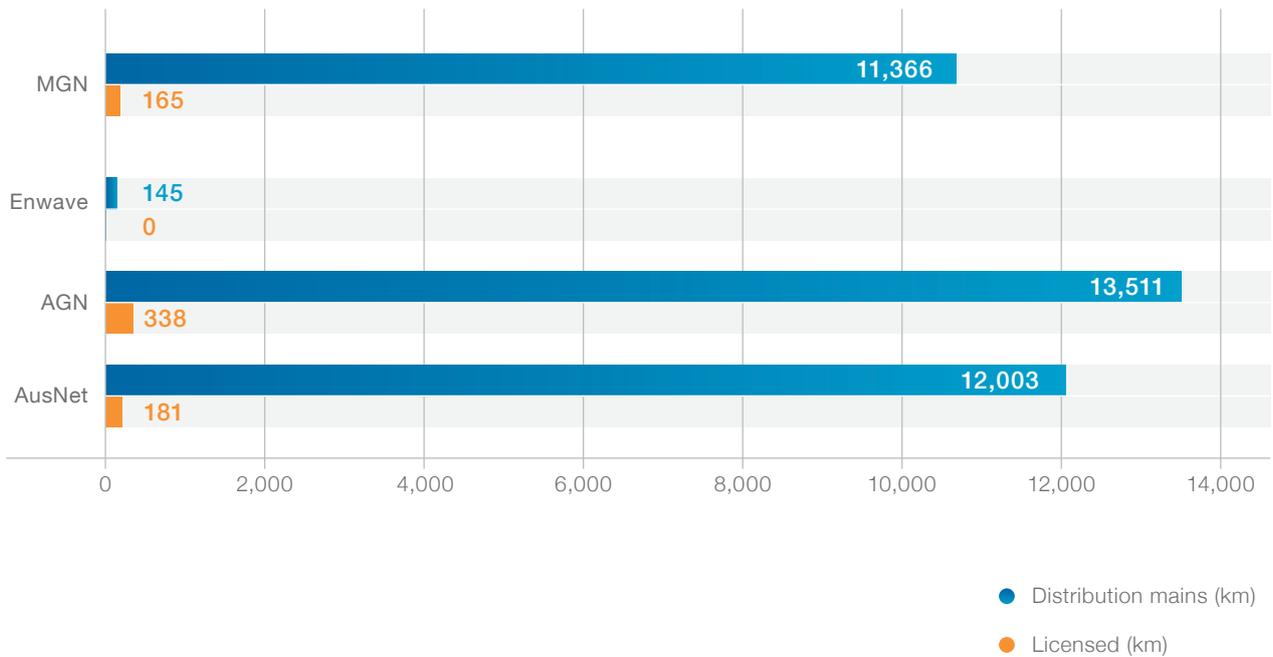
Figure 4 – Gas distribution by operator

Four natural gas DB pipeline businesses operate approximately 38,000 kilometres of distribution pipelines and mains (see Figure 4 – Gas distribution by operator). Three distribution businesses – Australian Gas Networks, Multinet Gas, and AusNet Services – operate licensed pipelines and are required to submit Annual Safety and Integrity Compliance Reports. All operators have developed Asset Management Plans that set out each organisation’s decision-making process and considerations for risk management and continuous improvement.

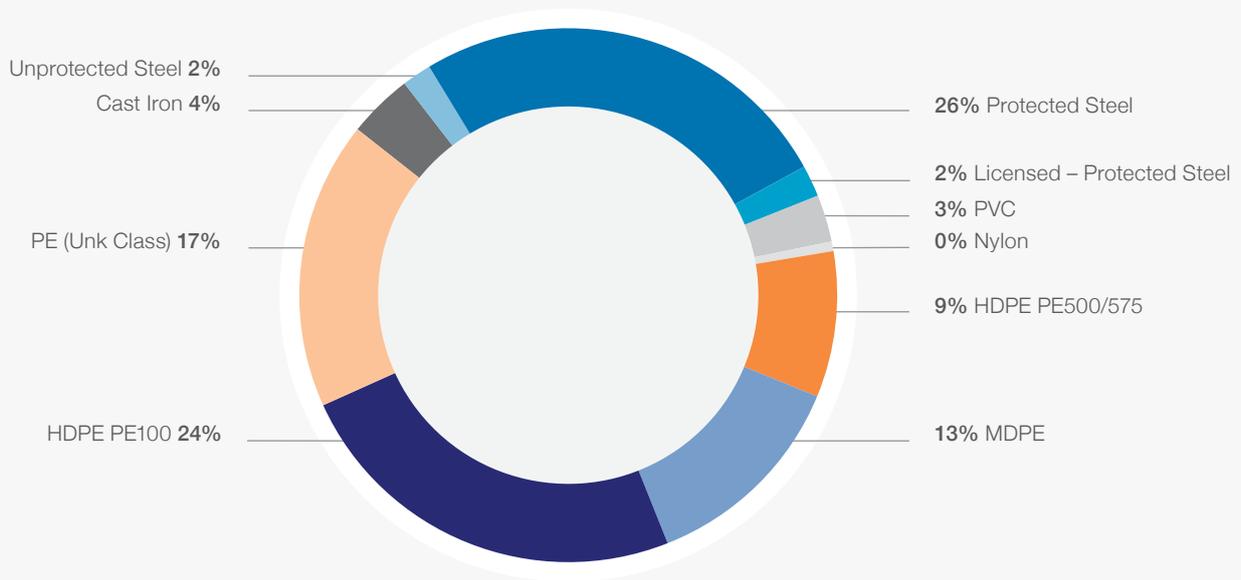
Figure 5 – Licensed and distribution pipeline materials

Licensed and distribution pipelines are predominantly made from protected steel and high-density polyethylene, followed by other classes of polyethylene (see Figure 5 – Licensed and distribution pipeline materials). Of the pipeline materials currently being replaced with high-density polyethylene as part of the mains replacement program, cast iron and polyvinyl chloride make up 4 per cent and 3 per cent respectively (see Section 2.4.3 for more information).

- Cast Iron
- Unprotected Steel
- Protected Steel
- Licensed – Protected Steel
- PVC
- Nylon
- HDPE PE500/575
- MDPE
- HDPE PE100
- PE (unknown class)

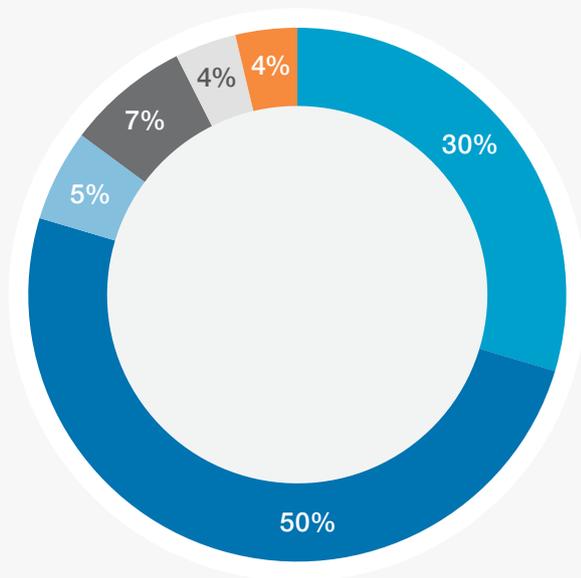
Figure 6 – Licensed pipelines by year of construction

More than 80 per cent of pipelines in service were built before 1980, with an average age of approximately 44 years (see Figure 6 for the distribution of licensed pipelines based on the year of construction).

- Prior to 1970
- 1970–1980
- 1980–1990
- 1990–2000
- 2000–2010
- 2010–2020

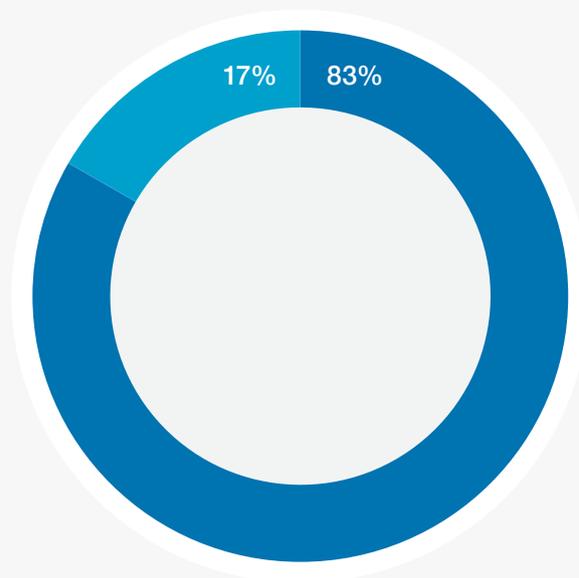
Figure 7 – Licensed pipelines CP compliance

In total, 83 per cent of licensed pipelines comply with current CP requirements in accordance with AS2832. Issues due to non-compliant CP systems were escalated to ESV and operators implemented rectification programs (see Figure 7 for the compliance level of all licensed pipelines during the reporting period). Non-compliant CP systems identified during potential surveys were investigated and rectified to ensure compliance with AS2832.

- Non-compliant
- Compliant

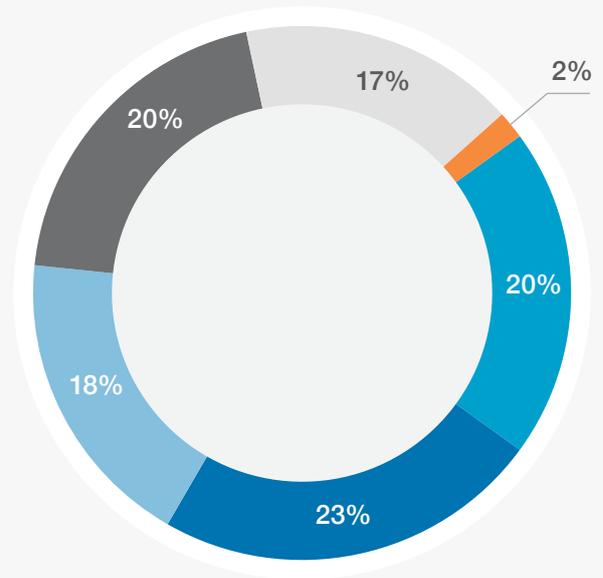
Figure 8 – Distribution of natural gas transmission pipelines by year of construction

With an average age of 33 years, 61 per cent of Victoria's natural gas transmission pipelines were built before 1990 (see Figure 8 for the distribution of pipelines by year of construction).

- Prior to 1970
- 1970–1980
- 1980–1990
- 1990–2000
- 2000–2010
- 2010–2020

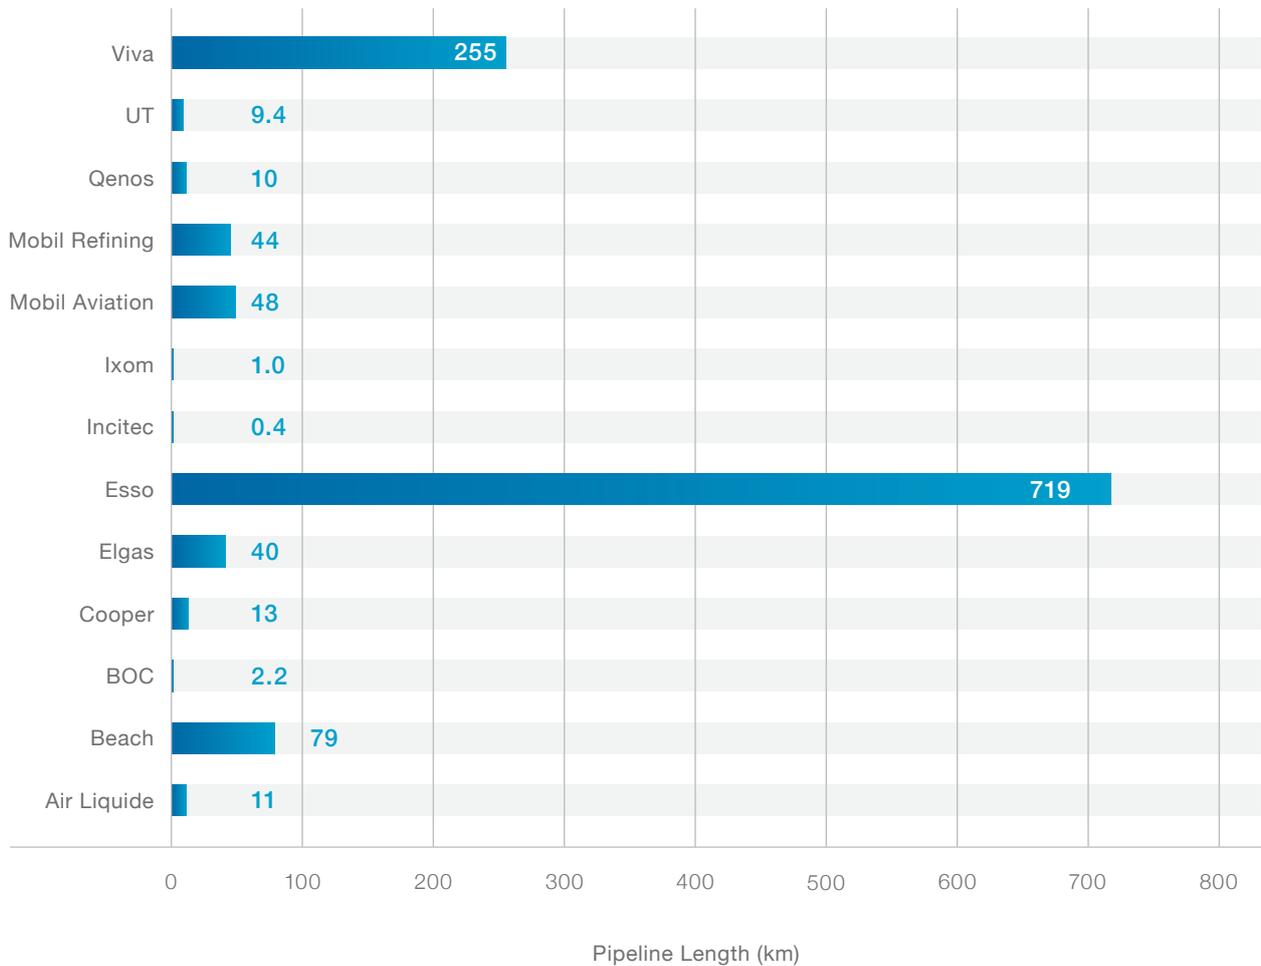
Figure 10 – Distribution of non-natural gas transmission pipeline licenses by operator

Figure 10 shows the distribution of operators to the number of active pipeline licenses.

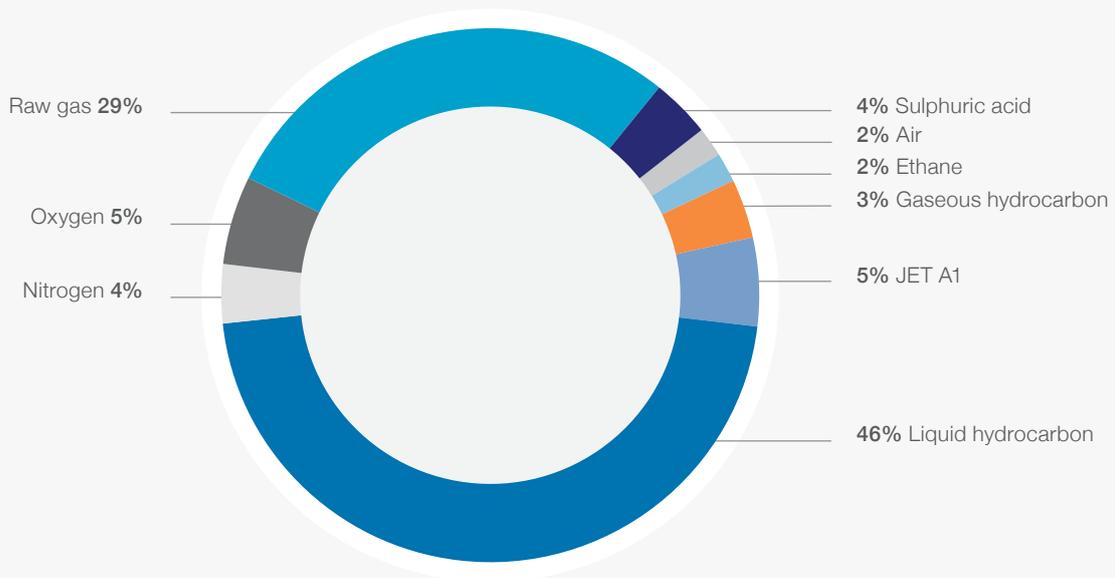
Figure 11 – Distribution of pipeline service fluid by licence

Non-natural gas transmission pipelines carry many fluid types. Predominantly liquids, these pipelines pose a high environmental risk from spillage and should be regularly inspected as a direct result (see Figure 11 for the distribution of the various service fluids being transported).

- Air
- Ethane
- Gaseous hydrocarbon
- Jet A1
- Liquid hydrocarbon
- Nitrogen
- Oxygen
- Raw gas
- Sulphuric acid

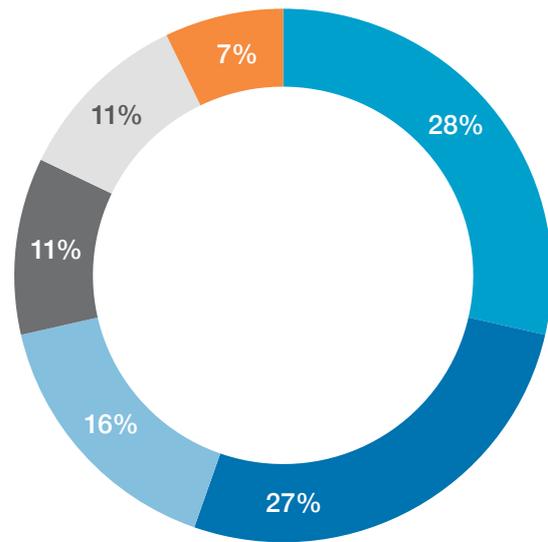
Figure 12 – Distribution of pipeline construction year

Of the non-natural gas transmission pipelines in service, 55 per cent were built before 1980. They have an average age of 39 years (see Figure 12 for the distribution of transmission pipelines based on the year of construction).

- Prior to 1970
- 1970—1980
- 1980—1990
- 1990—2000
- 2000—2010
- 2010—2020

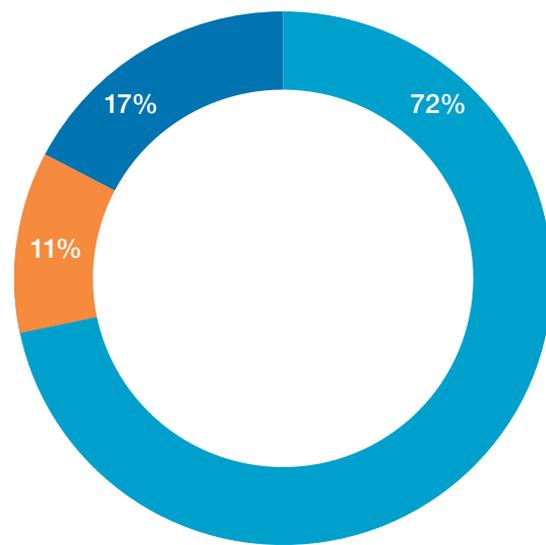
Figure 13 – Distribution of cathodic protection compliant pipelines

- 72 per cent use a CP system involving impressed current cathodic protection
- 11 per cent use sacrificial anodes
- 17 per cent, typically above ground, do not use CP systems of any type (see Figure 13 for the distribution of pipelines with and without CP systems).

- ICCP (or combination)
- Sacrificial anode
- None

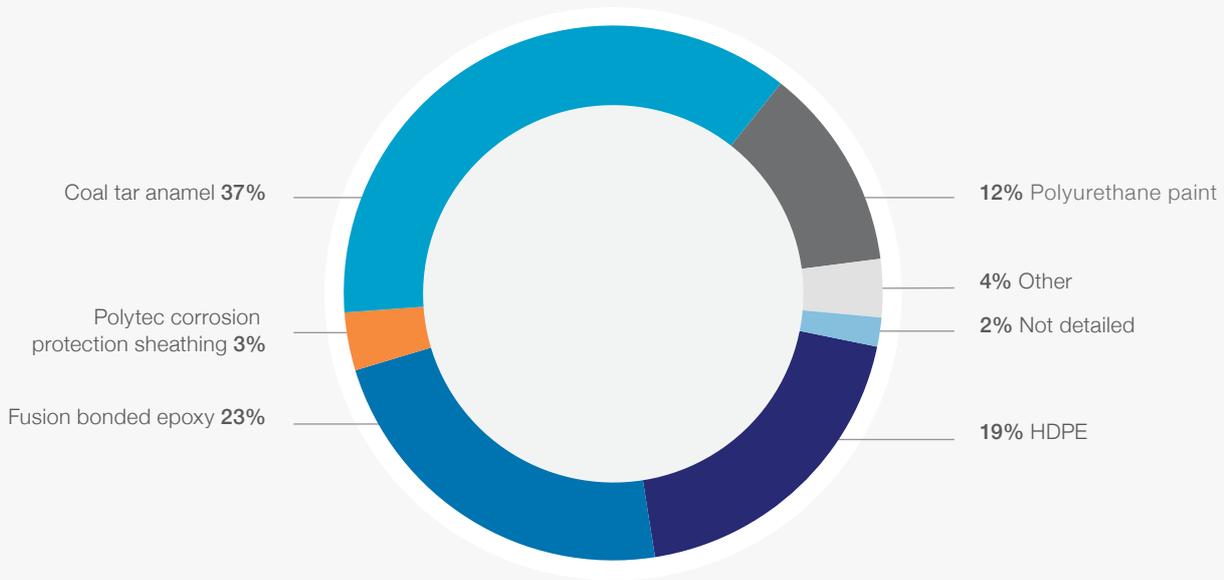
Figure 14 – Distribution of external pipeline coatings

Operators are expected to carry out coating surveys every five years to ensure coating anomalies are identified. Over the reporting period, three pipeline operators carried out five DCVG surveys, finding 41 coating anomalies. This corresponds to approximately 3.3 coating anomalies per 100 kilometres, which indicates a good overall coating condition. (See Figure 14 for the distribution of external pipeline coatings.)

Given the majority were constructed before 1980, a large proportion of pipelines use coal tar enamel coatings. Generally applied in the field, rigorous quality assurance was not achievable, so the coating tends to lose adhesion over time. Industry is aware of this and those pipelines coated with coal tar enamel have a recoating plan in place to address this issue. These plans are provided to ESV and monitored to ensure these works are conducted.

- HDPE
- Polyurethane paint
- Fusion bonded epoxy
- Other
- Polytec corrosion protection sheathing
- Not detailed
- Coal tar enamel

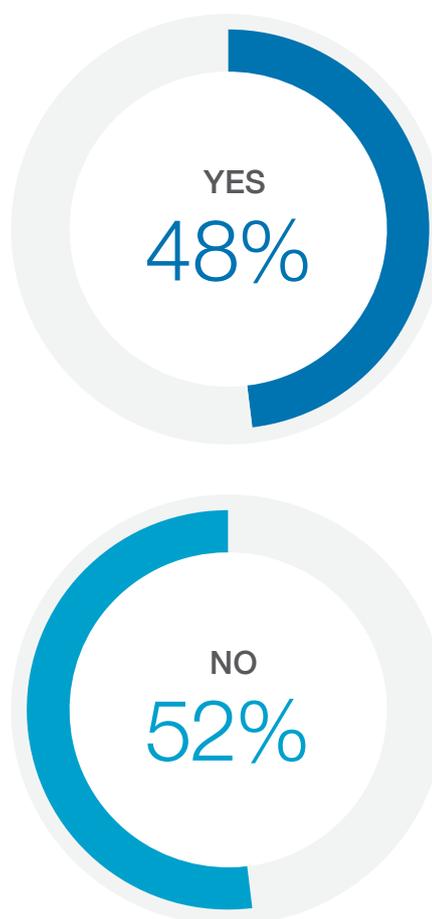
Figure 15 – Distribution of piggable pipelines

Just under half of the active pipelines are piggable. For non-piggable pipelines, DCVG surveys and subsequent pipeline anomaly assessments are adopted to ensure adequate pipeline corrosion management (see Figure 15 for the distribution of piggable to non-piggable pipelines).
