Powercor Wood Pole Management

An assessment of sustainable
wood pole safety outcomes

Public Technical Report

March 2020

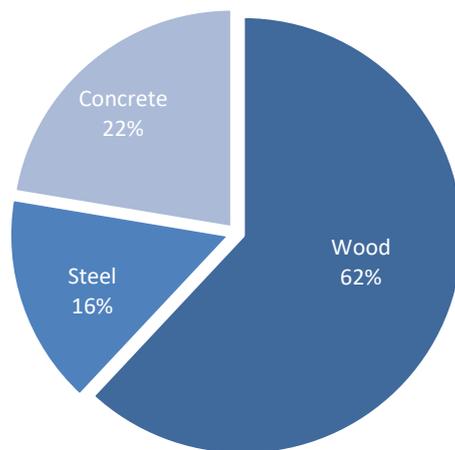
Figure 2: Composition of pole materials

The population of power poles is predominantly of wooden construction (365,900, 62 per cent) of which 58 per cent (212,200) are located in HBRA, as shown in the figures 2 and 3 below.

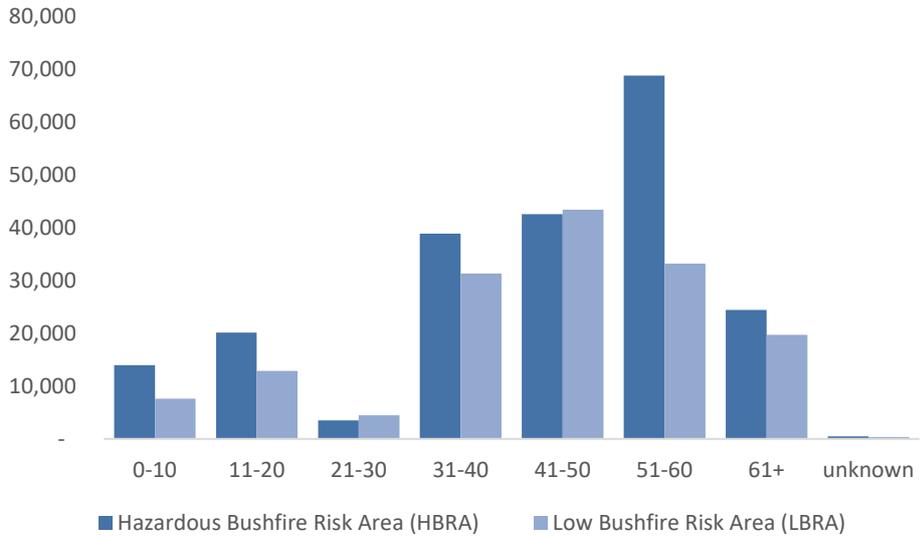
Figure 4: Age profile of wood poles installed by bushfire risk area as at 2019

The average age of the wood pole population is 44 years, with 53 per cent (194,000) already over 45 years of age. The distribution of wooden power poles by age and by bushfire risk area is shown in Figure 4.

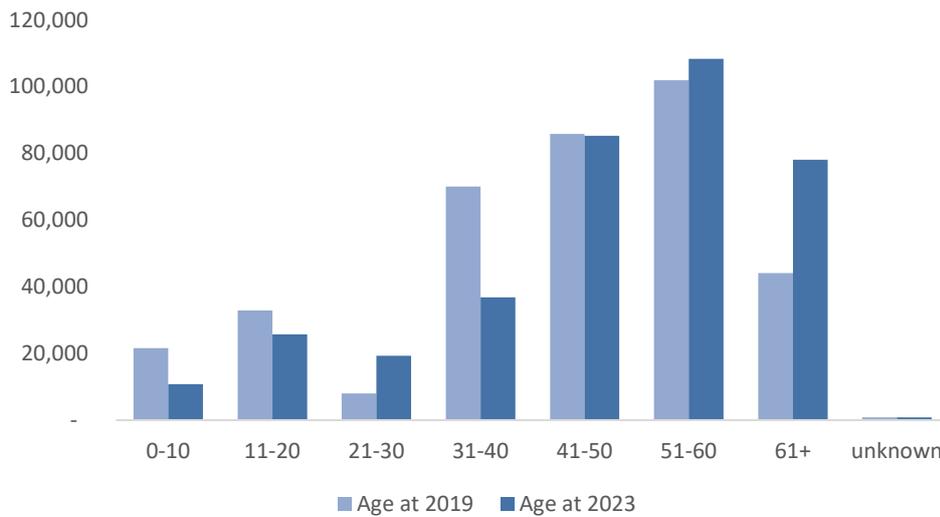
Figure 5: Age of wood poles installed as at 2019 and 2023

To provide an indication of the increasing age profile, when the age of each wood pole is increased by five years (without replacement), by the year 2023, the largest increase is to the poles in the 61+ years category.

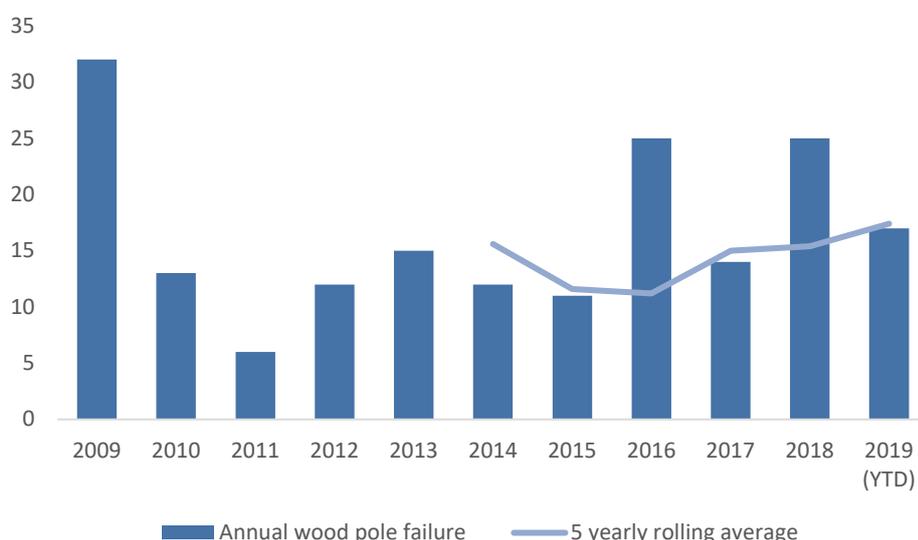
Figure 6: Powercor’s wood pole failures

The number of wooden pole failures shows an increasing trend over the last few years as illustrated in Figure 6. Powercor sets a threshold and monitors the performance of wood pole failures based on Powercor’s five-year rolling average, which can be seen to be increasing since 2016.

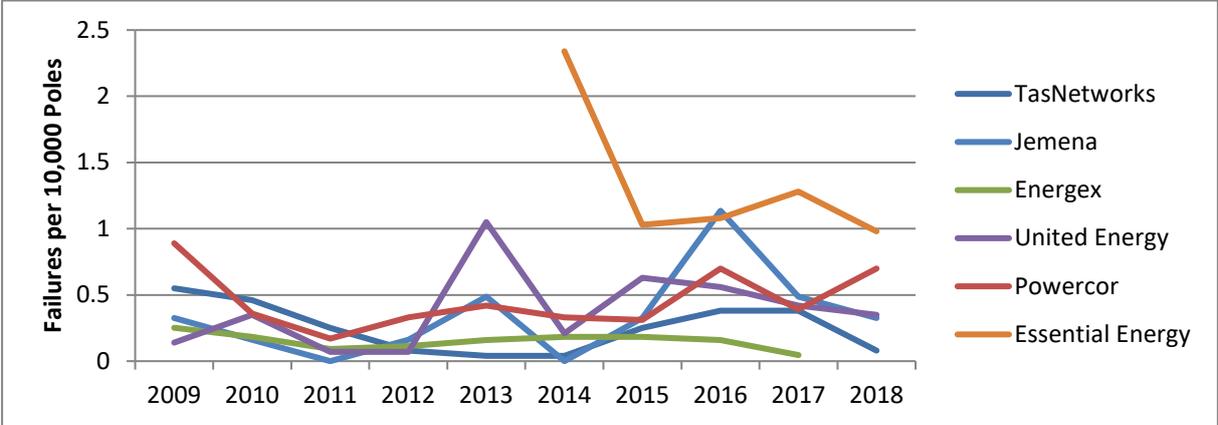
Figure 7: Comparison of wooden pole failures per 10,000 poles

While in aggregate, the average annual pole failures per 10,000 poles for Powercor are commensurate with its peers across Victoria, and lower than the Australian average. However, the increasing trend is one that requires further review by Powercor (refer Figure 7).

¹⁶ the median values are determined from the 10-years of normalised wood pole failure data for the six comparator distribution businesses shown in Figure 7

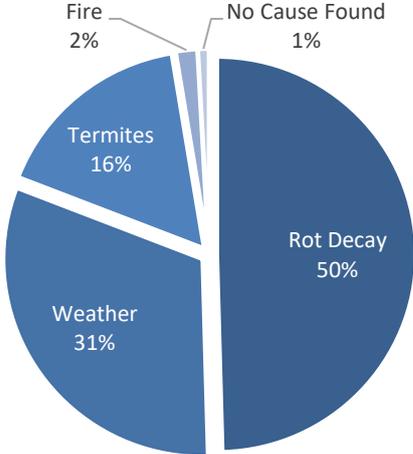
Figure 8: Cause of wood pole failures

Without intervention the failure rate will continue to increase as poles age. The major causes of unassisted wooden pole failure are rot decay (50 per cent) followed by weather (31 per cent) and termites (16 per cent) (refer Figure 8). Unassisted pole failures occur when the pole is no longer able to withstand the forces it was designed to withstand (such as wind and the weight of power line conductors).
