# United Energy Wood Pole Management

A review of sustainable wood pole safety outcomes

**Public Report**

June 2023

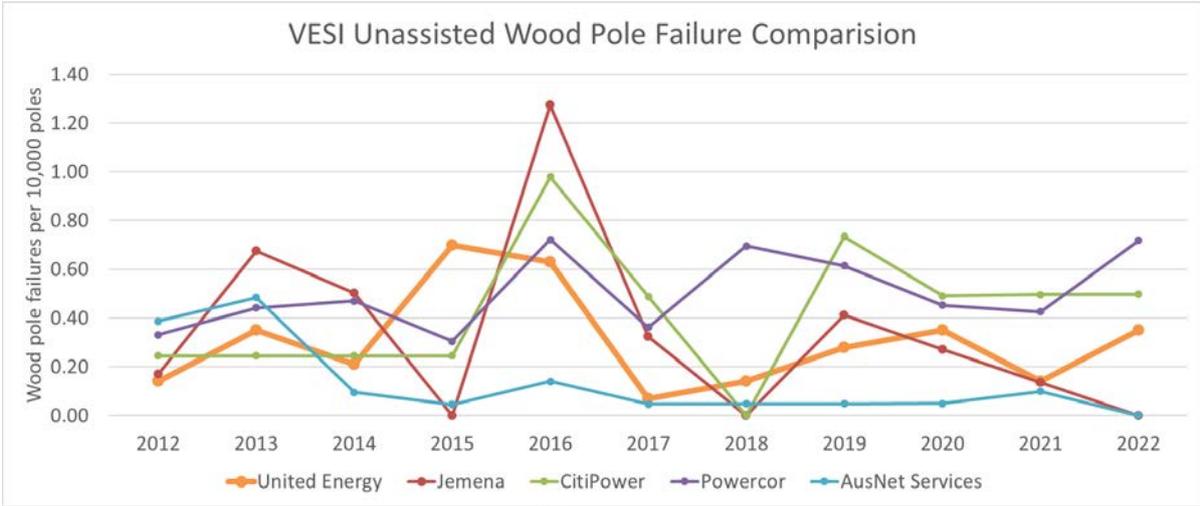
**Figure 2: Comparison of unassisted wood pole failure rate by Victorian MEC**

Source: Serious and other serious electrical incidents information submitted to ESV by MECs from 2012 to 2022

United Energy’s five-year average unassisted pole failure rate of 0.28 per 10,000 poles is the second lowest of the Victorian MECs. Nonetheless, this failure rate has increased steadily since 2017.
