Safety performance report on Victorian electricity networks

October 2022

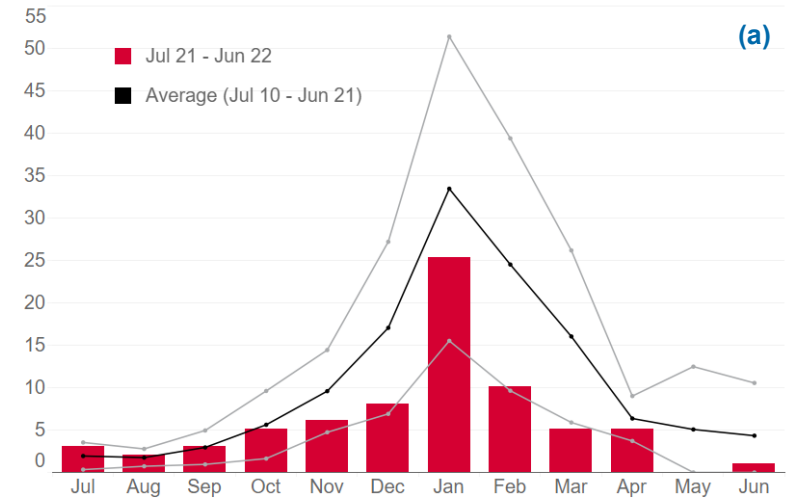
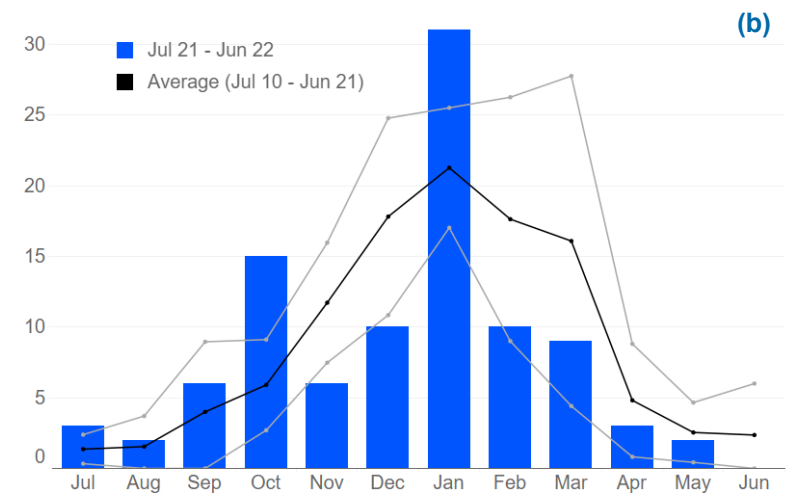
The averages and bounds in Figure 2 show a clear seasonal trend in ground fires due to both asset failures and contact events. Throughout most of the year, there are similar numbers of fires from asset and contact events; however, there is a more pronounced peak in asset-related ground fires in January and February.

Figure 2 Ground fire incidents due to (a) asset failures and (b) contact events

The grey line is one standard deviation above and below the average

The numbers of asset-related ground fires (red bars in Figure 2a) were within one standard deviation of the 2010-2020 average for most of the year. The exceptions were February and March, which had fewer fires than expected. The number of fires across the bushfire season (November to April) were below the long-term average for each month.

Figure 2b shows that the numbers of contact-related fires were well in excess of the historic numbers in October and January. The numbers of fires across most of the bushfire season were below the historic average, with the exception of January.

The outliers in Figure 2b are the peaks in January 2022 and October 2021 that are well above the normal band of expected fires.

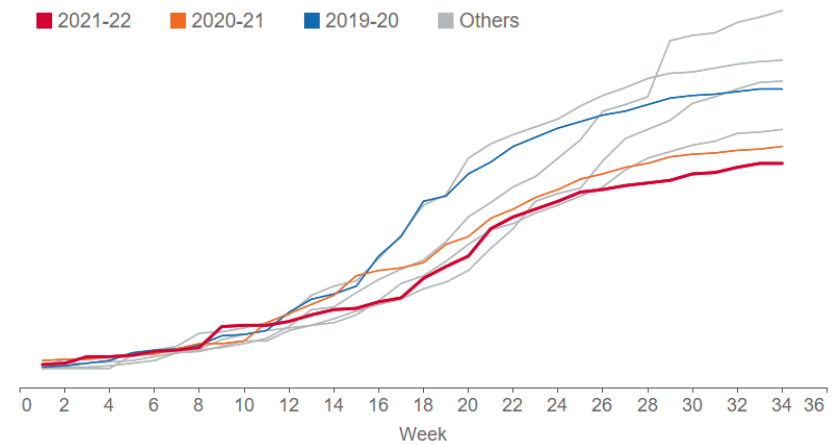
Figure 3 shows the cumulative number of ground fires throughout the fire season (October to April). While the total fires in the first nine weeks of the fire season were ahead of previous years, the numbers of fires tapered off and the total fires across the entire fire season was at the lowest level in the last seven years.

Figure 3 Cumulative fires across the fire season

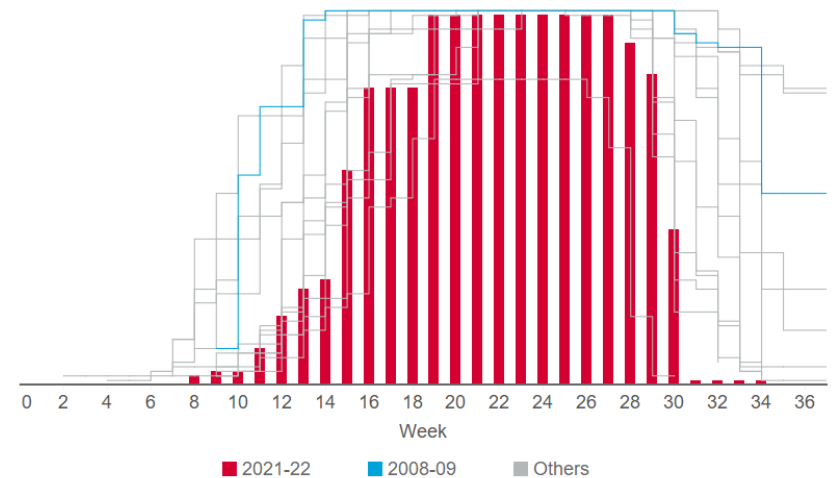
The first declarations for this year's season started later than last year, slowly rose over eight weeks and then plateaued for three weeks (Figure 4). By week 19, declarations had been issued for 81 of 82 municipalities or parts thereof and then plateaued without the entire state being declared. The CFA began slowly removing declarations in weeks 28 and 29, after which they were removed from all but one municipality for the rest of the fire season. The official fire season finished several weeks earlier than previous years.

Figure 4 Summary of CFA fire declarations from 2008 to 2022

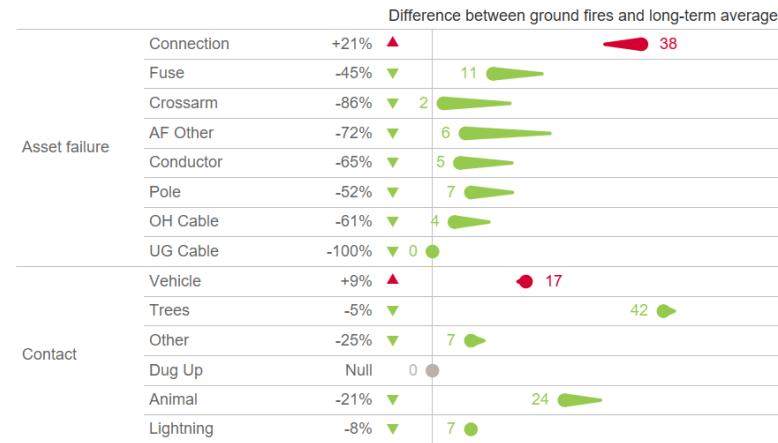
Figure 5 shows the number of ground fire events on the Victorian networks. The green arrows show the reduction from the long-term average across the 2010-2021 period (improvement), and the red arrows show the increase (decline).

Figure 5 Ground fire-related incidents occurring on Victorian networks

The four most common causes of fires were tree contact, connection faults, animal contact, and vehicle impacts (including mobile plant and farming equipment). The same four events comprised last year's top four causes of fires.

After last year's increase, tree contact fires have fallen this year (Figure 6) to be lower than the long-term average (Figure 5).

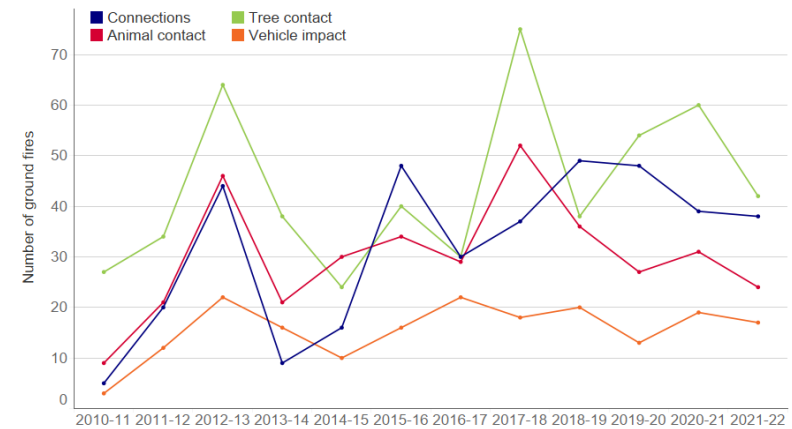
Figure 6 shows the trend over the last twelve years for the four most common causes of ground fires. This indicates that:

- fires from tree contact have dropped this year and are now 5 per cent below the historic average, with the decrease most likely due to the wet summer
- after rising steadily from 2013-14 and 2019-2020, fires from connection faults have fallen for a second year but are still 38 per cent above the historic average
- animal contact fires dropped this year and are now 21 per cent below the historic average
- fires from vehicle and mobile plant contacts dropped this year and are 9 per cent above the historic average.

Figure 6 Historic trends for common ground fire events

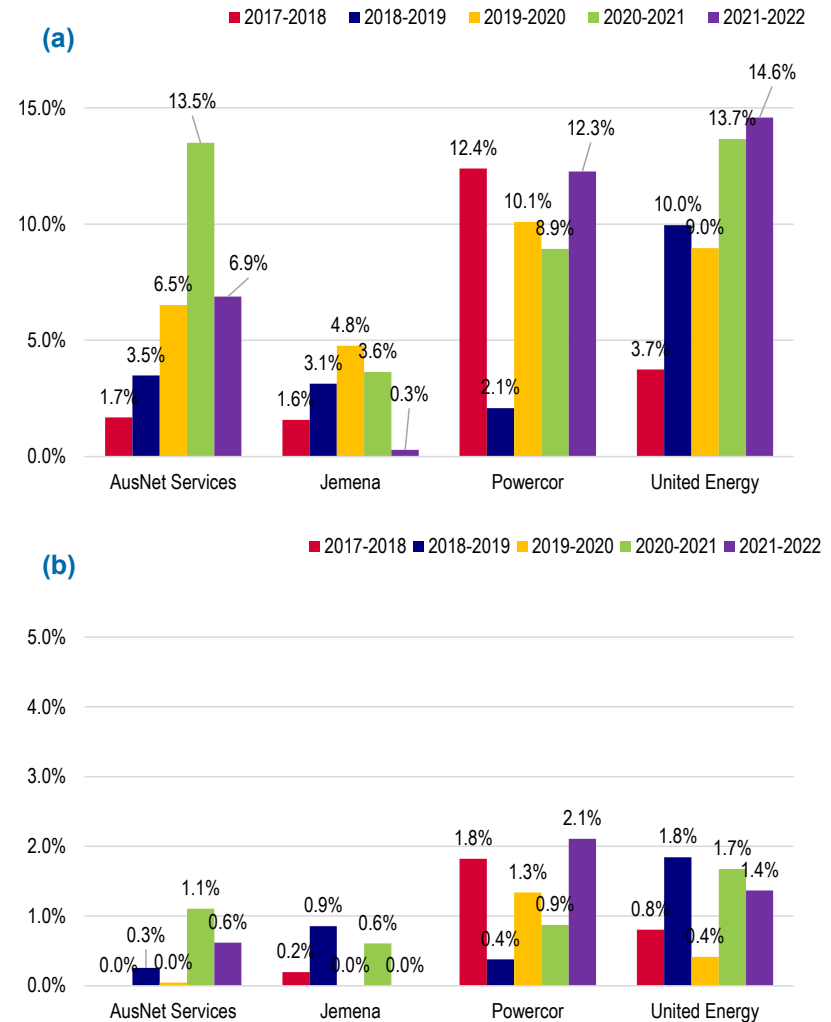
ESV has seen the average rate of non-compliant vegetation across the networks in HBRA decrease slightly this year, although there has been an upward trend over the last five years. There have been increases on the Powercor and United Energy networks (Figure 9a). While there was a decrease on the AusNet Services network, non-compliances are still elevated. Jemena had a significant decrease in non-compliance this year.

The average rate of major non-compliances affecting the networks increased in HBRA this year. This was solely due to increased non-compliance on the Powercor network (Figure 9b). A major non-compliance is regarded as a high risk situation where vegetation is touching, or could soon touch, uninsulated conductors.

Figure 9 Non-compliance rates in HBRA
(a) all non-compliances and (b) major non-compliances

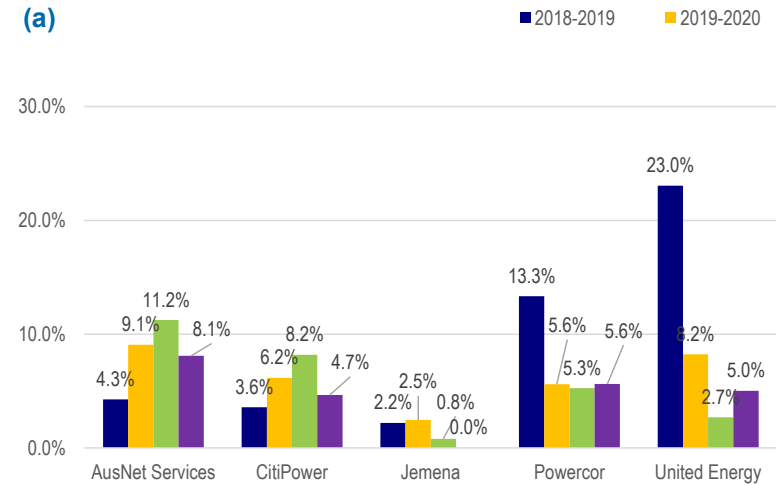
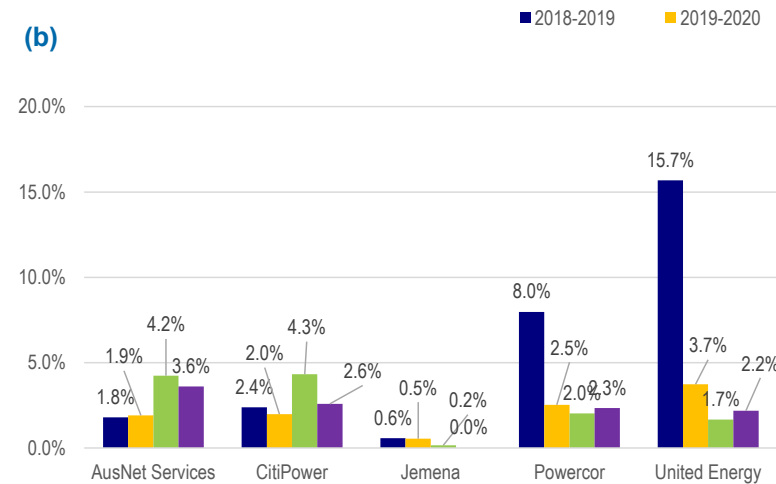
The rate of non-compliant vegetation affecting the distribution networks in LBRA remains relatively low and steady (Figure 10a). The rate of major non-compliances affecting the distribution networks in LBRA also remains low and steady (Figure 10b).

Figure 10 Non-compliance rates in LBRA (a) all non-compliances and (b) major non-compliances

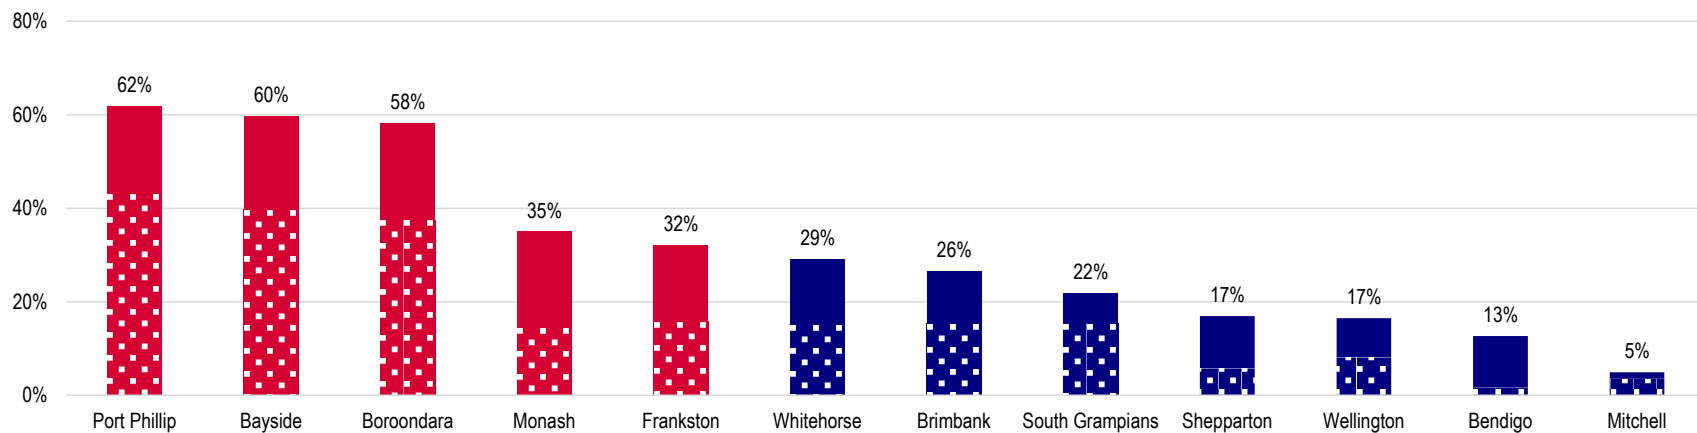
Figure 11 shows the non-compliance rates observed for each of the councils inspected. ESV identified the rate of non-compliance in LBRA in 2021-2022 is much higher for councils (31.3 per cent on average) than for the distribution businesses (5.7 per cent on average).

Figure 11 Non-compliance rates for councils inspected in 2021-2022

The councils shown in red had non-compliance rates in excess of the council average. The dotted area shows the levels of high risk non-compliance within the overall non-compliance rate.

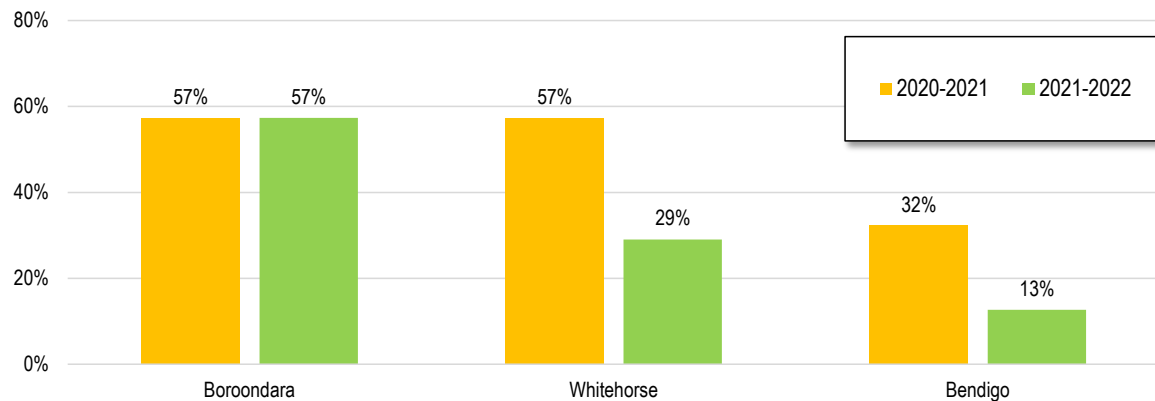
It was pleasing to note that both the Cities of Whitehorse and Greater Bendigo had responded by showing vastly improved compliance standards; greatly improving electricity safety in these municipalities (Figure 12). While the performance of the City of Boroondara did not improve from 2020-2021 to 2021-2022, this was not unexpected for reasons previously explained in this report (see page 10).

Figure 12 Changes in performance of the three worst-performing councils from 2020-2021

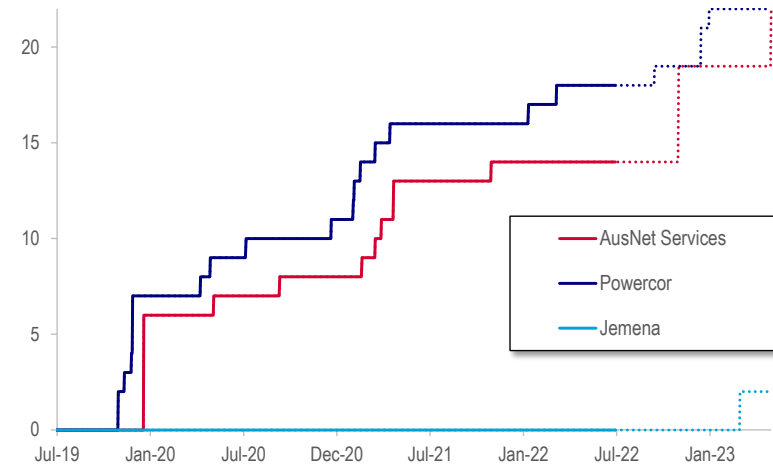
By 30 June 2022, ESV had accepted 14 AusNet Services zone substations and 18 Powercor zone substations as compliant. Figure 13 shows the cumulative number of compliant REFCLs installed by each major electricity company and the anticipated progress to achieving full compliance at all mandated substations. Figure 14 shows the coverage of the substations with REFCLs mandated by the regulations.

Figure 13 Compliant REFCLs installed to 30 June 2022

Dotted lines are projected delivery times

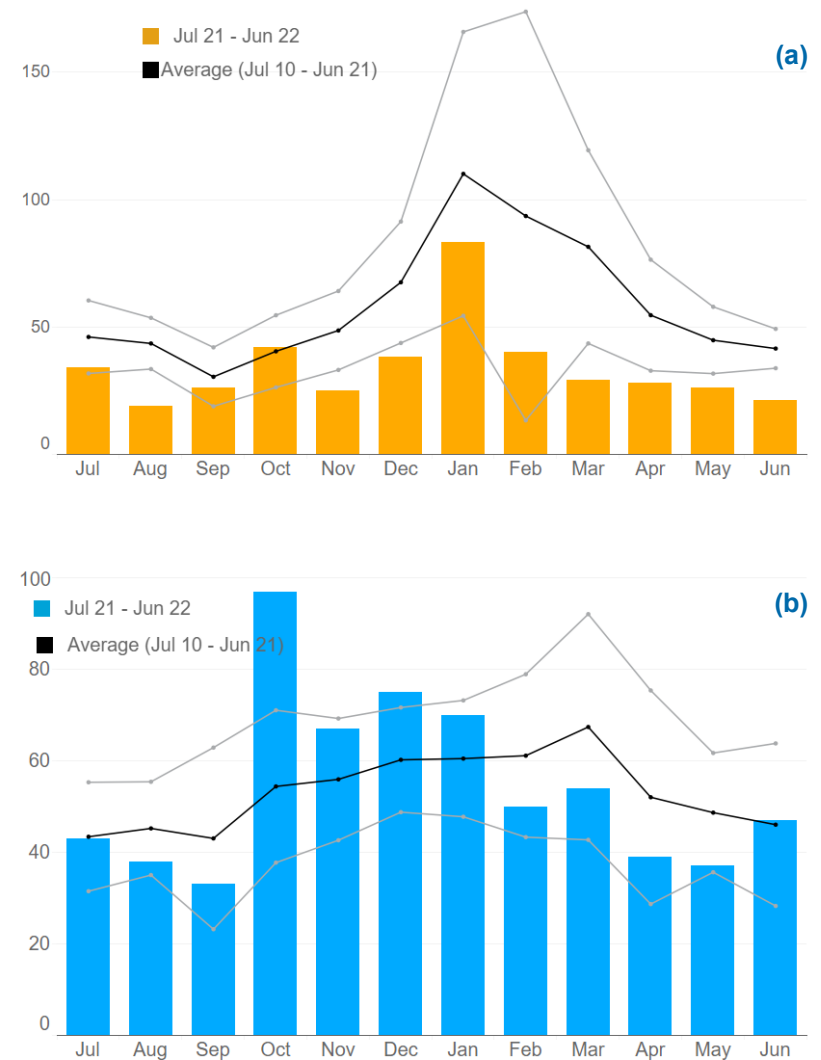
The historical average for the period January 2010 to June 2021 shows a seasonal trend with increased asset failures over the summer period (Figure 15a). The numbers of asset failure incidents in the last year were well below the 2010-2021 average, with seven of the 12 months being more than one standard deviation below the average. For a second year in a row, asset failure events are below expectations.

The numbers of contact events show less seasonality and a less pronounced peak occurring in March (Figure 15b). Such events are largely outside the direct control of the networks to manage.

Figure 15 All incidents in the period due to (a) asset failures and (b) contact events

The grey line is one standard deviation above and below the average

Contact events this year also showed a high degree of variability. Two months were more than one standard deviation below the long-term average, and two months were higher than one standard deviation above the average.

The peak in October 2021 was primarily due to tree contact incidents associated with a major storm front on 28-30 October. This accounted for 46 of the 97 incidents that month. Most of these incidents were contained to the United Energy network (32 of 46 incidents).

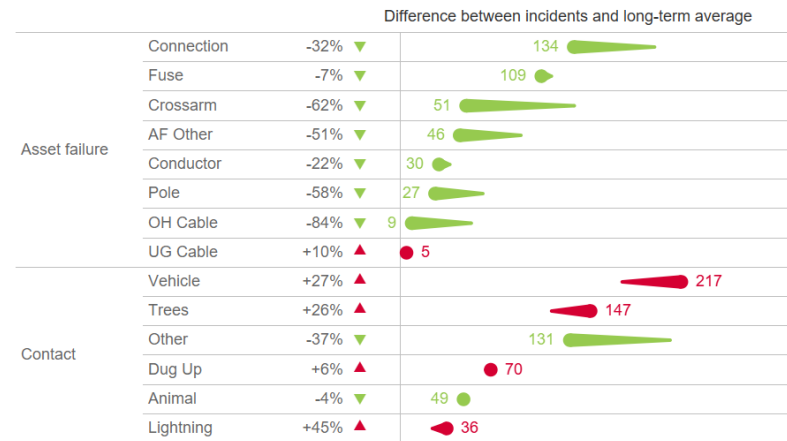
Figure 16 shows the number of incidents on the Victorian electricity networks. The green arrows show the reduction from the long-term average across the 2010-2021 period (improvement), and the red arrows show the increase (decline).

Figure 16 Incidents occurring on Victorian networks

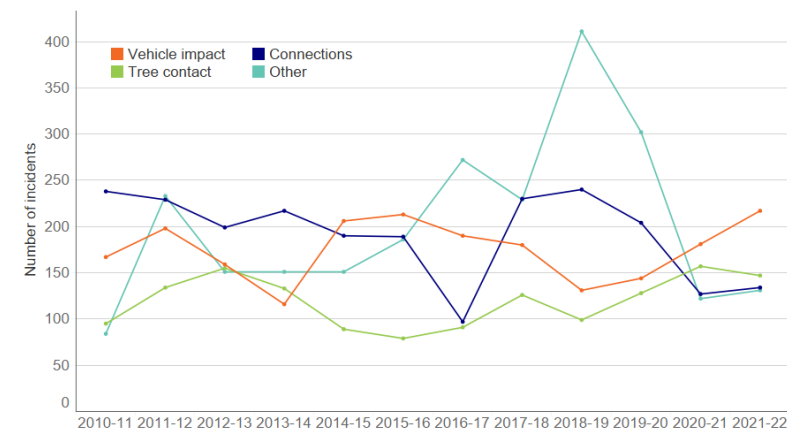
Figure 17 shows the trend over the last ten years for the top four events above. This indicates that:

- vehicle impacts have increased this year and are 27 per cent higher than the long-term average
- tree contacts have also dropped slightly but are still 26 per cent higher than the long-term average
- connection faults have increased slightly to be 7 per cent lower than the long-term average
- after a marked decrease last year, other contact events have increased slightly but are still 37 per cent lower than the long-term average.

Figure 17 Historic trends for common incident events

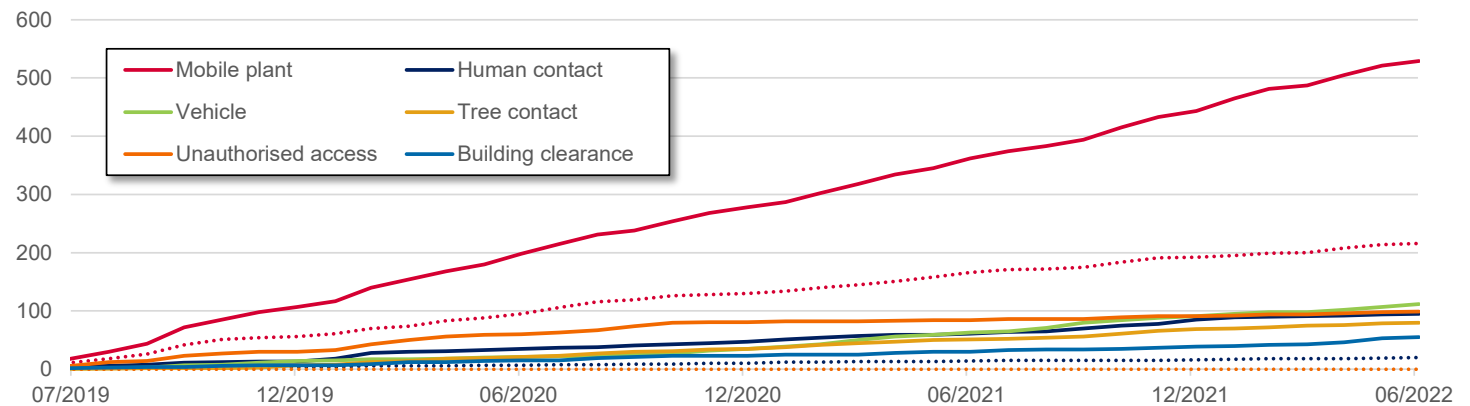
Figure 18 shows the cumulative number of No Go Zone (NGZ) incidents over the last three years. The activities that pose the highest safety risk from breaches of the NGZ are operating mobile plant near powerlines, vehicle transit and unauthorised access. The last twelve months has also seen a step upwards in building clearance breaches.

Figure 18 Cumulative trends involving NGZ incidents since 1 July 2019

solid lines = overhead assets, dotted lines = underground assets

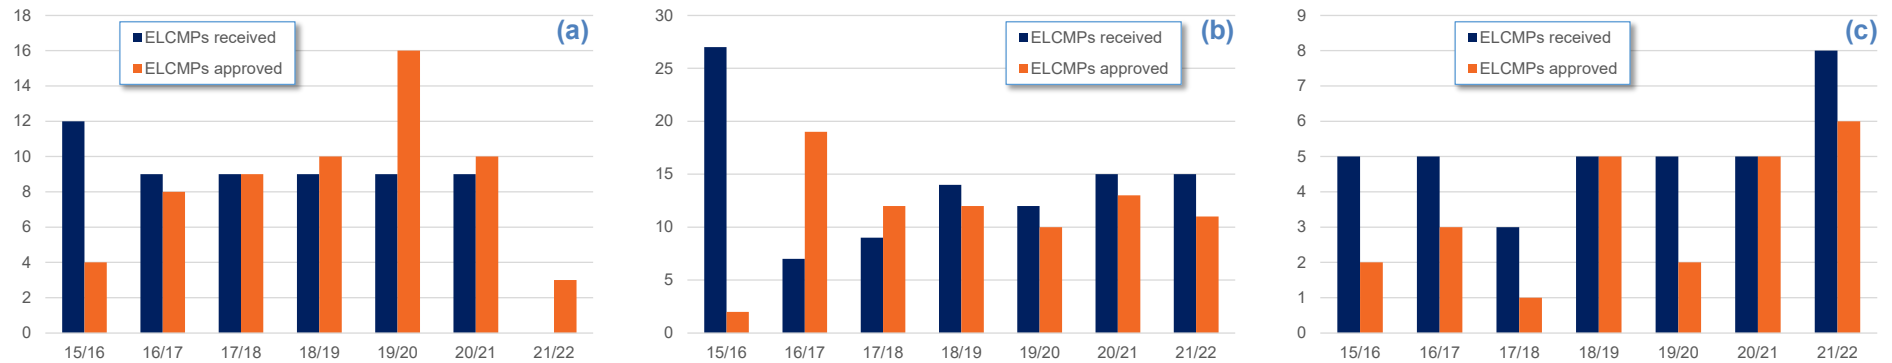
The numbers of ELCMPs received and approved by ESV each year are shown in Figure 22.

Figure 22 ELCMPs received and approved for (a) major electricity companies, (b) councils and (c) other responsible persons

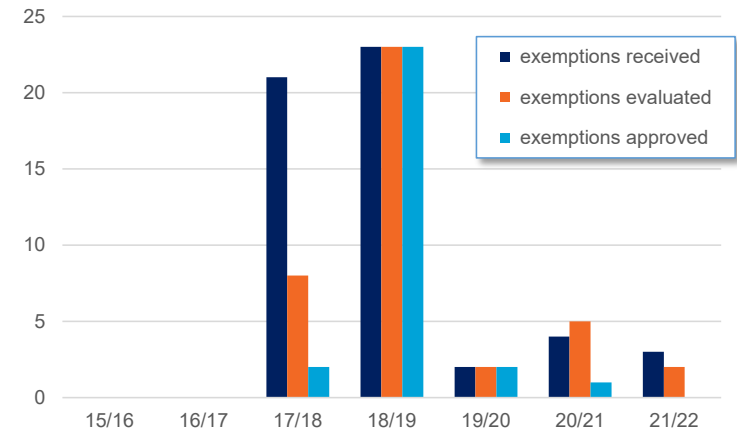
Figure 23 Bushfire Mitigation Plan exemptions

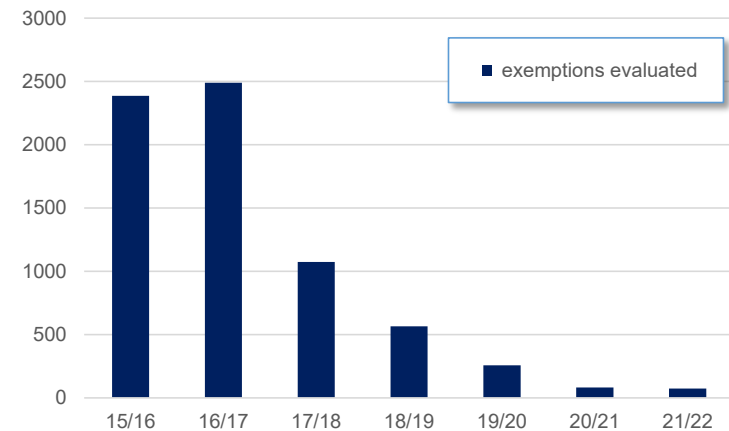
The number of such applications has fallen dramatically from its peak in 2016-17 (Figure 24). The bulk of applications received in recent years related to the installation of the National Broadband Network (NBN). Those applications have tapered off significantly now that most of the network backbone has been deployed.

Figure 24 Electric lines on public lands exemptions

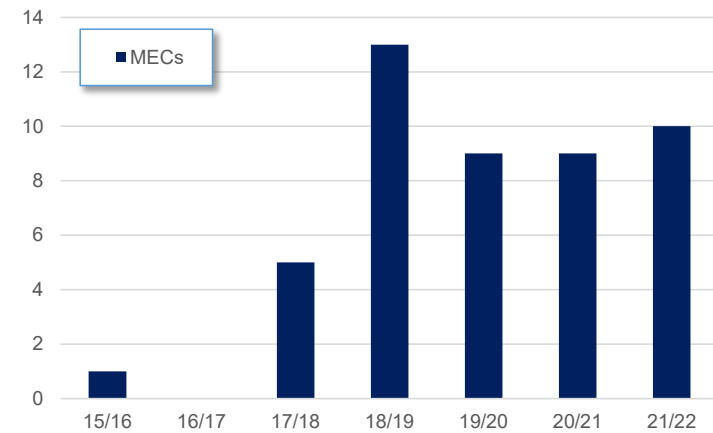
Figure 25 shows the numbers of ESMS audits undertaken each year.

Figure 25 Numbers of ESMS audits

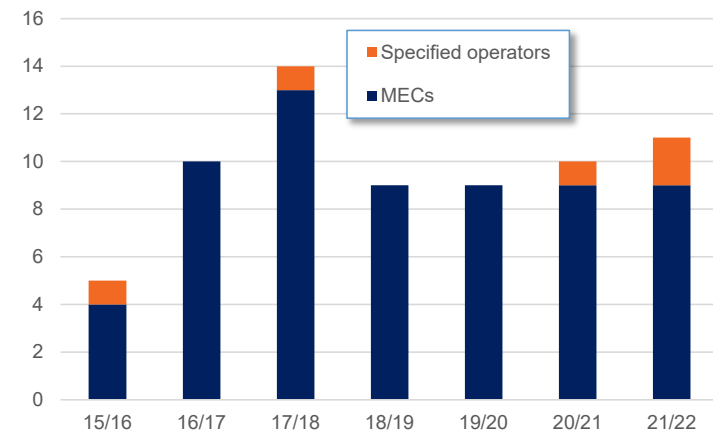
Figure 26 shows the numbers of bushfire mitigation audits undertaken each year. Nine of the ten major electricity companies are audited at least once each year; TransGrid was not audited this year due to the young age of its assets. The peak in 2017-2018 resulted from secondary pole audits of four of the distribution businesses due to stakeholder concerns.

Figure 26 Numbers of bushfire mitigation audits

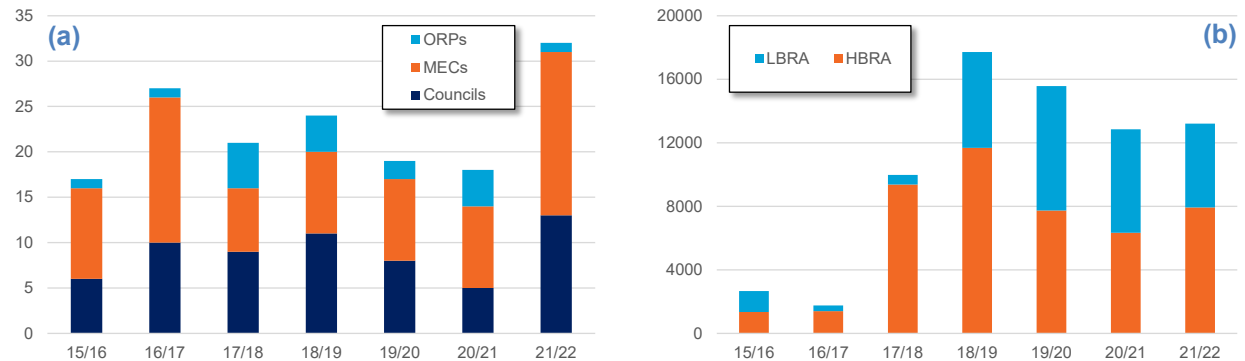
Figure 27(a) shows that the numbers of pre-summer audits have remained relatively stable over the last six years, although the number of individual audits undertaken increased in 2021-2022. Figure 27(b) shows that the volume of spans inspected by ESV has increased from 2,000-3,000 spans in 2015-16 and 2016-17 to over an average of 15,000 yearly since 2018-19.

The number of spans inspected by ESV has decreased in the last two years due to COVIDSafe requirements and other general impacts caused by the pandemic. ESV has had to manage the audit function around resourcing constraints. We prioritised inspections in HBRA to ensure that the results of our inspections were representative of the broader compliance standards for the networks.

Figure 27 Electric line clearance audits and inspections showing (a) the number of pre-summer outcomes audits and (b) the volume of spans inspected during these audits and inspections

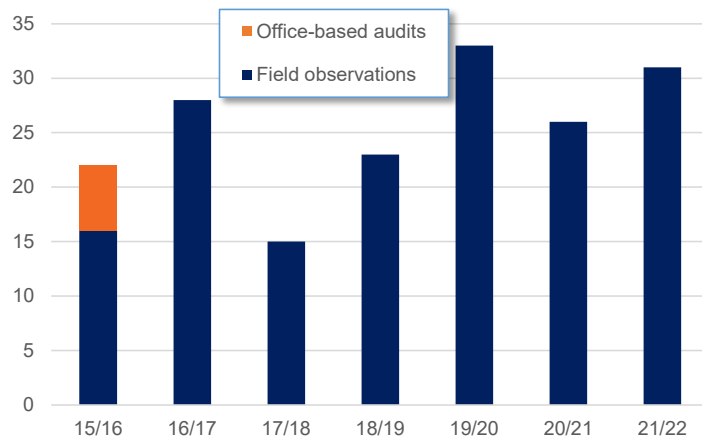
Figure 28 shows the number of work practice observations undertaken each year. ESV’s Safety Outcomes Assurance team conducted a total of 31 field-based observations this year, including observations of asset inspectors for the first time. This work was interspersed with their education and consultation duties working with industry committees, urban and rural businesses, and other relevant organisations across the state.

Figure 28 Numbers of works practice observations

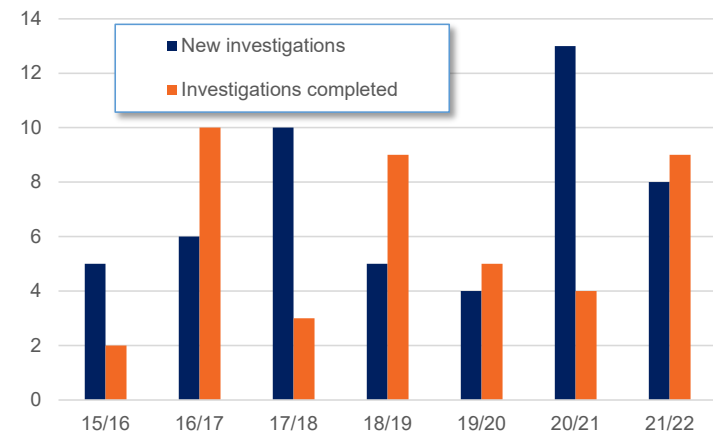
Figure 29 shows the numbers of new investigations opened each year and the number that have been completed. Given the level of detail required to support an enforcement action, many of these investigations may extend into future years.

Figure 29 Numbers of new and completed investigations

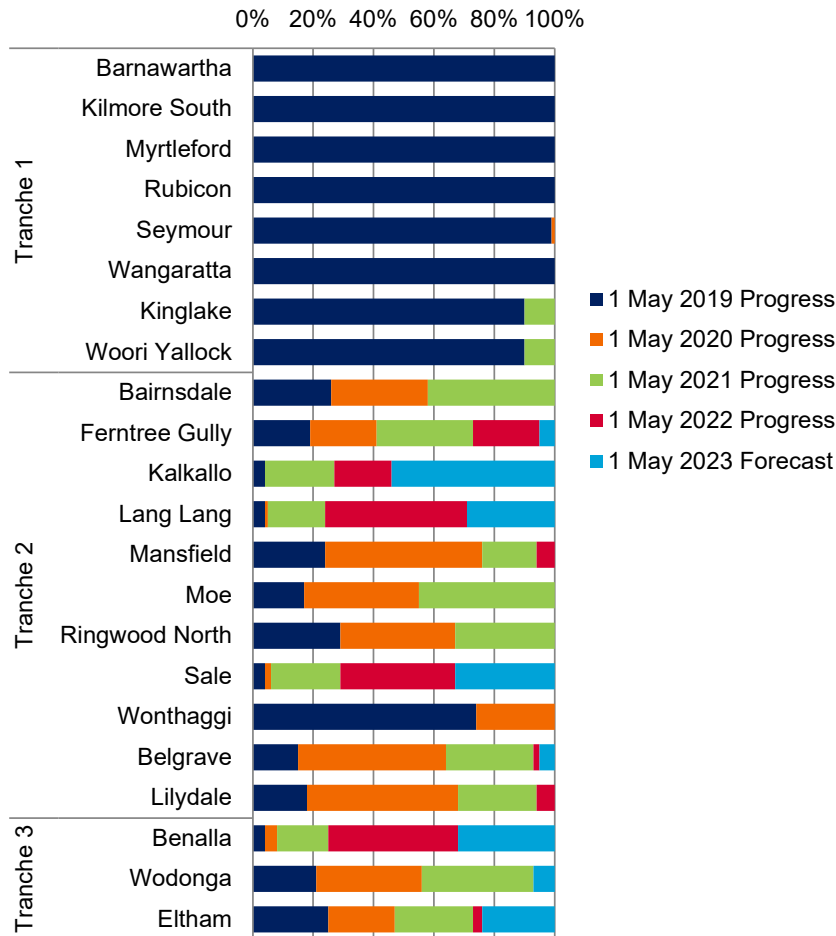
Figure 31 shows the progress of the AusNet Services REFCL installation program as of 1 May 2019, 2020, 2021 and 2022, and its anticipated progress in the next twelve months.

By 30 June 2022, ESV had accepted 14 AusNet Services zone substations as compliant, and granted time extensions in relation to four zone substations.

Figure 31 Status of the AusNet Services REFCL program

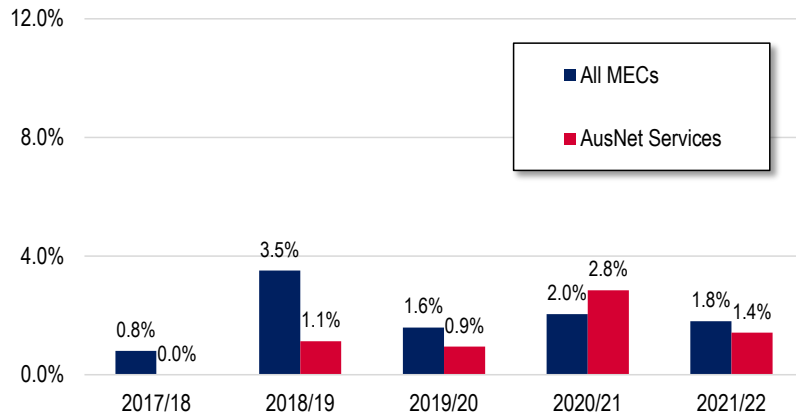
In 2021-2022, ESV observed a decrease in the rate of major non-compliances affecting the AusNet Services distribution network when compared to the rates observed in 2020-2021 (Figure 32). A major non-compliance is regarded as a high risk situation where vegetation is touching, or could soon touch, uninsulated conductors.

Figure 32 Rate of major non-compliances (HBRA and LBRA)

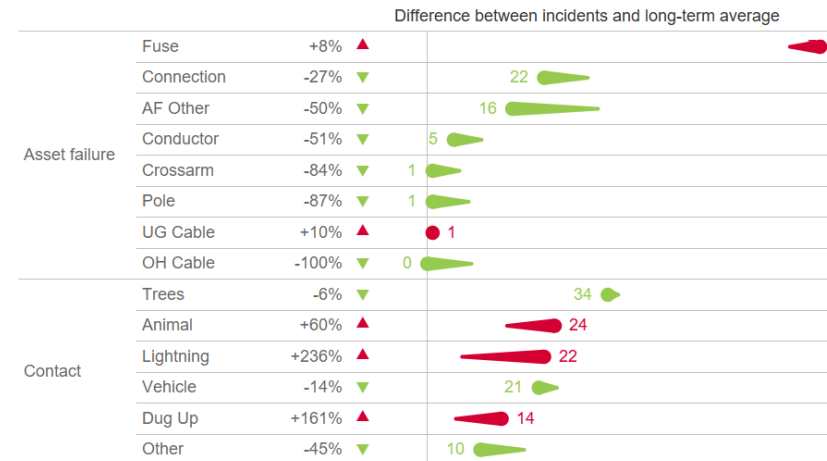
Figure 33 shows the number of all serious electrical incidents reported to ESV via OSIRIS by AusNet Services during the 2021-2022 period. The green arrows show the reduction from the long-term average across the 2010-2021 period (improvement), and the red arrows show the increase (decline). Figure 34 shows the same for those incidents that resulted in a ground or vegetation fire.

Figure 33 Incidents on the AusNet Services network

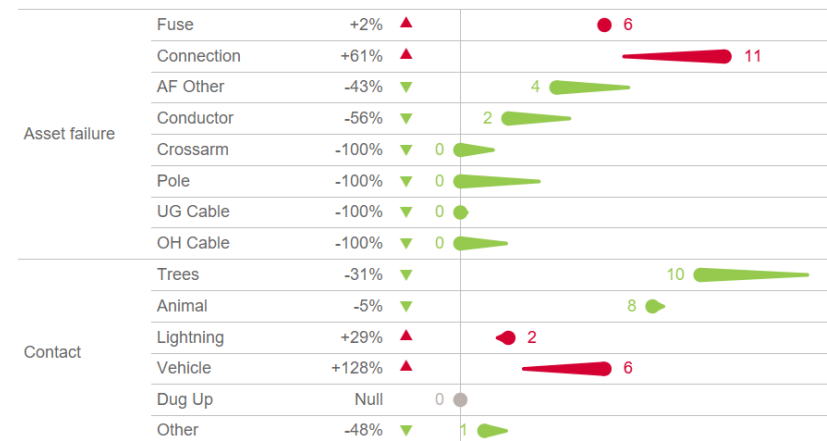
Figure 34 Incidents on the AusNet Services network resulting in ground fires

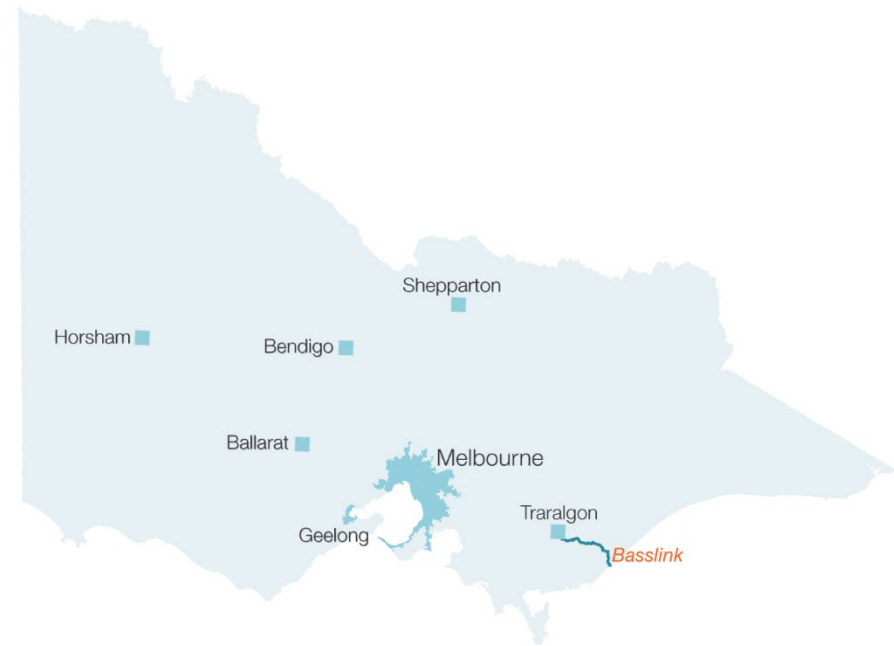
Basslink owns and operates the HVDC interconnector between Victoria and Tasmania. In Victoria, its assets comprise the Loy Yang converter station connected to the 500kV transmission system via 3.2 km of overhead line. From the converter station, 57 km of overhead line and 6.4 km of underground cable connect to the submarine cables that cross Bass Strait to Tasmania (Figure 35). Only the onshore assets in Victoria are subject to regulation by ESV.

Figure 35 Location of Basslink transmission assets (dark blue line)

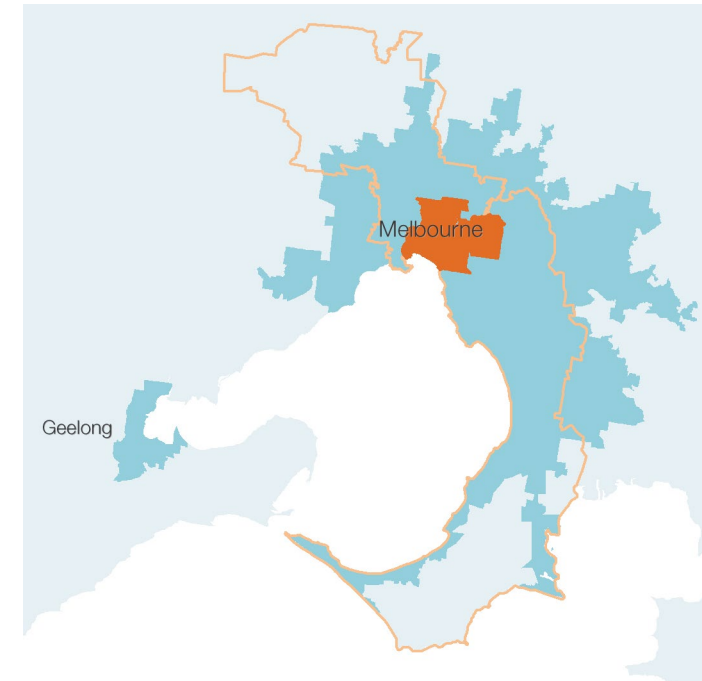
The CitiPower distribution network covers an area of approximately 157 km², and includes Melbourne's central business district and inner suburbs (Figure 36). It comprises approximately 2,550 km of overhead line, 2,700 km of underground cable, 48,800 power poles and 9,000 public lighting poles. All of the CitiPower network is in LBRA.

Figure 36 Service area for the CitiPower distribution network (orange area)

Jemena and United Energy service boundaries are shown as orange lines

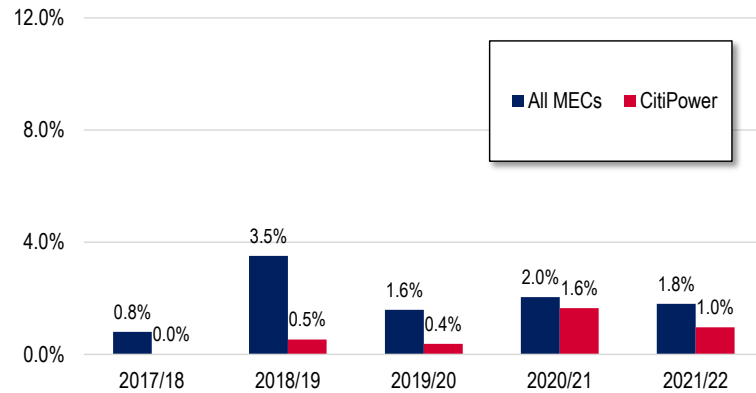
In 2021-2022, ESV observed a decrease in the rate of major non-compliances affecting the CitiPower network when compared to the previous year (Figure 37). A major non-compliance is regarded as high risk where vegetation is touching, or could soon touch, uninsulated conductors.

Figure 37 Rate of major non-compliances (LBRA)

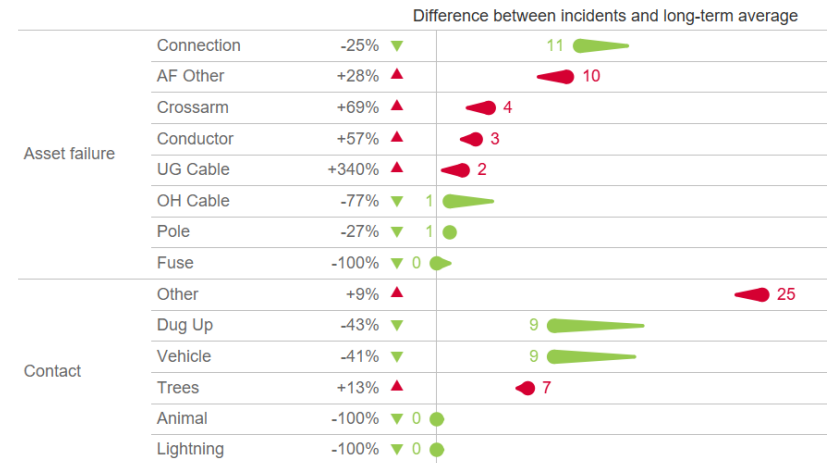
Figure 38 shows the number of all serious electrical incidents reported to ESV via OSIRIS by CitiPower during the 2021-2022 period. The green arrows show the reduction from the long-term average across the 2010-2021 period (improvement), and the red arrows show the increase (decline). Figure 39 shows the same for those incidents that result in a ground or vegetation fire.

The numbers of asset failure incidents were higher in 2021-2022 than the long-term average in four categories, lower in three categories and stable in one category. Contact incidents were higher in two categories, lower in two categories and stable (or zero) in two categories.

Figure 38 Incidents on the CitiPower network

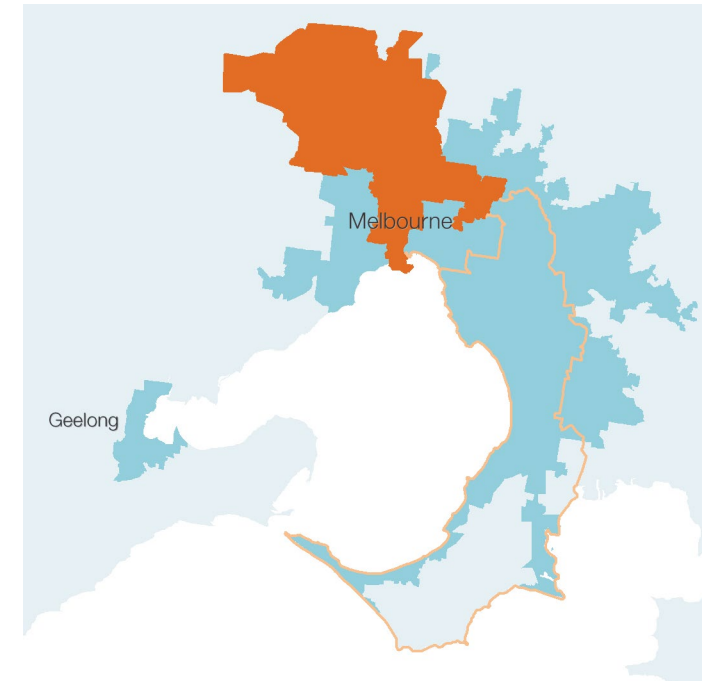
The Jemena distribution network covers an area of approximately 950 km², across Melbourne's northern and western suburbs, including Melbourne International Airport (Figure 40). It comprises approximately 4,500 km of overhead line, 2,200 km of underground cable, 93,600 power poles and 28,700 public lighting poles. Most of the Jemena network (59 per cent) is in HBRA.

Figure 40 Service area for the Jemena distribution network (orange area)

CitiPower and United Energy service boundaries are shown as orange lines

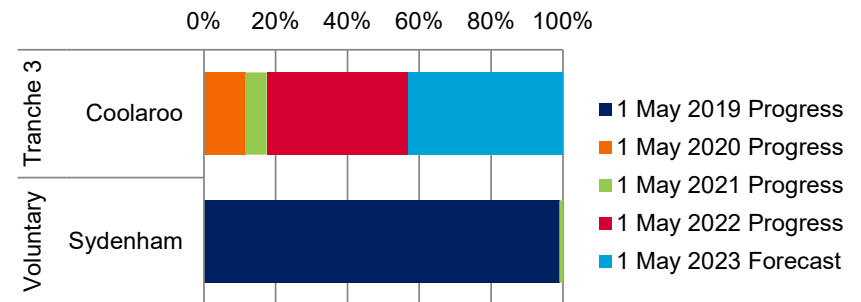
Figure 41 shows the progress of the Jemena REFCL installation program at 1 May 2019, 2020, 2021 and 2022, and its anticipated progress in the next 12 months.

Figure 41 Status of the Jemena REFCL program

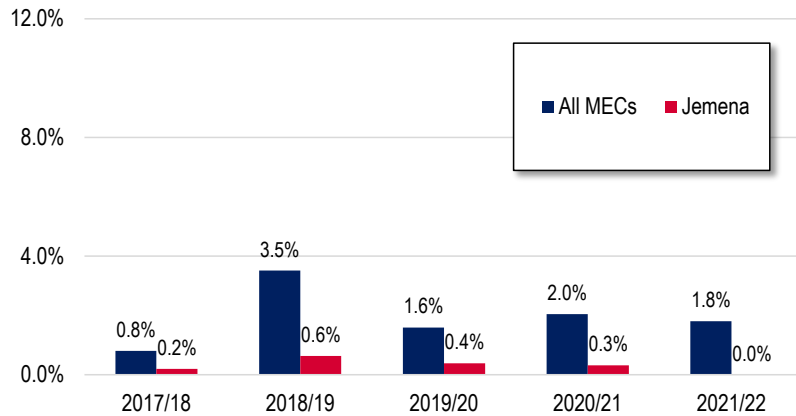
In 2021-2022, ESV found no major non-compliances affecting the Jemena network in HBRA. Last year's decrease in the rate of major non-compliances continued (Figure 32). A major non-compliance is regarded as a high risk situation where vegetation is touching, or could soon touch, uninsulated conductors.

Figure 42 Rate of major non-compliances (HBRA and LBRA)

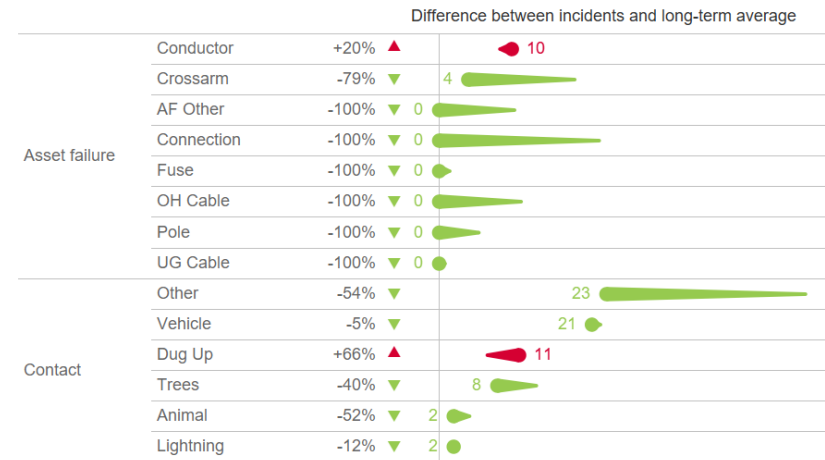
Figure 43 shows the number of all serious electrical incidents reported to ESV via OSIRIS by Jemena during the 2021-2022 period. The green arrows show the reduction from the long-term average across the 2010-2021 period (improvement), and the red arrows show the increase (decline). Figure 44 shows the same for those incidents that result in a ground or vegetation fire.

The most common incidents on the Jemena network in 2021-2022 were other contact events, vehicle impacts, dug-up cables and conductor failures. Three of these events are outside of the direct control of Jemena and one (conductor failures) is within its control. Only dug-up cables and conductor failures were higher this year than the long-term average.

Figure 43 Incidents on the Jemena network

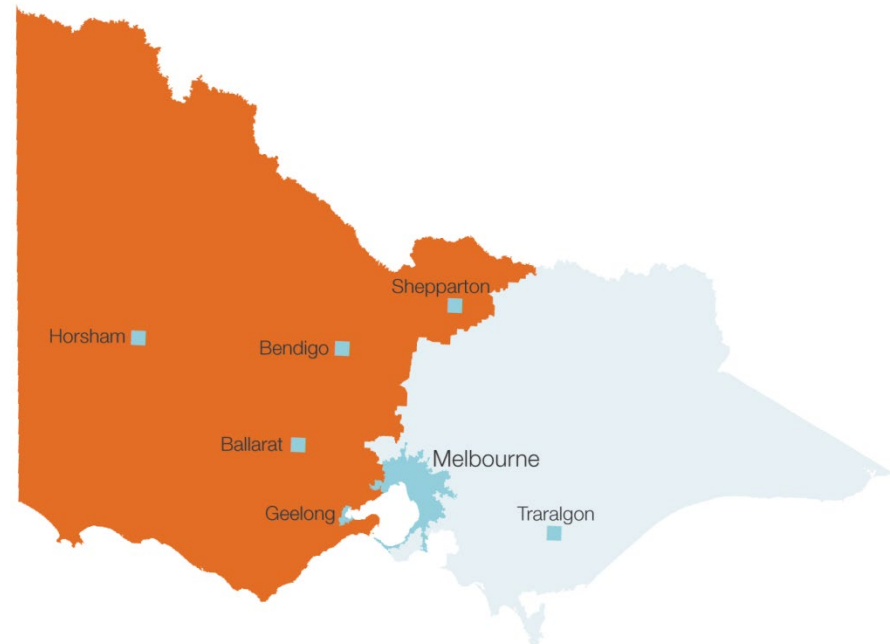
The Powercor distribution network covers any area of approximately 145,700 km², and includes Melbourne's Docklands Precinct, west from Williamstown to the South Australian border, north to the Murray and south to the coast (Figure 45). It comprises approximately 68,700 km of overhead line, 9,200 km of underground cable, 489,000 poles and 100,100 public lighting poles. Most of the Powercor network (96 per cent) is in HBRA.

Figure 45 Service area for the Powercor distribution network (orange area)

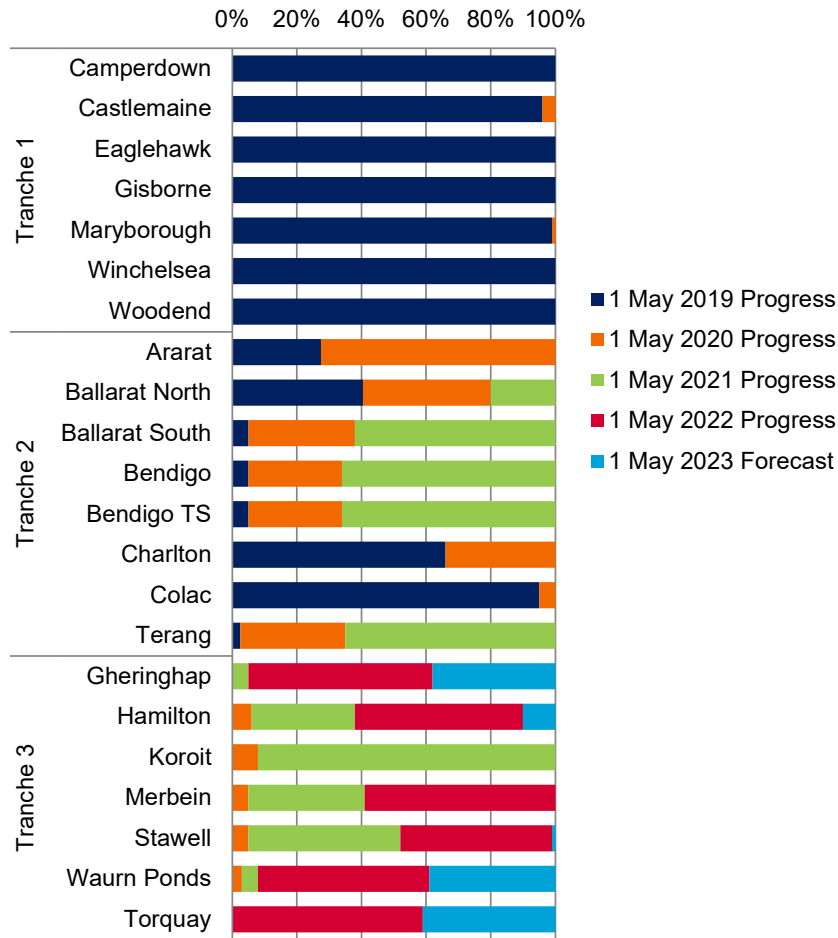
Figure 46 shows the progress of the Powercor REFCL installation program at 1 May 2019, 2020, 2021 and 2022, and its anticipated progress in the next twelve months.

In 2019-2020, ESV granted an exemption in regard to Powercor's obligation to install REFCLs at Corio and Geelong. Instead a REFCL will be installed at the new Gheringhap zone substation, which will supply those powerlines in hazardous bushfire risk areas. This reduced the number of Powercor REFCLs from 22 to 21.

In 2020-2021, Powercor advised ESV that it would split the existing Waurn Ponds network and supply one half from a new REFCL-protected Torquay zone substation. An exemption was not required as all powerlines will be REFCL-protected. This took the total number of Powercor REFCLs back up to 22.

Figure 46 Status of the Powercor REFCL program

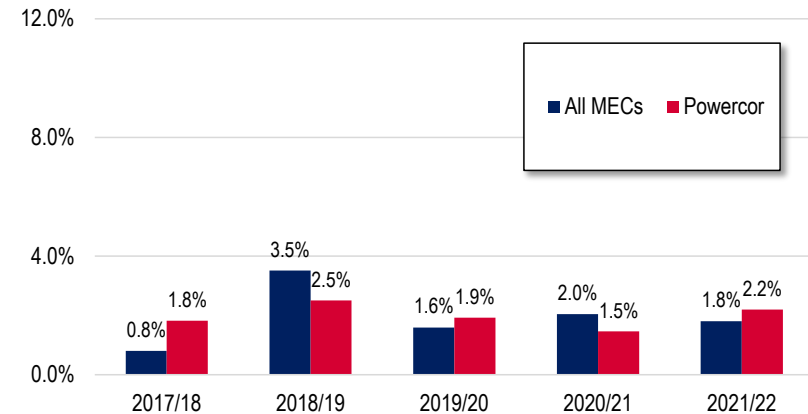
In 2021-2022, ESV observed an increase in the rate of major non-compliance affecting the Powercor network when compared to the rates observed in 2020-21 (Figure 47). A major non-compliance is regarded as high risk where vegetation is touching, or could soon touch, uninsulated conductors.

Figure 47 Rate of major non-compliances (HBRA and LBRA)
