Safety performance report on Victorian electricity networks

October 2022

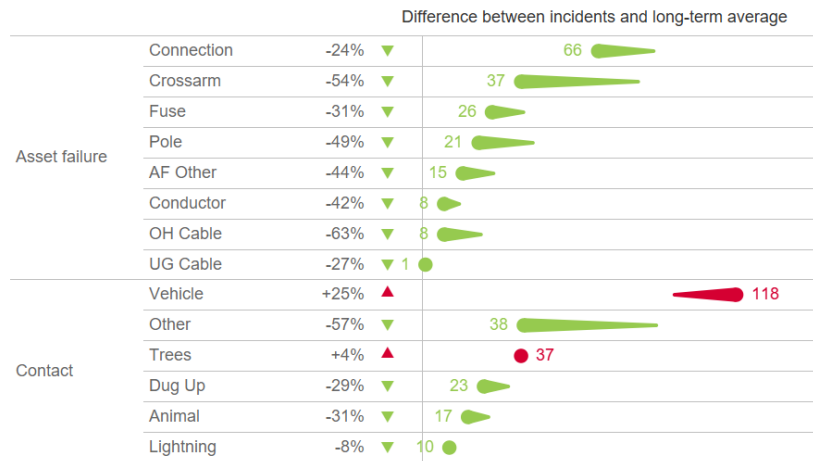
Figure 48 shows the number of all serious electrical incidents reported to ESV via OSIRIS by Powercor during the 2021-2022 period. The green arrows show the reduction from the long-term average across the 2010-2021 period (improvement), and the red arrows show the increase (decline). Figure 49 shows the same for those incidents that result in a ground or vegetation fire.

The most common incidents on the Powercor network in 2021-2022 were vehicle impacts, connection faults, other contact events, crossarm failures and tree contact. Two of these items (vehicle impacts and other contact events) are not within the control of the Powercor, two are within the direct control of Powercor (connection faults and crossarm failures) and one is partly within its control (tree contact). The numbers of incidents were lower in 2021-2022 than the long-term average in all asset failure categories. Vehicle impacts have increased, tree contact is stable and the remaining four contact categories have decreased.

Figure 48 Incidents on the Powercor network

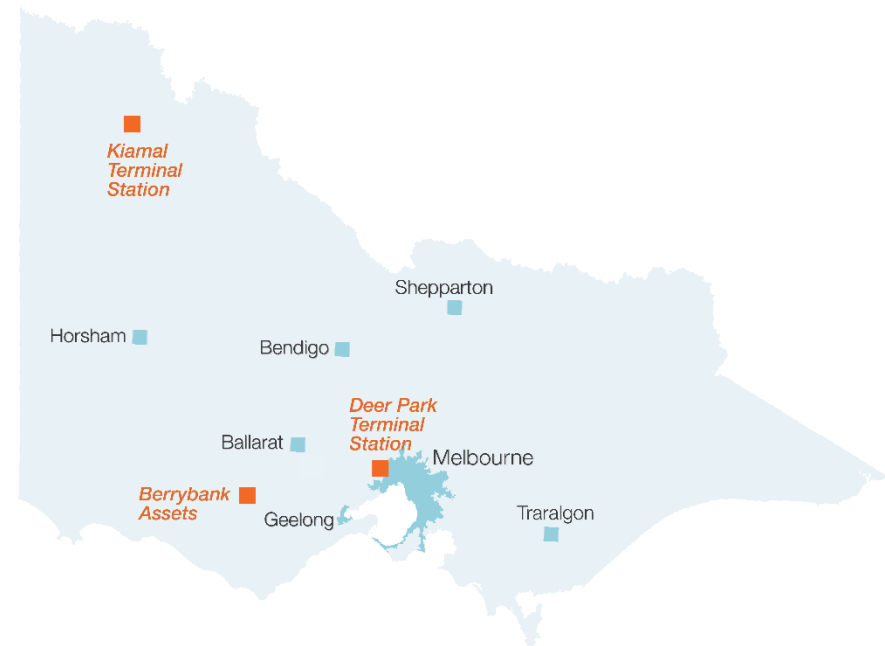
TransGrid operates and manages the high voltage electricity transmission network in NSW and the ACT. Recently, TransGrid has expanded its asset base to include assets in Victoria where it is servicing specific customer projects. These assets include the Deer Park Terminal Station, the Kiamal Terminal Station and the Berrybank Terminal Station and Zone Substation. TransGrid also operates a 7.5 km 220kV overhead transmission line from Berrybank Terminal Station to Berrybank Zone Substation (Figure 50).

Figure 50 Locations of TransGrid assets (orange squares)

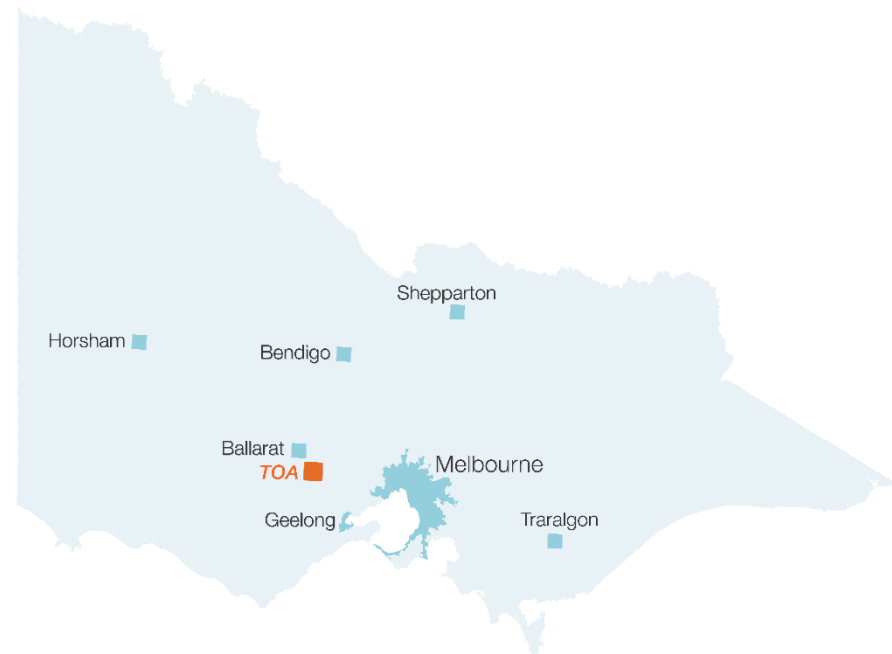
TOA owns and operates the connections from the Mt Mercer Wind Farm and from the Moorabool North and South Wind Farms to the electrical transmission network (Figure 51). The Mt Mercer transmission line is a 22km 132kV powerline and the Moorabool North and South transmission line is a 30km 132kV powerline. Both connect to the Elaine Terminal Station, which steps the voltage up from 132kV to 220kV for injection into the AusNet Services transmission network.

Figure 51 Location of TOA transmission assets (orange square)

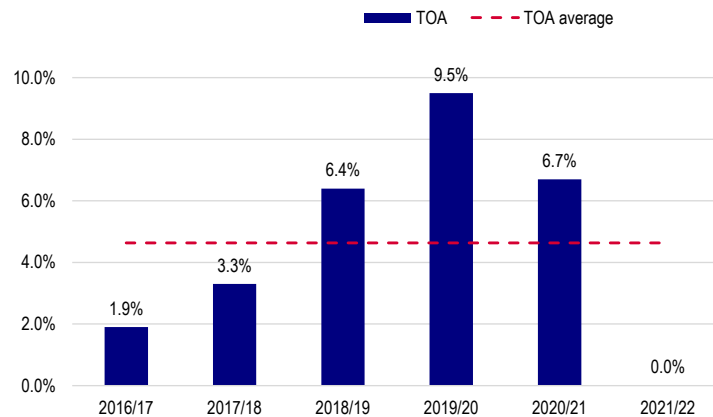
In last year’s network safety performance report, we noted that the upward trend had been addressed with a reduced non-compliance rate being observed in 2020-2021. This reduction has continued into the 2021-22 period (Figure 52).

Figure 52 Non-compliance rates for TOA

In 2019-2020, ESV noted that there had been a steady increase in the rate of non-compliant vegetation affecting this network each year since 2016-2017.

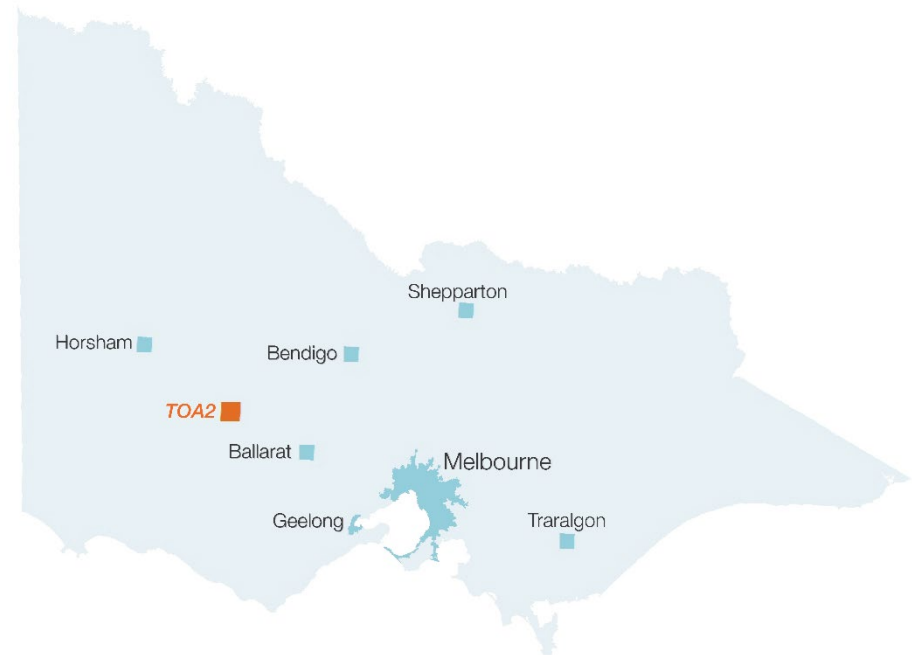
TOA2 owns and operates the connection from the Ararat Wind Farm to the electrical transmission network (Figure 53). This includes a 21 km 132kV powerline and the Ararat Terminal Station, which steps the voltage up from 132kV to 220kV for injection into the AusNet Services transmission network.

Figure 53 Location of TOA2 transmission assets (orange square)

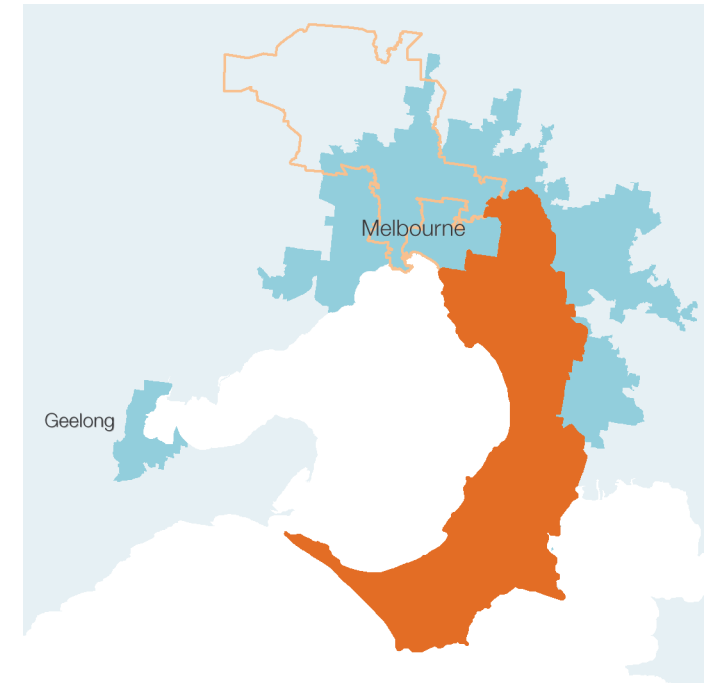
The distribution network covers an area of approximately 1,470 km² across Melbourne's eastern and south-eastern suburbs and the Mornington Peninsula (Figure 54). It comprises approximately 9,920 km of overhead line, 4,010 km of underground cable, 168,500 poles and 35,000 public lighting poles. Half of the United Energy network (50 per cent) is in HBRA.

Figure 54 Service area for the United Energy distribution network (orange area)

Jemena and CitiPower service boundaries are shown as orange lines

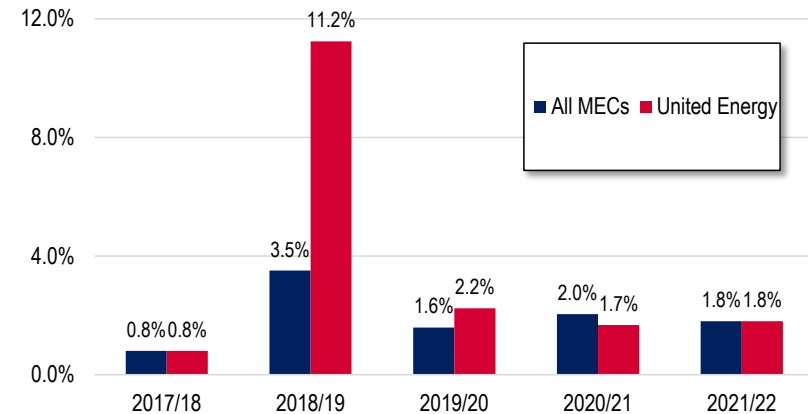
In 2021-2022, ESV observed a small increase in the rate of major non-compliance affecting the United Energy network when compared to the rates observed in 2020-2021 (Figure 55). A major non-compliance is regarded as high risk where vegetation is touching, or could soon touch, uninsulated conductors.

Figure 55 Rate of major non-compliances (HBRA and LBRA)

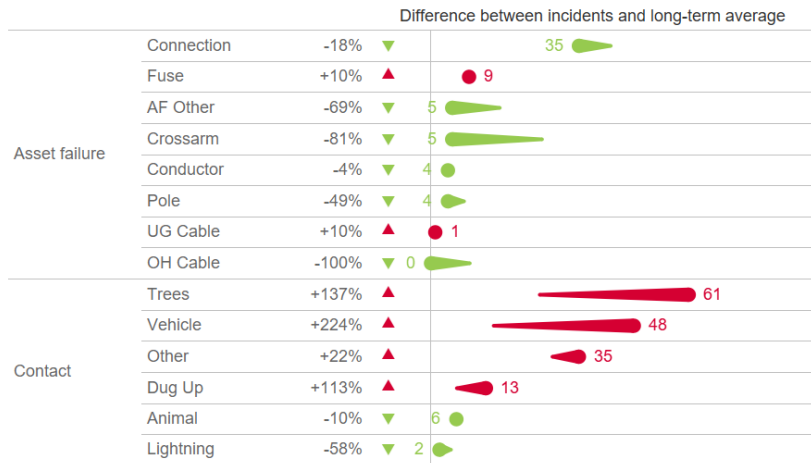
Figure 56 shows the number of all serious electrical incidents reported to ESV via OSIRIS by United Energy during the 2021-2022 period. The green arrows show the reduction from the long-term average across the 2010-2021 period (improvement), and the red arrows show the increase (decline). Figure 57 shows the same for those incidents that result in a ground or vegetation fire.

Figure 56 Incidents on the United Energy network
